Pinhole leak discovered in process gas line

19 June 2011

Alert ID: 00xxx

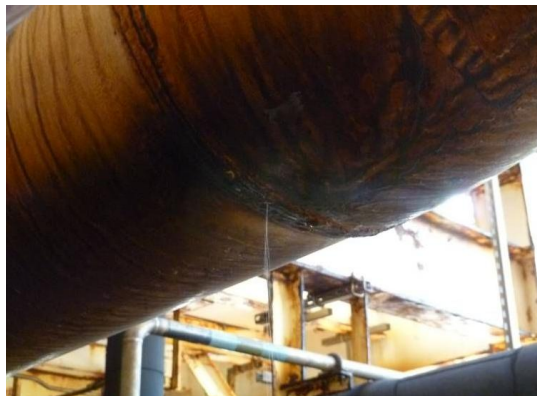
An operator was carrying out daily routines on the gas compression upper deck when a leak was observed from the six o'clock position of a circumferential butt weld in a 14" line in the process gas system. The CCR was contacted and the plant shutdown immediately. Initial external visual inspection found that the leak was a pin hole in the weld.

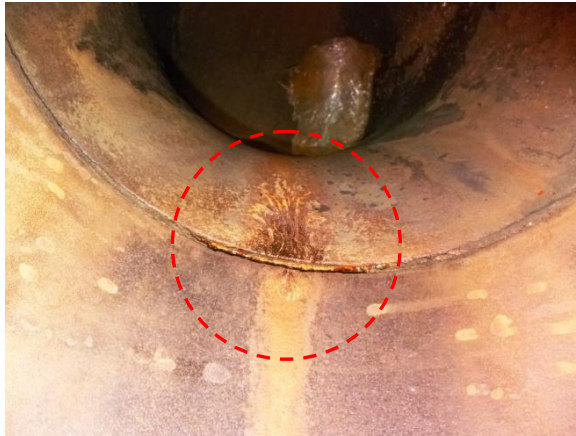
A metallurgical analysis of the welds and analysis of the corrosion deposits was conducted. The analysis concluded that cause of the weld failure was carbon dioxide corrosion, in the form of preferential weld attack. The analysis indicated that the weld metal contained ~0.7% nickel, and that the hardness values for the welds were normal. A review of welding

Lower part of the pipework
(six o' clock position- Localised Root Defect)

recommendations indicates that this weld consumable is satisfactory, i.e. the welding itself is not a root cause for the failure. Visual inspection of corroded welds indicates that weld corrosion initiated at the weld heat affected zones (HAZ) either side of the circumferential butt welds by a galvanic corrosion mechanism and progressed, at the most corrosive locations, into the weld metal itself, probably due to erosion corrosion once the circumferential grooves had formed at the HAZ.

1. Conduct cost-benefit analysis of the cost of installing and operating a gas phase corrosion injection system against a medium term replacement of the line in a CRA (corrosion resistant alloy)

2. Line replaced prior to commencement of production
3. Future projects to have the appropriate level of "Maintenance and Operations" experience involved, at the design stage to ensure that operating experience, practical requirements, best practices and lessons learned are incorporated into the design. The findings of this investigation (with regard to material selection and corrosion) to be communicated to engineering design teams.

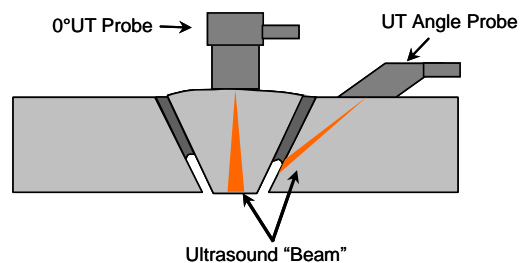
Fig. 5.- Compression (0°) and Angle probe UT Probe Weld Scans

3. Zero degree UT inspection techniques failed to identify the weld corrosion. In December 2010 the welds had been inspected using this method and were found to be at nominal or near nominal thickness. On the welds inspected, the morphology of weld corrosion that had occurred has concentrated metal loss in a narrow band of the HAZ either side of the welds, and the severe root corrosion was limited to small areas at the 6 o'clock position thereby making detection of the defects difficult. A UT angle probe would have highlighted the weld root/HAZ corrosion.

4. The use of the zero degree UT probe technique on its own to scan through the weld cap to detect weld root corrosion is no longer permitted and should be re-evaluated. Angle probe UT method now used to inspect weld corrosion. Corrosion management contractor will conduct an annual review of the appropriateness and effectiveness of inspection and NDT methods and techniques being employed taking into account industry lessons learned and advances in technologies
