Lessons Learned

“Beam Trolley Dislodged from Gantry Beam”

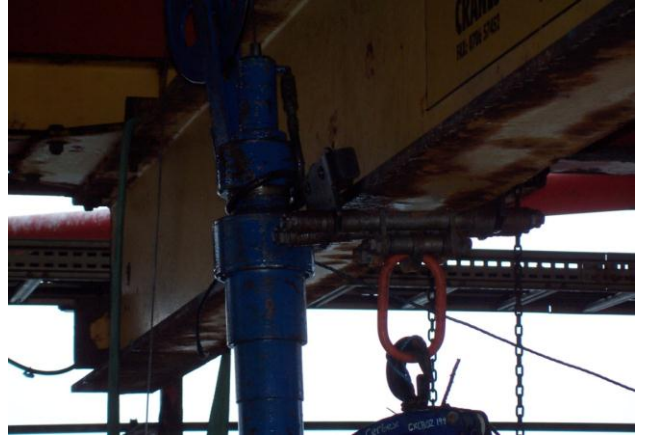
On the 18th May 2012 the wells team were performing well operations on the Bessemer installation involving a lubricator suspended from the overhead gantry crane. At 13:05hrs a member of the team identified that one of the wheels had come off the side of the beam and the second wheel had only a limited contact. Work stopped immediately. The lubricator and lifting equipment (including the beam trolley) were safely recovered to the deck and an investigation initiated.

Beam Trolley was incorrectly sized for the gantry beam (the wheel flanges were set approximately 11mm wider than they should have been):

The clearance between the wheel flanges (as shown on photo 1) on the beam trolley was 225mm, whereas the actual distance of the beam was 210mm. This gives an over sizing of 15mm.

Section 12.9 of the North Sea Lifting Rules (Safe Use of Beam Trolleys) states that the correct clearance should be between 1.5 to 2mm, therefore the maximum permissible clearance should have been no greater than 4mm.

Taking into account the maximum recommended clearance of 4mm, the clearance would have exceeded this by 11mm

The installation of a beam trolley constitutes a ‘rigging’ operation and by its very nature requires (as a minimum) an OPITO Stage 3 Rigger to perform this task. This was not identified at either the planning or implementation stages of the programme, therefore no provision was made for a OPITO Stage 3 Rigger, which ultimately led to the beam trolley being misaligned on the gantry beam during operation due to the fact that it was installed incorrectly.

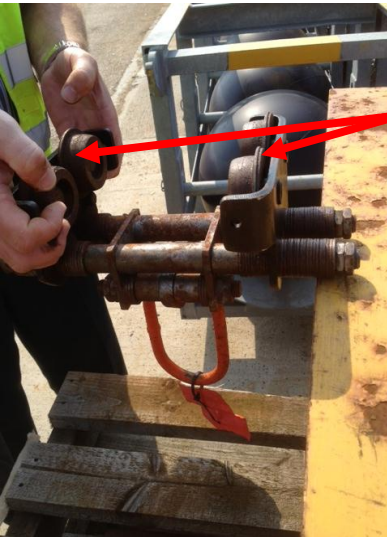
- Beam trolley was not installed by competent person and the fact that the beam trolley was too wide for the beam was therefore not identified during installation.
- Neither the onshore responsible supervisor nor the offshore crew using the equipment were expecting the beam trolley to be out of tolerance and assumed the beam trolley was supplied ready to be installed and used.

- Lack of understanding (both onshore and offshore) of the level of competence required for the installation of a beam trolley. Installation of a beam trolley is considered to be a ‘rigging’ operation and therefore requires a minimum competency of OPITO Stage 3 Rigger.
