# Hydraulic Fitting Failure Causing an Uncontrolled Descent of a Load

## **Safety Flash** Issued 27/09/2012

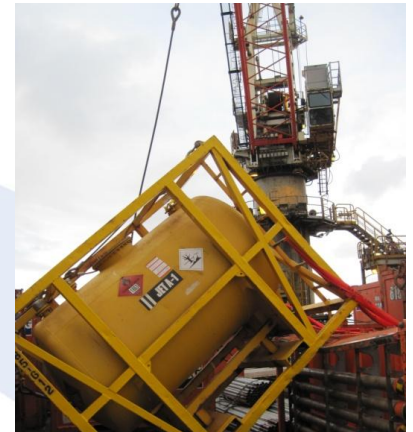
During a routine lift on an offshore installation, an uncontrolled descent of a load occurred. The lift involved a full 6 tonne heli fuel pod which was being lifted using the whip hoist from the east pipe deck to a height of approximately 20ft. The load being lifted was well within the capacity of the crane. During the hoisting process, the load descended rapidly, striking a wireline cage which caused the pod to tilt, causing damage to the deck plate. There were no injuries as a result of the incident but there was a release of approximately 100 litres of oil from the crane's hydraulic system, and approximately 1 litre of heli fuel from the vac breaker on the Pod itself due to the impact.

The heli fuel pod dropped 20ft striking the wireline cage before hitting the deck plate

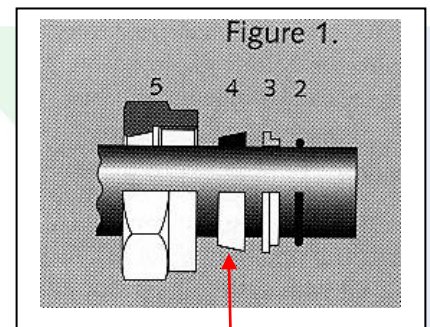
Investigations into the incident found that a section of hydraulic tubing had separated from a hydraulic fitting close to one of the whip hoist motors. The separation of the tubing from this fitting resulted in a sudden loss of pressure in the whip hoist system allowing it to pay out uncontrolled. The fitting itself was one of a number on the crane in an exposed location and had no protection from the elements. It relies on the serrations on the collet to grip the tube (component (4) on illustration, right) which were found to have severely degraded. The orientation of the fitting was vertically arranged allowing the build-up of salt laden water on the top surface as a possible aid to corrosion.

The fittings (some of which were over twenty years old) were not part of a planned maintenance or intrusive inspection regime.

- Similar hydraulic fittings should be examined and checked for excessive corrosion as soon as possible
- A planned maintenance schedule should be considered to specifically include hydraulic fittings
- The low boost pressure systems' response time in applying brakes should be established (where applicable) and appropriate action taken if found not to be effective.

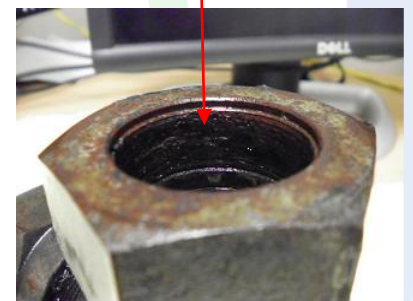
Failed fitting
