PS25834 Uncontrolled lowering of load Dangerous Occurrence

Incident description

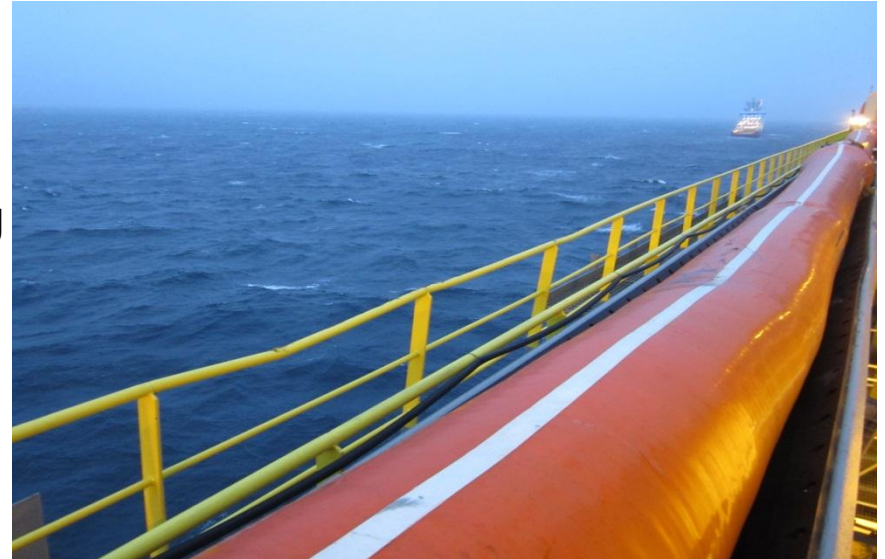
- During cargo offload Framo hydraulic oil system tripped causing the crane to stop. The load remained suspended by the crane brakes.
- On restart of Framo system the load (7te container) was allowed to lower in an uncontrolled manner, coming to rest on the cargo offload hose and guardrail.
- Once Framo system had been fully restored the crane was function tested and the load returned to the supply vessel.

- Crane being used in Lift From Supply Vessel (LFSV) mode.
- Crane hydraulic pressure system decayed to zero when Framo tripped.
- Framo system restored whilst in LFSV mode – brake released by design in this mode.
- Combination of position of ELLS (Emergency load lowering system) flow control valve & inherent oil leakage within motor allowed winch motor to descend faster than expected.

- Inadequate training in the correct use of LFSV function including inadequate identification of crane differences.
- No emergency operating procedures for the safe restoration of hydraulic oil pressure following Framo trip.
- FMEA considering potential failure mode of creation of HP flowpath could not be found.
- Framo system trip identified as common alarm, more specific cause of trip required.

1. Evaluate and revise training, add assessment module and roll out to all Crane Operators.
2. Create operating and emergency procedures. Incorporate suspended load exercises into HSSEQ plan
3. Consider LFSV mode change to automatic.
4. Hasten delivery of new crane Operating Manuals.
5. Assess the close out effectiveness of Maersk engineering change procedure
6. Carry out a reliability review of the Framo System.
