Step Change Safety Alert Template

TEMPSC support structure – loss of integrity

9th April 2013

Support structure for TEMPSC winch housing

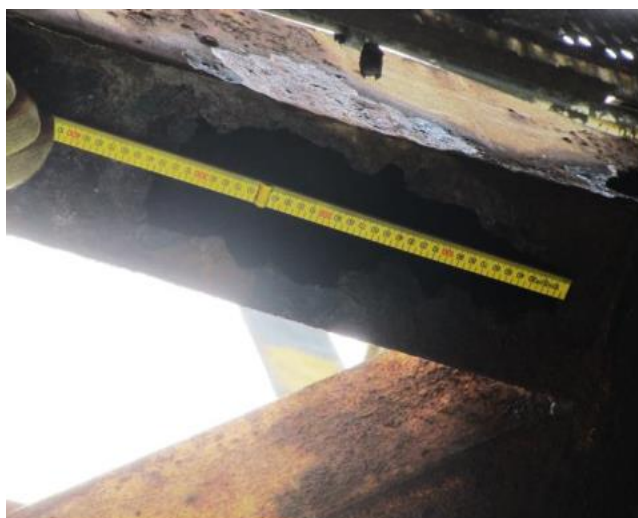
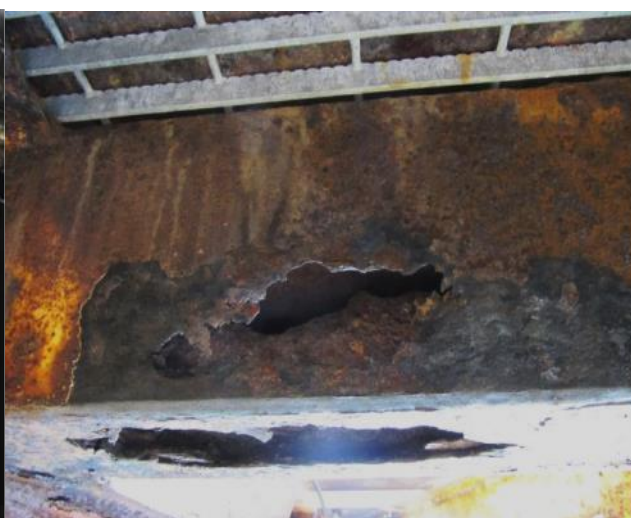
During an operation to clean the lifeboat cantilever platform pad eyes and retaining pins, the inboard rectangular hollow section (RHS) beam, or 'box section', supporting the lifeboat winch was struck with a hammer causing a significant piece of corrosion to be displaced from the side of the RHS. Further close visual inspection revealed the beam was holed.

A further survey was carried out by a structural specialist to determine the extent of the corrosion and loss of wall thickness on the RHS beams. During this inspection, significant corrosion and total loss of wall thickness was discovered resulting in the loss of structural integrity.

The survey report stated that the RHS in question was not in a suitable condition for use. The material loss due to internal corrosion was found to be significant to the winch supporting RHS members. Due to the extreme severity of material loss there would be no alternative but to take the lifeboat out of service until remedial work was undertaken to the RHS.

Internal corrosion not identified within RHS

- *Conduct investigatory surveys on other installations in the field to identify all locations where RHS beams are installed and determine their inspection technique and frequency in the RBI program, this may include NDT to determine wall thickness and potential internal corrosion*

- *Ensure that specific survey information from commissioned reports and actions are registered and transferred to workpack scopes. Actions to be raised as work orders in MMS. Ensure that individuals associated with these actions are clear on their responsibilities in terms of information flow and capture.*
