Incident alert template

Summary
Barrow used to transport a spool tipped during manoeuvre.

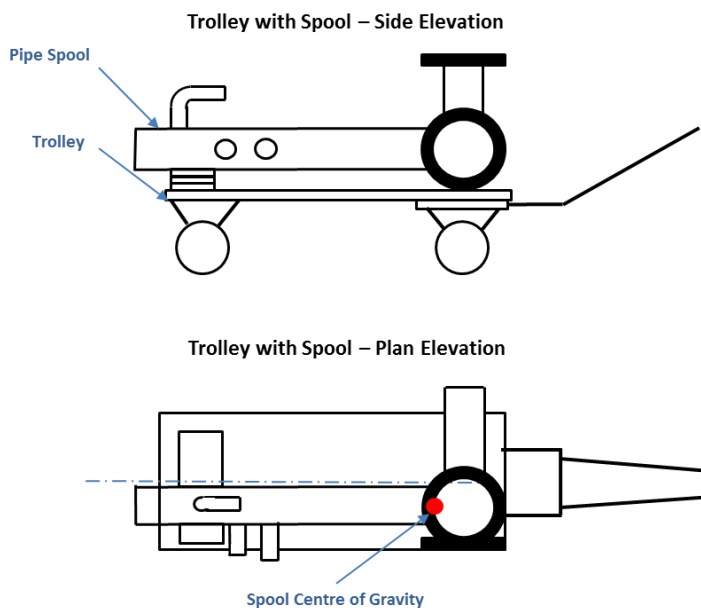
Figure 1

Cause of accident or incident
The potential for the instability in the trolley was not identified during the loading or manoeuvring of the trolley.

A spool was secured on a 4 wheel trolley with the Centre of Gravity of the spool located towards the front corner of the trolley (Figure 1). When the front wheels of the trolley were rotated to move the assembly, the combined trolley plus load became unstable due to the location of the centre of gravity relative to the wheel position resulting in the load overturning (Figure 2). Part of the spool struck the Injured Party as it tipped over.

- When undertaking manual handling activities, the combined risk of the load, the equipment and the transportation route need to be fully assessed.
- The design of barrows used should be reviewed and fully considered.
