National Offshore Petroleum Safety Authority

Safety Alert 17 : Engine Room Fire

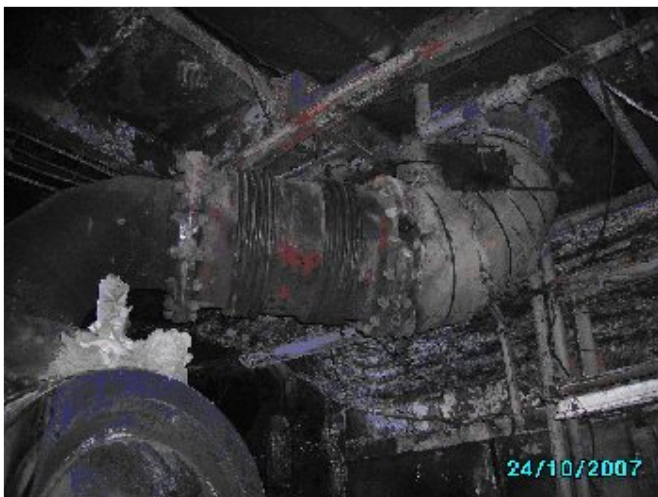
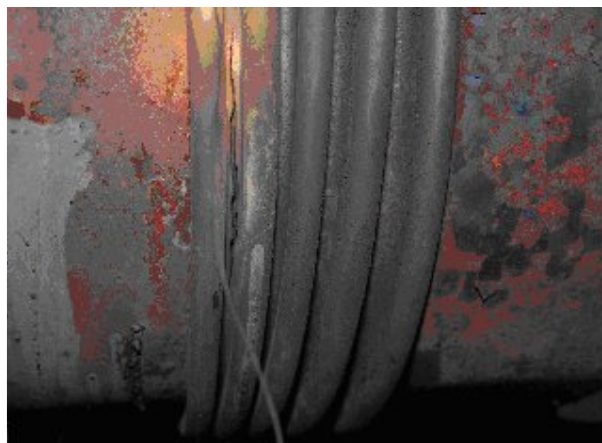
The cause of the fire is believed to be radiant heat from an uninsulated and cracked exhaust bellows igniting the insulation in the deck head. The insulation was later found to be soiled (loaded with soot and hydrocarbons). The fire spread through the engine room and briefly flashed over to the engine room roof.

Above Pictures - Uninsulated and cracked engine exhaust bellow where fire was thought to initiate. Picture to right - Hydrocarbon contaminated insulation on an adjacent engine exhaust bellow. A hole in the pipe was found when the insulation was removed for inspection.

- Engine room fires are a very serious risk. Inspection and maintenance of exhausts, fuel lines, turbochargers & superchargers are critical, including the inspection and replacement of contaminated/damaged insulation. Housekeeping and cleanliness make a difference in reducing risk and damage.
- Provision and testing of emergency equipment is critical (in this case some CO2 cylinders did not activate when required and some portable fire extinguishers did not function). Redundancy in emergency systems can save lives.
- Consideration for facility specific common mode failures and escalation factors (in this case the rig air system).
- The role of stand-by vessels is critical.
- Highlights importance of emergency response for various scenarios. Practice makes perfect.
