Step Change Safety Alert Template

Gas Leak from Actuated Ball Valve Trunnion

26/03/2014

Offshore Fixed Production Platform

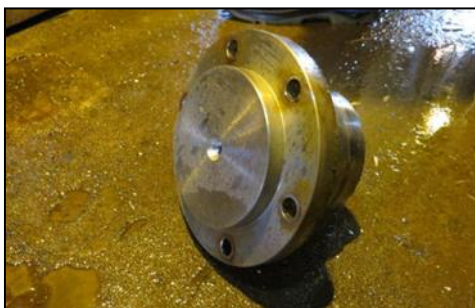
During investigation of the scene, the trunnion from SDV-11379 was found to have parted from the valve body causing a loss of containment. The trunnion, installed in the 6 o'clock position approximately 1 metre from the deck, was projected vertically downwards. The trunnion bounced off some scaffold boards underneath the valve and then struck a 2" cooling medium pipe, before coming to rest circa 1.7 metres from the valve.

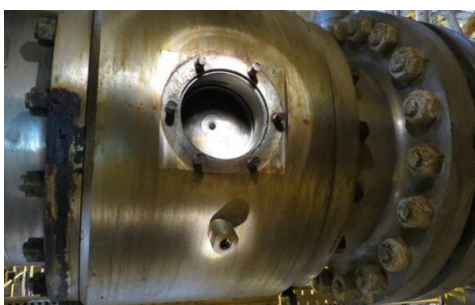
The investigation of the valve found that the six of six trunnion fixing cap screws remained screwed into the valve body but all cap screw heads had separated from the cap screw (at the shoulder). Five out of the six cap screw heads were recovered from the deck within a ten metre radius of the valve.

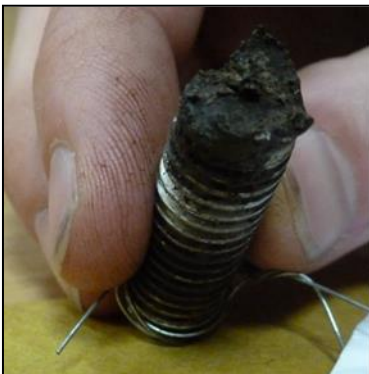
Visual inspection of the cap screw fractures revealed extensive corrosion product covering the fracture faces with the exception of a small corrosion free region on one cap screw. Chemical analysis of the failed cap screws determined the composition to match UNS S30430 stainless steel. Metallurgical examination of the cap screws confirmed the presence of cracking characteristic of chloride induced stress corrosion cracking (SCC) in six out of six capscrews. The corrosion free region noted on one cap screw exhibited no signs of chloride SCC.

It is concluded that the cap screws failed due to chloride induced stress corrosion cracking, with the final capscrew failing in tensile overload due to the pressure force exerted on the trunnion during pressure equalisation across the valve. The total failure of the trunnion cap screws allowed the valve trunnion to be projected under line pressure from the valve.

The valve is installed in a gas compression module with deluge coverage, increasing exposure to a chloride environment. Process design temperature for the valve is 130°C. The valve has been in service for circa 21 years. The trunnion is located at the bottom of the valve (6 o'clock position), allowing water to travel down the valve body, under the trunnion flange and collect in the recess within the trunnion bolt holes around the cap screw shanks.

- Undertake a review of asset valve populations to identify those valves potentially at risk from Chloride induced SCC considering valve; operating temperature; design and materials of construction; location and potential for chlorides environment.
- Replace trunnion cap screws of valves potentially at risk with cap screws not susceptible to Chloride induced stress corrosion cracking
- Review company material / valve specifications and revise as required to recognise failure mode and specify materials accordingly
- Develop and implement a Long Term Strategy for valve cap screw inspection and replacement
- Review and revise the asset ALE strategy based upon learning from this incident
