Step Change Safety Alert Template

Small gas weep identified in vent line as gas introduced

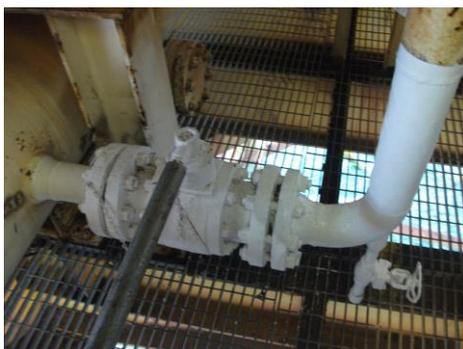
4" valve from export header was opened manually to vent gas to atmosphere in line with correct procedures. Upon opening the valve it became immediately apparent that there was a pin hole in the piping just downstream of this valve (within 18") on the 4" line. The Valve was immediately closed.

This valve had been subject to the action following an anomaly report to replace 32 flange nuts and a recommendation to clean and paint the remaining sections of the valve body in June 2013. The flange studs and nuts were replaced and the valve body was grit blasted and painted as recommended. A further approximately 18" section of the 4" diameter vent pipework was also grit blasted and painted, this additional section had not been inspected and was not included on the anomaly report. The decision to carry this out was made by the painters. During the grit blasting process to remove the rust, a section of the pipe developed a pin hole resulting in a very small weep from the pin hole when the line was put back into service.

- To mitigate future issues of this kind, the procedure included in the work pack has been amended to undertake Inspection following any cleaning and painting of pipework prior to being put back into service.
