Safety Alert #237

REVISION A

To: All Frank's locations
Subject: **High Potential Near Miss Incident – Involving a Belt Tong** Gearench SCT2036
Purpose: Lessons & Awareness to Prevent a Recurrence; *Interim Torque Ratings* / Limits to be used while investigation continues.

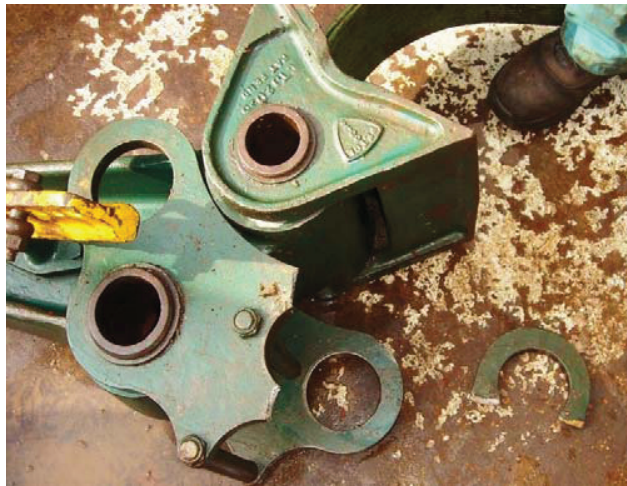
Figure 1

A High Potential Near Miss incident has occurred on a Frank's job while making up 36” conductor pipe using a Belt Tong. Three joints had been made-up to 40,000 ftlbs of torque. When making up the fourth connection, the driller reached approximately 25,000 ftlbs when part of the tong fractured and fell approximately 5ft to the drill floor. No personnel were injured in this incident as procedures had been followed and all personnel had moved to places of safety during the make-up operation (see *Figure 1*).

- Damage from previous use of the tong without ensuring that the latch pin was fully engaged with the lower Yoke Plate overloaded the upper Yoke Plate and created cracks. With time and subsequent use, these cracks grew to the point that the upper Yoke Plate was no longer able to resist the load, ultimately fracturing the plate.
- Quality control issues, while not directly responsible for this incident, have been uncovered. The problem relates to the strength of the plate not fully meeting specification.

- **Immediately** MPI all Belt Tongs, not already inspected since 11 January 2008, per the manufacturer’s guidance attached, Frank's maintenance procedure OPS-P-4.1.6 and Frank's inspection procedure EI-P-4.1.8.
- **Always** ensure that the belt retaining pin is fully engaged before commencing make-up / break-out operations. As always, ensure that all personnel stay clear of tools during make-up & break-out operations.
- Due to quality issues recently discovered relating to a lower than specified material strength in the Yoke Plates, FRANK’S is imposing lower *Interim Torque Ratings* for these tongs. (See *TABLE 1*) These limits will remain in effect until the issues can be resolved and additional corrective actions taken. At that time, Service Bulletin 150 and this Safety Alert will be revised, and re-issued.
