# National Offshore Petroleum Safety Authority

# Safety Alert 19 : Dropped Blocks

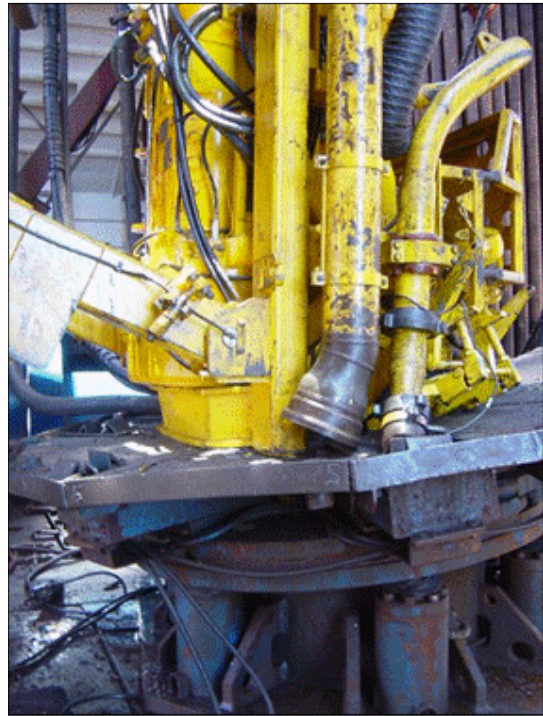
The semisubmersible Mobile Offshore Drilling Unit (MODU) was in the final stages of pulling the Blowout Preventer (BOP). The BOP was being lifted the last metre to gain clearance for access to the BOP transporter in the moonpool. With the travelling block at the uppermost limit, the Kinetic Energy Management System (KEMS) was 'tripped', and the resulting action was not as expected. A failure in the drawworks disc braking system allowed the traveling blocks, complete with riser and suspended BOP, to descend approximately 50 metres in an uncontrolled manner, until the Top Drive impacted against the riser gimbal at the rig floor level. The subsequent investigation concluded that there was no operator error and the incident was a result of a disc brake system failure.

Top drive impacted on riser gimbal at rig floor

The anti-bird nesting components were incorrectly installed thus limiting the 1200 psi used to function the service brake to 200psi.

When the drawworks were hoisted into the KEMS upper limit the anti-bird nesting system reduced the pressure to the service brakes from 1200psi to 200psi and the emergency brake pressure was dumped allowing the calipers to set. Due to the limited supply pressure of 200psi, the service calipers had minimal, if any, effect. The emergency calipers and Elmagco brake were not designed to stop the load under dynamic conditions on their own.

Causal factors included incorrect installation of the anti-bird nest / disc brake hydraulic interface; inadequate commissioning of the upgraded (6 months prior) disc brake system; the disc brake system handover from the supplier to rig personnel was inadequate; Management of Change process during system upgrade was not implemented effectively; and follow up and understanding of previous disc brake incidents was inadequate

- Rigs equipped with disc brakes equipped with anti-bird nesting functions should be alerted to the potential problems arising from incorrect installation of hydraulic control valves.

- Commissioning procedures for modifications to existing facilities should be reviewed to ensure:
  - Commissioning is carried out on a complete system basis, as well as on the system interfaces.

- User training is adequate to obtain sound knowledge of the upgrade and its impact and interactions with other facility systems.
  - As built drawings and operating manuals are available to facility personnel for newly installed/upgraded systems

- Rig owners should review the implementation of their Management of Change process to ensure that it is properly implemented for upgrade work on their facilities with clear work scopes and accountabilities identified.
