Marine Safety Forum – Safety Flash 08-12

Issued: 4th March 2008

Subject: Seaman Injured in Crane Pennant Wire Incident

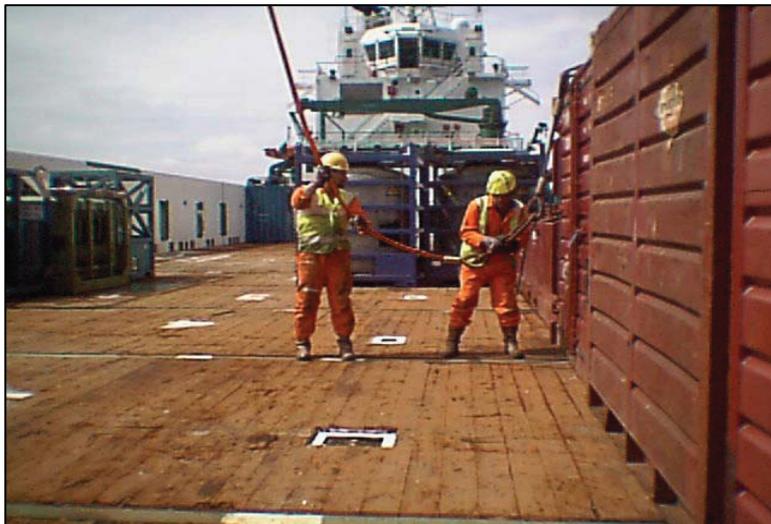
Two ABs were in the process of disconnecting a 20-foot half height basket, AB1 holding the crane pennant and AB2 disconnecting the hook. As the stern of the ship fell into the trough of a wave, AB1 suddenly found himself hoisted into the air 2-3 feet, at which point he let go and landed on the deck on his feet. He felt a slight twinge to his back but continued working. When the ship left the platform, he informed the bridge of the incident but continued working until the end of his shift.

Posed photograph showing typical activities while connecting/disconnecting a container

- Though the ABs had concerns about the movement of the hook and pennant wire, they did not call a safety time out.
- The ABs should not have continued to disconnect the pennant if they felt there was insufficient slack.
- If in doubt, 'stop the job' and review.
- Be aware that the stern of a ship has the greatest vertical movement in a seaway.
- A brief tool box talk must be held before every new or routine task to review the hazards.
- When an incident occurs, it must be reported immediately to prevent a recurrence, and early attention may help to mitigate any injury sustained.
