<b>HSE ALERT</b>	Reference Number:	HQS-HSE-AL-100
		Prepared / reviewed:	M Holmes/W Cabucio
		Approved by:	J Moore
		Issue Date:	20 October 2008

## THERMAL TREE CAP (TEA COSY) FALLS RESULTING IN FATALITY

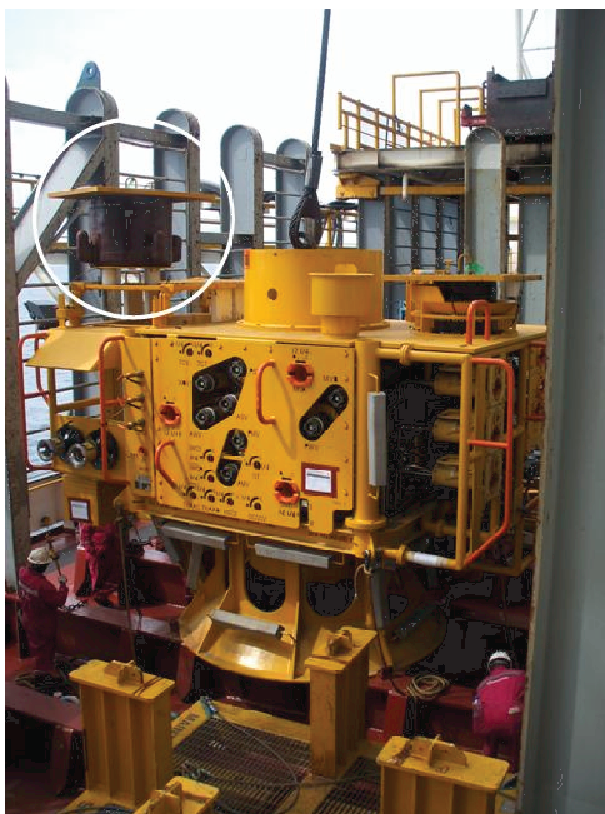
The operation was utilizing a rig crane to move a Subsea Tree from the storage bay to the transport trolley. When the tree was approximately 20 inches above the trolley, a crane failure resulted in a non-powered descent of the tree to the trolley. As a result, the unsecured thermal cap was dislodged from its pedestal and fell, fatally striking an employee involved in the task. The thermal cap weighed approximately 980 pounds.

1. An unsecured Thermal Cap along with an uncontrolled descent of the Subsea Tree, resulted in the thermal cap being dislodged, while suspended by the crane.
2. This uncontrolled descent of the Subsea Tree occurred due to an over-torque of the crane's motor that operates the main block hoist.

- Review, with respective operators and their suppliers, the operator's and their supplier's Dropped Object survey accompanying Subsea Trees planned to be handled or run on company installations.
- If a Dropped Object survey has not been conducted, it must be completed and reviewed by all parties prior to handling or running any Subsea Tree.
- Ensure all items identified as potential dropped objects are either removed from the Subsea Tree (preferred method) or secured in a manner approved by the Subsea Tree supplier's engineering department to prevent and restrain the potential dropped object.
- The Rig Manager – Asset is responsible to review and approve the Subsea Tree supplier's engineered solution prior to implementing the securing method.

- The motor fitted to the main block hoist is consistent with the part number specified by the crane manufacturer manual.
- The motor fitted to the whip line is consistent with the part number specified by the crane manufacturer manual.
- The motor fitted to the boom hoist is consistent with the part number specified by the crane manufacturer manual.
- The findings from the above checks must be communicated to the Rig Manager – Asset and recorded in the installation's planned maintenance system.

- Ensure all equipment is assessed for dropped object risk as part of the **THINK** plan.
- Ensure all items identified as potential dropped objects are either removed or secured in a manner approved by the Rig Manager – Asset.
