LEARNING FROM INCIDENTS FOR INFORMATION

Learning Event no: Wells LFI -20

Business: **North Cormorant**

HIPO – DROPPED TOOL STRING INCIDENT

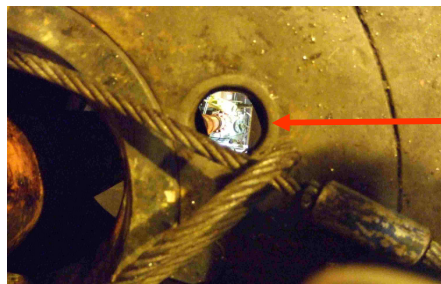
View from rig floor through Kelly bushing hole where stem fell through.

- Blanking off of Kelly bushing holes not implemented from previous incident.
- Risk of dropped objects from the drill floor to lower areas during rig up of wire-line not fully assessed by combined crew.
- No suitable hole/hatch covers provided on location for the skid deck hatch and rotary table areas. Tarpaulin was to be used on rig floor around riser.
- Manual handling of heavy toolstrings on rig is a two person job.
- Procedures not fully complied with by the combined crew requiring adequate hole covers during the operation.

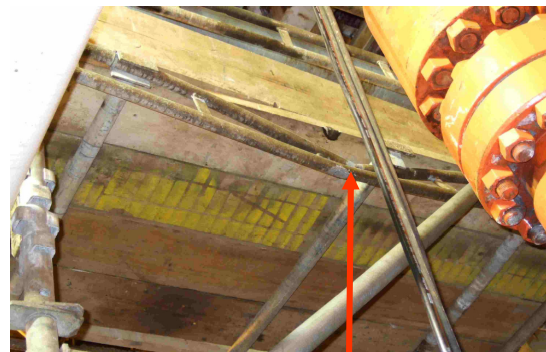
Damage to scaffolding in Mod 4 approx 45 ft from rig floor.

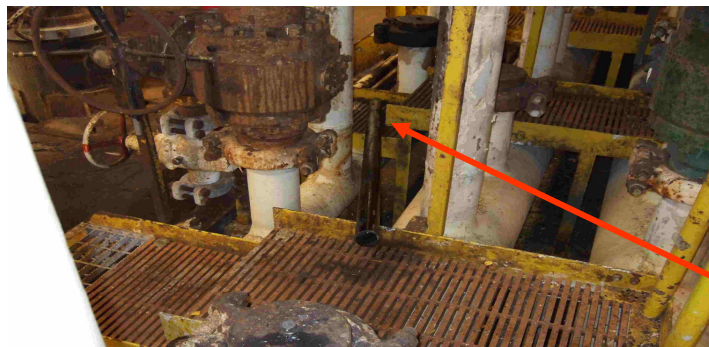
Position of tool in final resting place. Well bay deck.
