Safety Alert

From the International Association of Drilling Contractors

ALERT 08 - 37

FATAL INCIDENT – WORKER CAUGHT BETWEEN OUTRIGGER AND CHASSIS OF CRANE

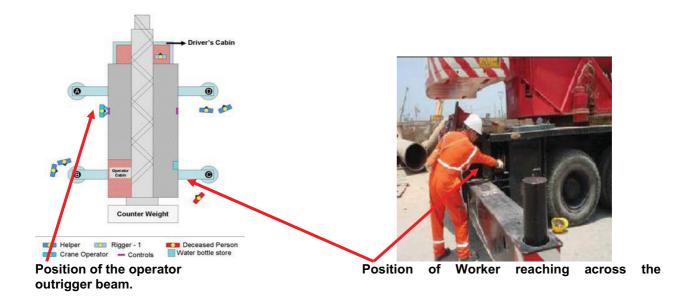
Six workers were preparing a truck-mounted crane for relocation in a lay-down area on the site. During outrigger retraction, one of the workers reached across an extended outrigger beam. It is thought that he was attempting to retrieve a water bottle stored in a recessed area of the crane chassis. As the outrigger was retracted into the sleeve, the worker was trapped between the chassis and the outrigger stabilizer cylinder. The worker was severely injured and transported by the other workers to the nearby hospital. Unfortunately on arrival the worker was pronounced dead.

- Human errors.
 - o The deceased placed himself between the crane chassis and the outrigger stabilizer cylinder.
 - The crane operator had no visual contact with the deceased as he operated the controls for the outrigger from the opposite side of the crane, instead of using the controls on the other side of the crane.
 - The deceased was not directly involved in the demobilization activity and the work area was not properly barricaded off to restrict access to the crane area.
- Inadequate risk awareness.
 - There was no evidence that a toolbox talk was conducted and that the specific risks associated with this activity were acknowledged and properly explained to the workers involved.
 - The work group was assembled ad-hoc for this activity comprising workers from different background and nationalities; hence language barriers may have hampered communication.

The supervisor left the work area before the task was completed as he considered this activity not being part of his work scope.

There was no adequate method statement and Job Safety Analysis (JSA) for this activity available as crane set up and breakdown activities were not properly addressed in the documentation provided for this job (e.g. lift plan, permit to work, JSA, etc.)

Several fatalities have occurred in the Group in the past involving crane operations. In general, risk management of those activities is focused on the actual hoisting and lifting operations at the site of work. This incident demonstrates that crane preparation or demobilization activities involve significant safety risks as well and hence require rigorous HSE management controls.

- Assure yourself that similar activities are adequately managed in your area of operational control and that key controls are effectively implemented when performing these activities by asking and answering the following questions:
 - Do you use similar type of equipment in your area of operation?
 - o Are preparation and demobilization activities treated as being part of your lifting and hoisting plan?
 - Determine if clear procedures are developed and work instructions for these activities are communicated?
 - o Do you supervise these activities permanently?
 - o How well are your workers trained in executing the emergency response plan?
 - o Determine how you are going to deal with language problems?
- Conduct a toolbox talk prior to commencing the work.
- Ensure that the work area is barricaded off to prevent access to the crane area for those not involved in the crane operation.
