# Safety Alert

From the International Association of Drilling Contractors

ALERT 08 – 42

## DROPPED OBJECT: KELLY DISCONNECTS FROM HOOK

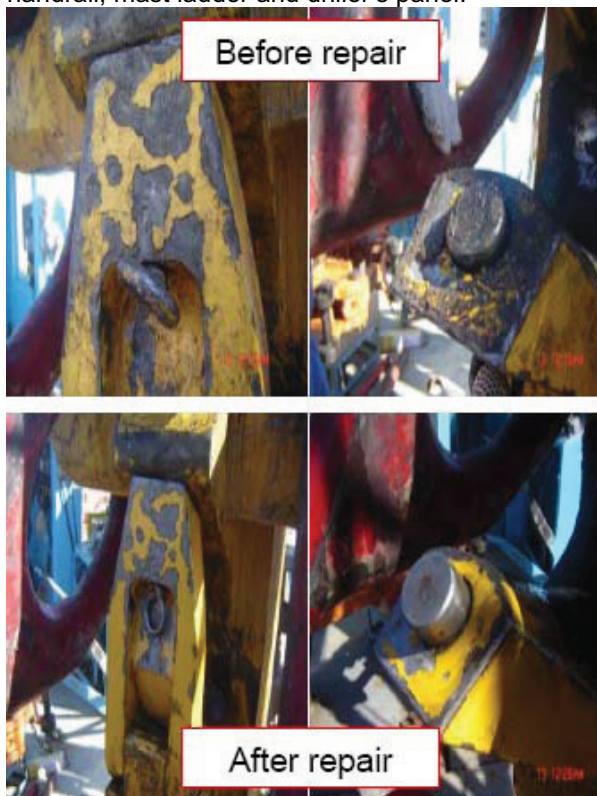
During drilling of the surface hole (12 ¼"), the driller made a connection and started to wash / ream down to bottom. Due to tight hole conditions, the drill string stopped two feet before the bushings were able to be set into the rotary table. The driller received direct instructions from the company representative to operate the kelly spinner to overcome the tight hole and the drill string did move down for ½ foot. The driller was re-instructed by the company representative to move the string up and down. During the process of moving the string down, the drill string reached a bridge, but the driller didn't notice it. This resulted in the string bouncing and the swivel hitting the hook, causing the latch to open and the kelly to drop to the rig floor resulting in damages to Kelly, rig floor handrail, mast ladder and driller's panel.

- The rig was provided with a 220 ton swivel instead of 150 ton swivel. Due to this, the bail diameter of this swivel is bigger than the hook space could accommodate. The larger bail made it difficult to close the hook without using force. This mismatch was not assessed by the engineering team or the rig crew. Failure to follow Management of Change (MOC) procedures.
- The air hoist was attached to a whip check that was used to close the lock of the hook latch. This resulted in bending the locking pin, preventing the pin from fully engaging. (Deviation from standard procedure).
- The driller was not paying attention to the hook load (weight indicator), so hitting the bridge caused the kelly to bounce.

- Swivel was replaced with one that fit the hook opening. In addition the kelly was replaced.
- The latch lock was repaired and the hook pin was inspected.
- Rig supervisors were instructed that any change in equipment shall be accompanied with a risk assessment in order to identify hazards and consequences. *Refer to the company's "Design Control and Development", Procedures and instructions Manual.*
