**TYPE OF INCIDENT:** NII  
**INCIDENT No:** 06-2009  
**COUNTRY:** UK  
**DATE OF INCIDENT:** 18/03/09

**BRIEF ACCOUNT OF INCIDENT:**

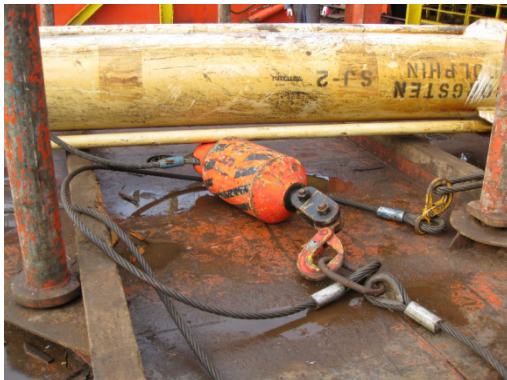
OPERATION WAS MOVING THE NEW SLIP JOINT FROM THE RIG FLOOR TO THE DECK USING THE STARBOARD CRANE WHIP LINE. THIS WAS SUCCESSFULLY COMPLETED BUT RE-POSITIONING WAS REQUIRED, AND ON THE 2<sup>ND</sup> RE-POSITIONING LIFT THE CRANE WHIP LINE DRIVE FAILED AND THE SLIP JOINT DROPPED APPROXIMATELY 18” TO THE DECK FOLLOWED BY THE HEADACHE BALL AND ABOUT 40’ OF WIRE.

Although procedural failings were identified, the incident was caused by a mechanical failure of the crane which could have happened at any time and with any lift. Undetected defects such as this one are very dangerous and normal PM routines will not detect them. Any expert third party recommendations for intrusive inspections should be complied with in a timely fashion.

WHenever anything is lifted which is anywhere near the upper limit of the whipline SWL and there is any doubt at all of the exact weight, then it must always be treated as a main block lift.

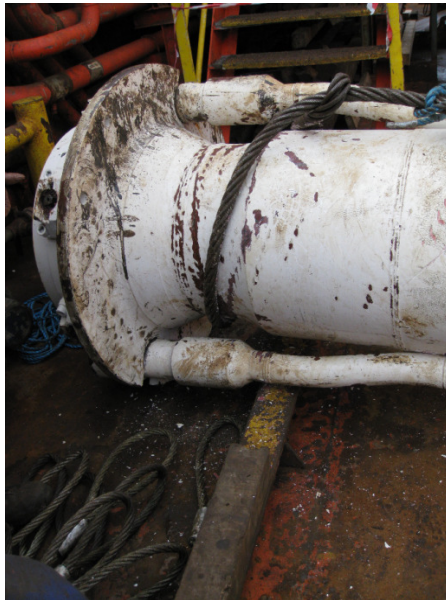
THE LOAD INDICATOR ON THE CRANE WAS UNRELIABLE, AND ALTHOUGH SPARES HAD ARRIVED, THE TIME HAD NOT BEEN TAKEN TO AFFECT THE REPAIR. A WIRELESS LOAD CELL HAD BEEN HIRED AS A STOP GAP UNTIL THE LOAD INDICATOR WAS REPAIRED BUT IT WAS NOT USED FOR THIS LIFT.

INFORMATION ABOUT THE WEIGHT OF THE NEW SLIP JOINT WAS MISLEADING AND MOSTLY INCORRECT AND IT WAS NOT MARKED SHOWING THE WEIGHT.
