# LESSONS LEARNED REPORT

## LINK ARM RETAINING PIN FELL 7 METRES TO RIG FLOOR

**TYPE OF INCIDENT:** NII  
**INCIDENT NO :** 470-08-12  
**COUNTRY:** UK  
**DATE OF INCIDENT:** 4<sup>TH</sup> MAY 2009

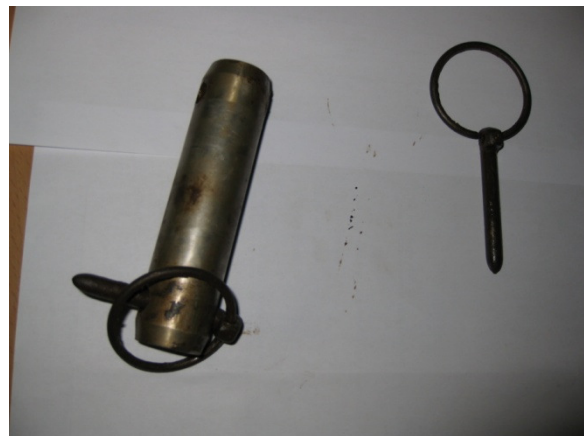
AT THE TIME THE DRILL CREW WERE USING THE YELLOW (PORT SIDE) TUGGER TO LIFT THE TEST NUBBIN ONTO THE RISER AFTER RUNNING 2 JOINTS AS PER PROGRAM. THE VICTORIA ARM WAS BEING USED TO POSITION THE NUBBIN OVER THE RISER SO TO MINIMISE PERSONNEL ON THE RIG FLOOR. AS THEY LIFTED THE NUBBIN TO THE DECK THE TUGGER OPERATOR DECLARED HE FELT A JOLT AND HEARD THE PIN FALL TO THE FLOOR - HE THEN LOWERED THE NUBBIN TO THE DECK. THE LINK ARM RETAINING PIN AND 2 LYNCH PINS (AS SHOWN) WERE FOUND ON THE RIG FLOOR.

*Retaining pin c/w 2 x lynch pins*

LACK OF AWARENESS WAS SHOWN TOWARDS POSSIBLE SNAGGING POINTS. PREVIOUS ALERT RELATING TO THE DISCONTINUED USE OF COTTER PINS AS SECONDARY SECURING PINS FROM NOV HAD NOT BEEN COMMUNICATED TO THE RIG.

- USE NOV TO DETERMINE IF ALL ACTIONS FROM PREVIOUS SAFETY ALERTS PERTAINING TO PS2 500/500 HAVE BEEN COMMUNICATED AND CARRIED OUT.
- ORDER AND INSTALL NOV RECOMMENDED BEST PRACTICE RETAINING PINS AT EARLIEST OPPORTUNITY

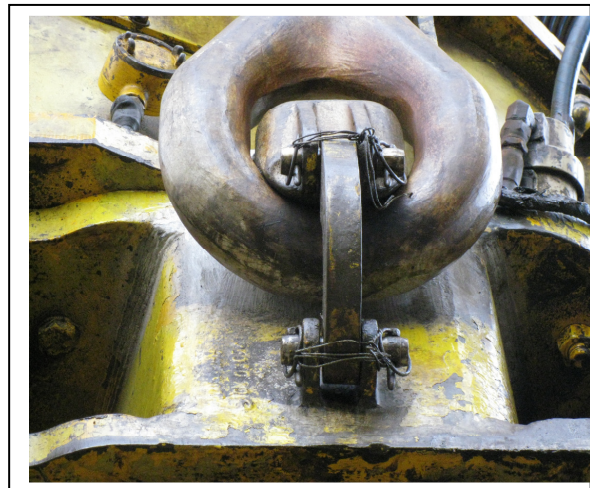
*Lynch pin with wirelock*

NO ONE GOT HURT. NO DAMAGE TO EQUIPMENT. RIG FLOOR WAS CLEAR OF PERSONNEL. JOB STOPPED TO ENABLE THOROUGH INVESTIGATION. THE DECISION TO WIRELOCK ALL 8 LYNCH PINS WAS TAKEN EARLY ON AND IMMEDIATELY PUT INTO PLACE.
