**TYPE OF INCIDENT:** NII  
**INCIDENT NO :** 480-09-4  
**COUNTRY:** UK  
**DATE OF INCIDENT:** 18<sup>TH</sup> MAY 09

DUE TO VIBRATION WHILST DRILLING TOP HOLE GLASS WEIGHING 1.5 KG FELL 12 METRES FROM WIND WALL FLOODLIGHT TO DECK.

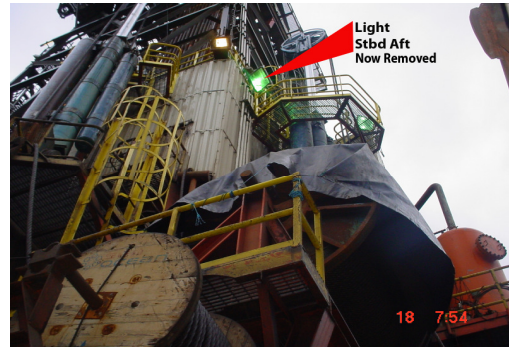
WHILST DRILLING 36 INCH TOP HOLE, WITH ASSOCIATED VIBRATION, A GLASS COVER FELL FROM A FLOODLIGHT POSITIONED ON THE STARBOARD WIND WALL POSITIONED AROUND THE DRILL FLOOR.

**LOCATION OF LIGHT PRIOR TO FALL**

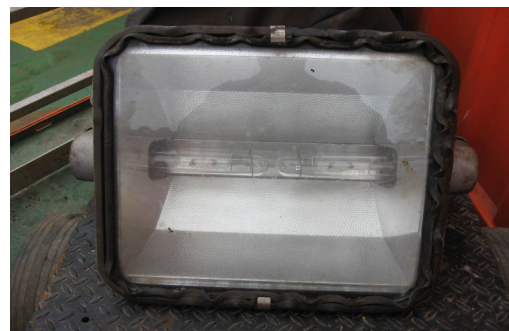
**PERISHED RUBBER ON ANOTHER LIGHT**

THESE TYPES OF LIGHT (PHILLIPS SNT 001 FLOODLIGHT 220V) NEED TO BE REPLACED BY A MORE SUITABLE VERSION. PLEASE CHECK THAT ALL YOUR FLOODLIGHTS ARE FIT FOR PURPOSE AND ADEQUATELY SECURED. FREE FROM DEFECTS, REGULARLY INSPECTED AND MAINTAINED IN GOOD ORDER. ALL EX RATED LIGHT FITTINGS SHOULD BE CHECKED TO ENSURE EX INTEGRITY AS THIS CAN BE AFFECTED BY DAMAGE TO SEALS ETC.

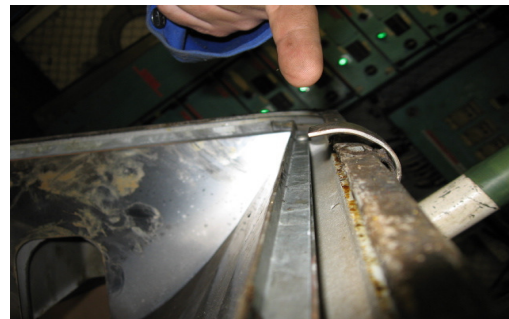
**CLIP MECHANISM (INADEQUATE)**
