Safety Alert

From the International Association of Drilling Contractors

ALERT 09 – 13

DROPPED DRAWWORKS PLATFORM

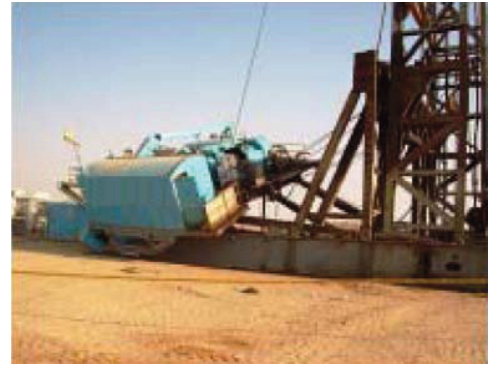
During the process of lowering the draw-works and support structure to the ground, one of two 35 ton sheaves used in the pulley system failed, causing one side of the draw works structure to fall 3 to 4 meters (10 to 13 feet) to the rig sub base. When the structure collapsed, five employees fell, resulting in major injuries (fractured bones and dislocated shoulder) and first aid cases. Potential was for multiple fatalities. The incident also caused major damage to the substructure and draw-works resulting in the rig being unserviceable. A second shackle had been added to the pulley system sheave used to lower the draw-works. This additional shackle caused misalignment of the sheave with the direction of the load. While lowering the platform, the tension in the pulley system increased forcing the sheave plates apart, releasing the sheave pin and resulting in immediate release of the cable and draw-works.

- The rig has been through extensive repair, redesign and recertification by the manufacturer.
- All design issues and the rig documentation were revised by the manufacturer.
- Updated rig move procedures to include details of critical safety tasks.
- Developed lift plans and consider Permit To Work requirements for significant lifts.
- Identified high risk areas during lifting and load movements and removed personnel from these areas during the lifting/loading operation.
- Confirm lifting equipment is certified and that personnel are competent to perform their tasks.

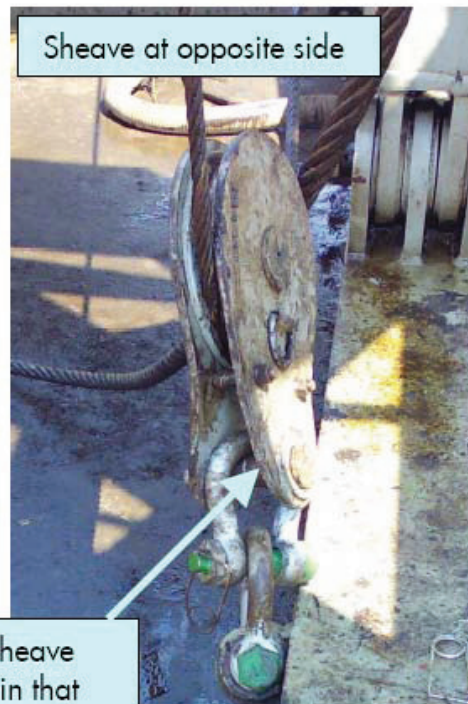
- Personnel were in exposed position during lowering of the draw-works.
- The person in charge had not performed the operation before and procedures did not give detailed and clear guidelines for the rig down operation.
- Although experienced personnel were present they were not listened to and an extra sheave was added to the rigging system.
- There was a failure in the Management of Change (MOC) by altering an existing approved design and the lack of documentation of the rig down procedure to assure consistent performance.
- Person-in-charge handover did not address safety critical tasks.
- Lifting equipment inspection and control procedures were not followed.
