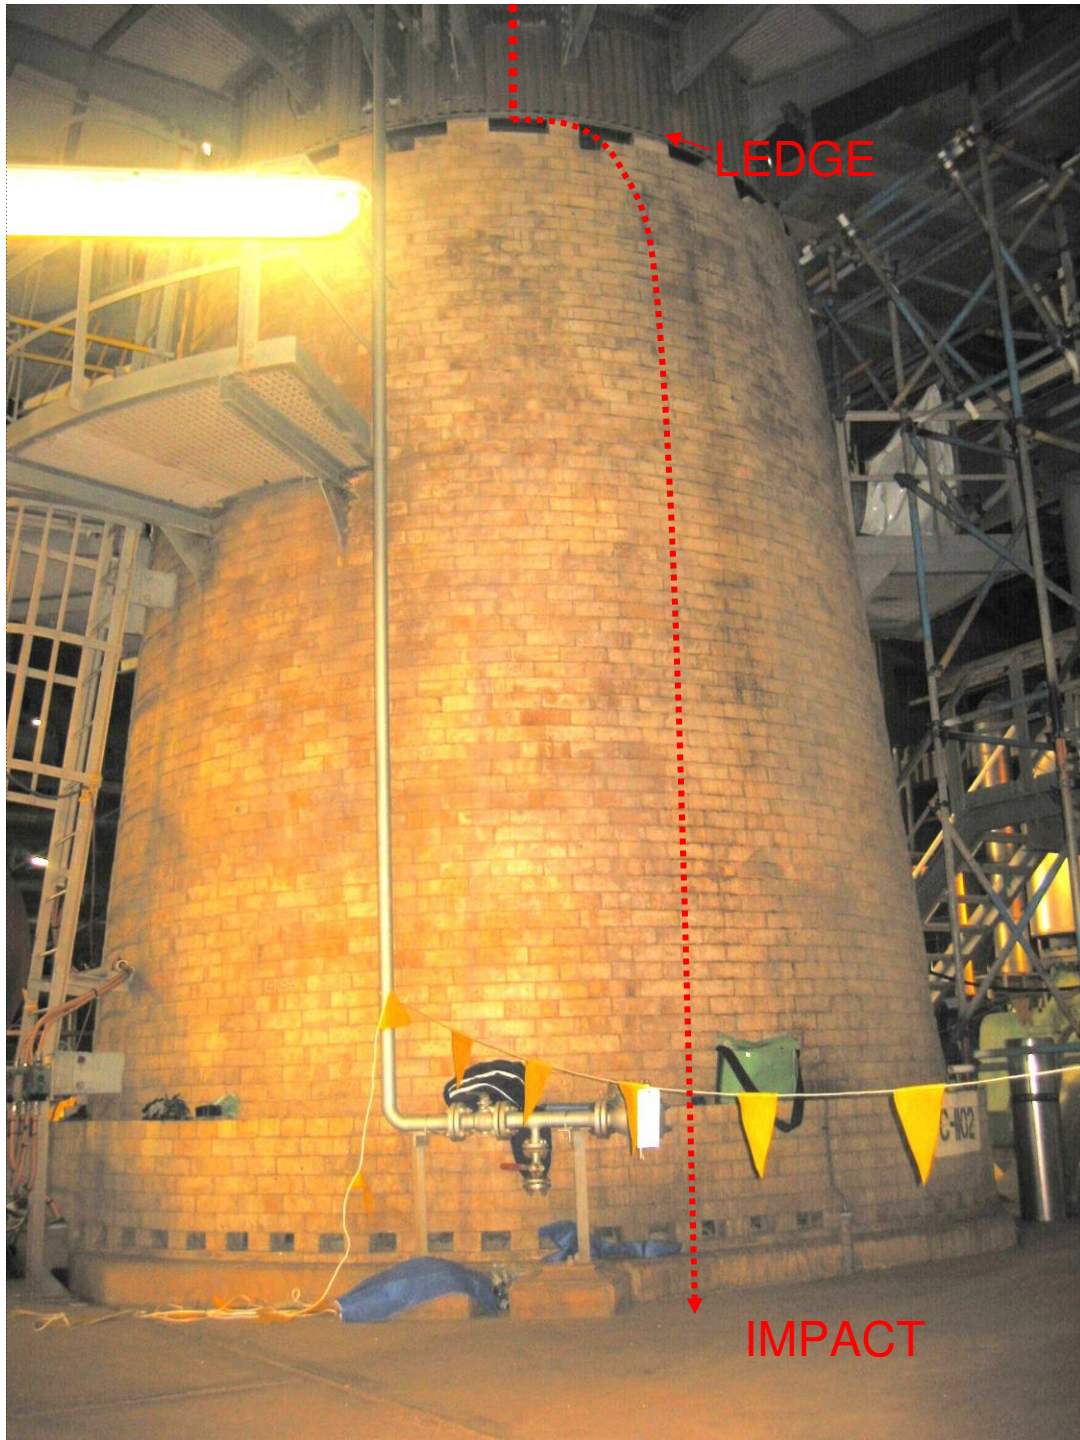
Spanner fell through gap between Column & fixed platform, deflecting off ledge on top of brick coarse.

Bunted area whilst in place, was not large enough to encompass "drop zone"

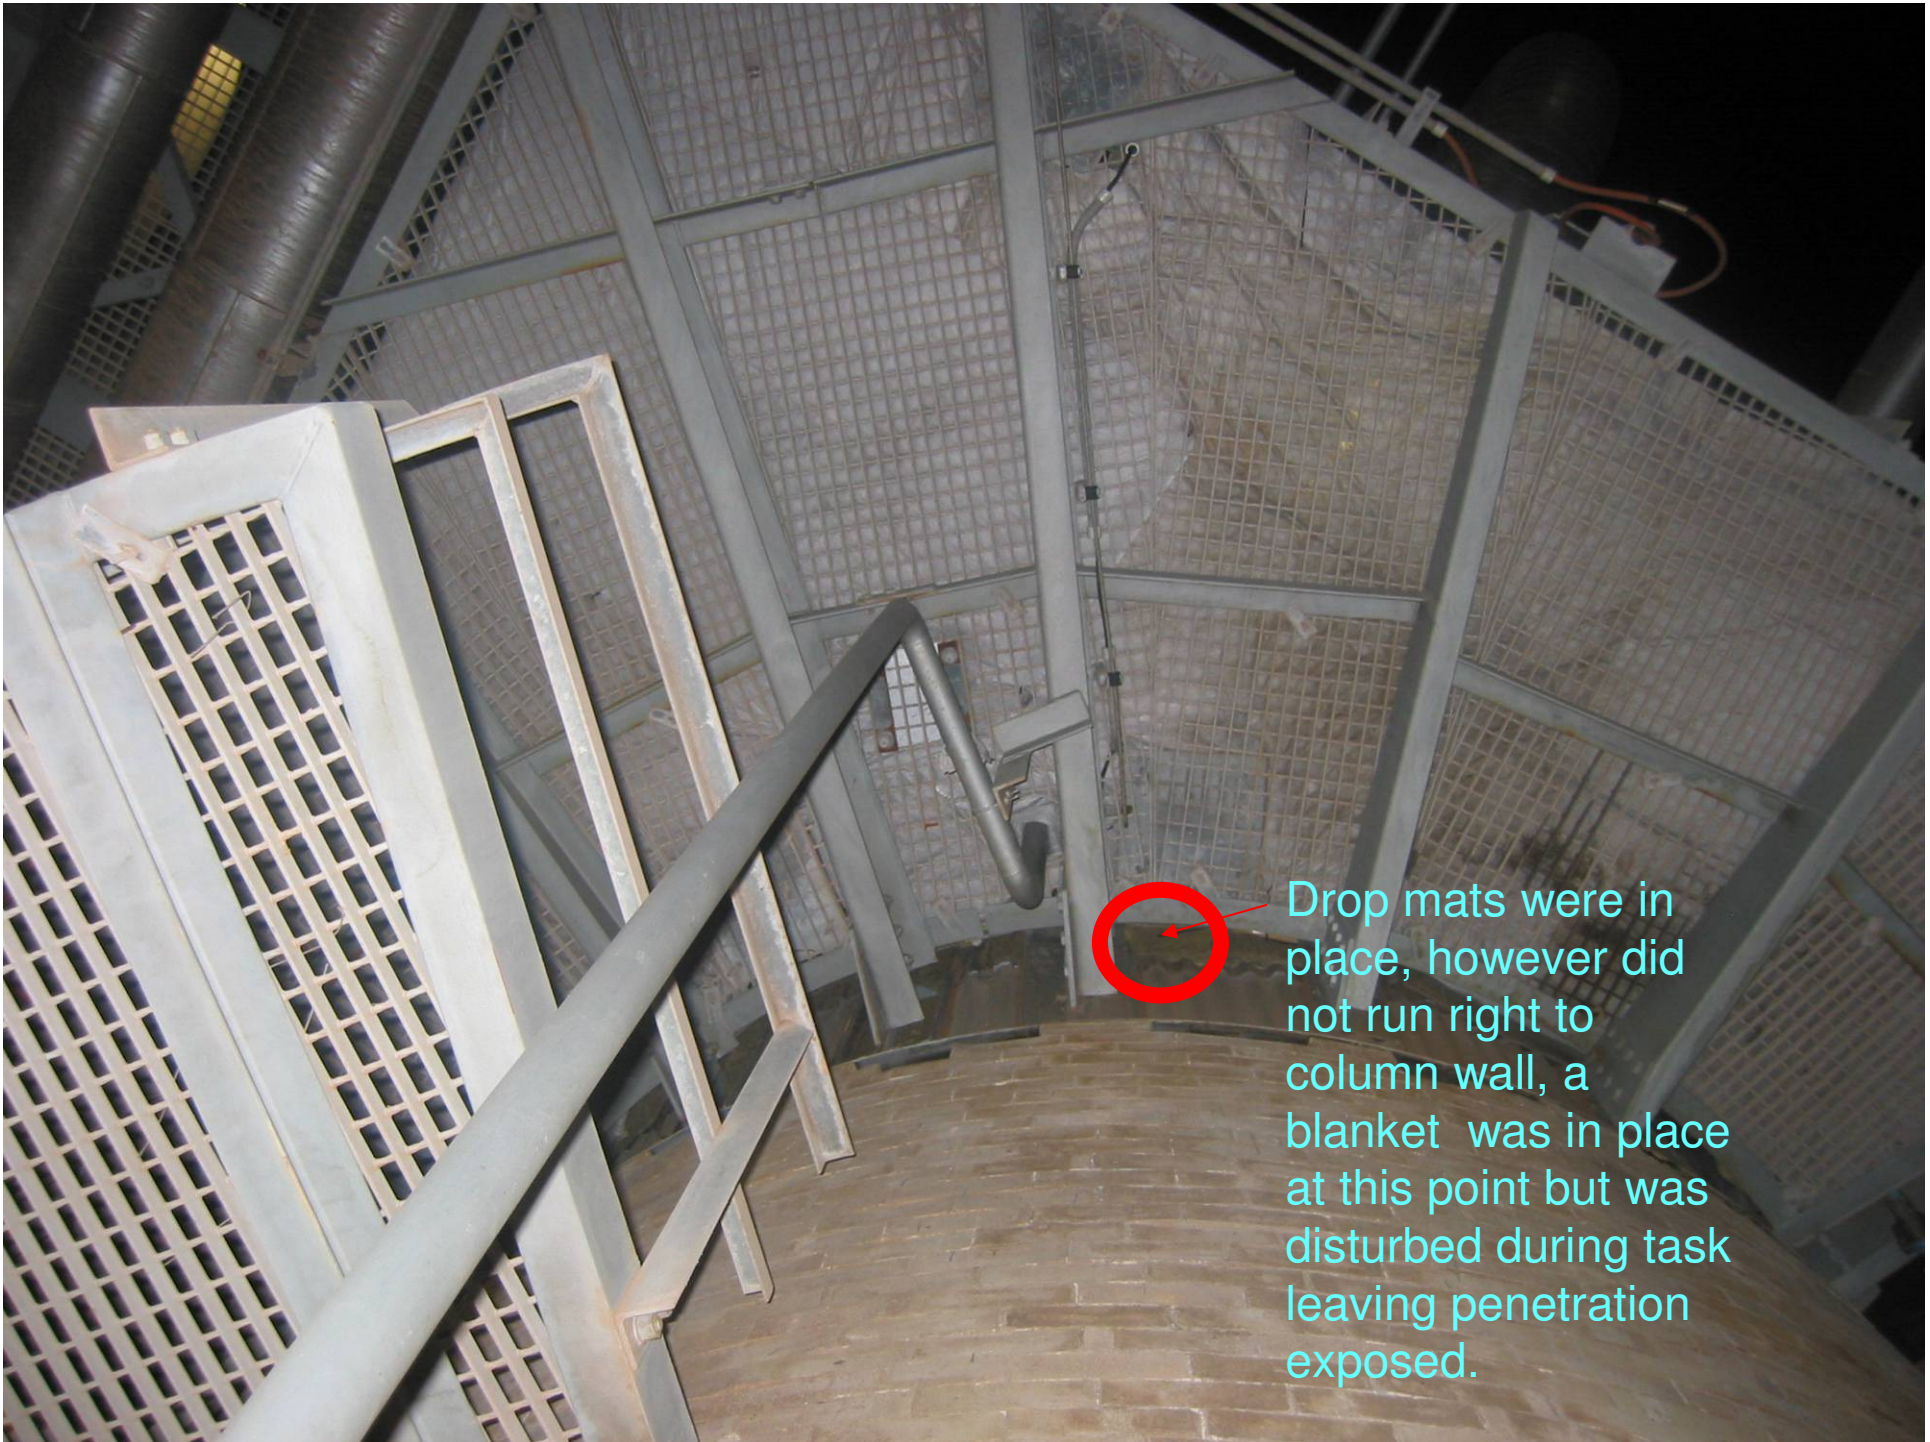
Drop mats were in place, however did not run right to column wall, a blanket was in place at this point but was disturbed during task leaving penetration exposed.
