Safety Alert

ALERT 09 – 25

HIGH POTENTIAL INCIDENT – DROPPED LIGHT

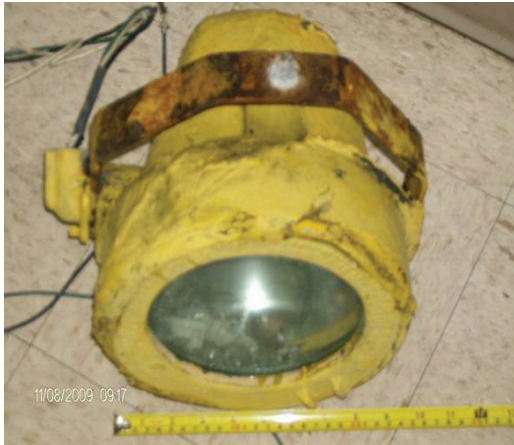
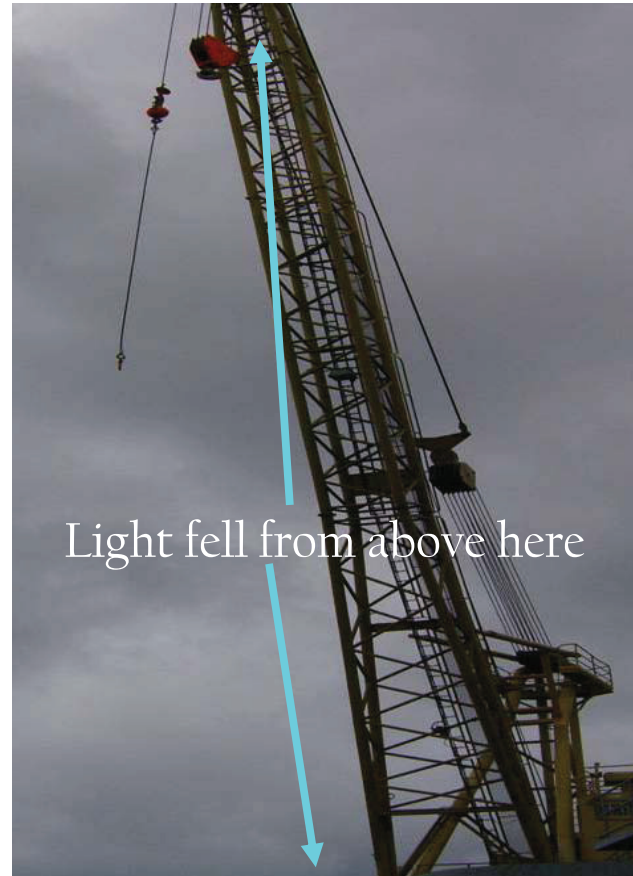
A 23 lb spotlight fell 90 feet (27.5 m) from a crane boom to the rig deck. The operation at the time was slewing the bow crane to over the chemical hatch from its stowed position at the forward leg. Having visually confirmed that the hook would not catch on any equipment on the radio room roof, the crane operator started to slew the crane toward the accommodation. As he did so the light fell to the deck beside the blue container pictured below. It then bounced and struck the wall of the radio room before coming to rest in the position shown. No one was in the area at the time of the incident.

1. The secondary retention wire was not properly attached to the light. Therefore it did not retain the falling light.
2. The vibration mounting was not as per original OEM recommendation.
3. The crane lights are not included in any maintenance, inspection or Dropped Object Survey.

1. A Review of SAP/ Tour Inspection / Crane reports is to include crane lights and retention.
2. DROPS inspection to include the rest of the Rig, i.e. cranes, not just derrick.
3. All repairs must have OIM and/or Engineering Approval.
4. The crane manufacturer was asked to review the lighting arrangements for cranes and provide recommendations.
5. Instructed rig and maintenance personnel that all secondary retention cables on potential dropped objects are to be checked for correct attachment, length and corrosion.
6. If light fittings are not required, remove them.
