## LEARNING FROM INCIDENTS FOR INFORMATION

**Incident: Fatal Injury**

**Date: 15<sup>th</sup> November 2009**

ALERT No.	Issued by	Approved by	Date
NSG-HSE Alert 2009-014	Paul Hosein	Graeme Anthony	24-11-09

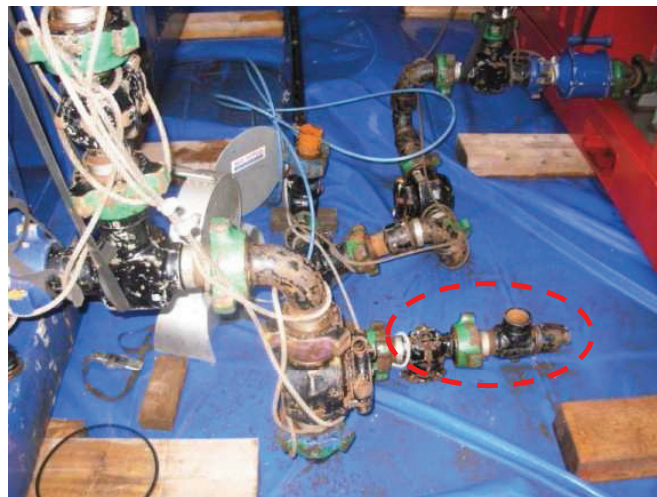
During a pressure test with nitrogen, a pressure relief valve in the treating line vented. The valve was rigged up in a vertical position approximately 2ft above the height of the line. As the valve vented, the assembly rotated through 90 degrees and hit the deck of the rig. During this rotation the assembly struck a member of the crew on the temple causing a fatal injury.

- As the valve vented, the force caused the vertical stack to rotate through 90 degrees until it came into contact with the deck.
- The injured person was in the high pressure area while pressure was being applied to the system in order to check the pressure on the Martin Decker recorder.

- No personnel to be in any high pressure area while pressure is being applied during a pressure test.
- All vertical treating iron stacks must be secured by the use of a stand, and anchored or tied to an immovable object.
