NATIONAL OFFSHORE PETROLEUM SAFETY AUTHORITY

Manriding Incident – Carabiner Failure

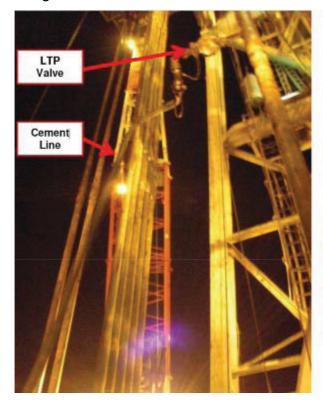
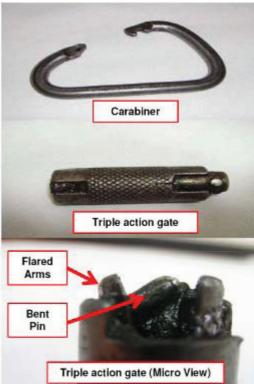
Examination of the carabiner was carried out by a Materials and Corrosion Engineer. A considerable amount of dirt was found lodged around the latch pin and between the latch yokes. This contamination may have prevented full gate closure of the carabiner by stopping the gate sleeve from rotating to lock the latch. This would have left the tensioner spring as the only mechanism holding the gate closed.

- 1. The carabiner was thought to have failed because it was used with the gate in the unlocked position.
- 2. The most likely cause of the carabiner being unlocked was dirt inside the gate mechanism preventing it from closing fully.
- 3. The carabiner was not rigorously checked for security when it was operated.
- 4. The planned maintenance system did not identify the carabiner on the manriding harness as an inspection item.

The man-riding procedures were not detailed enough to include rigorous inspection and checking of the carabiner for security when it was being operated by the user. This may have allowed the carabiner to be put into use with an unlocked gate. The operator has now replaced the carabiner on the man-riding harness with a 4-part shackle. This shackle is included in the lifting register as required in the man-riding procedure and is included in the loose lifting equipment inspection colour coding system.
