Safety Alert

From the International Association of Drilling Contractors

ALERT 10 – 12

“STRUCK BY INCIDENT” ON MONKEY-BOARD RESULTS IN A FATALITY

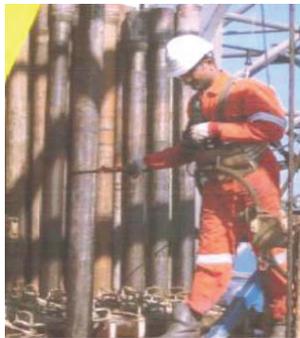
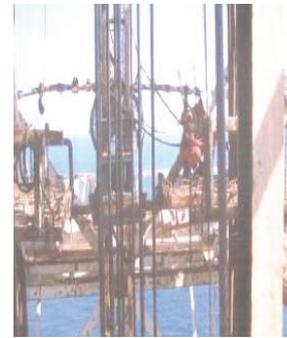
It was decided to pull three stands of 5” drill pipe out of the hole. Since the derrickman was unavailable, a floorman was assigned to work the monkey-board to rack back the drill pipe stands. The floorman unlatched the drill pipe from the elevators and used the remotely operated derrick winch to pull the drill pipe back to rack it. As the driller commenced lowering the travelling block, the winch wire suddenly became slack allowing the drill pipe to move into the path of the descending top drive system (TDS), making contact with it. The impact caused the drill pipe to deflect and move toward the other side of the monkey board; pulling the winch wire along with it. The floorman, was hit at the abdomen by either the pipe and the winch wire or only by the wire. While the injured person was under medical attention and monitoring by the rig doctor, he succumbed to his injuries about two hours after the incident. Photos below are a recreation of the incident.

1. Drill pipe stand was in the path of descending top drive.
2. Driller did not observe the 5 inch drill pipe moving back towards the descending top drive.
3. There was poor communication between the personnel involved in the operations.
4. The winch cable became slack allowing the drill pipe to move toward the path of the descending top drive.
5. Lack of proper competency assessment of the floorman assigned to derrick duties.
6. Inadequate Risk Assessment.

1. Driller shall maintain line of sight with the derrickman and monkey board along with the monitor, which displays the monkey board area to ensure that no obstruction is in the path of the top drive system prior to ascending / descending.
2. Driller and derrickman shall ensure an effective two way communication system at all times. The communication procedure should be discussed and agreed upon in the toolbox talks / Pre Job Safety Meeting.
3. Driller to ensure adequate manning on rig floor at all times.
4. The current JSA is to be revised to ensure it covers all potential hazards and control measures for monkey-board operations including this particular risk exposure.

5. A memo was issued to all drilling rigs not to assign any employee a job outside his job description unless deemed competent to do the task and it has been approved and documented by the Rig Superintendent. Issued standing instructions to all rig medical staff to initiate a "Medivac" for any "struck by" injury or suspected case of internal injury to head, chest or abdomen.
