# Safety Alert

ALERT 10 – 33

## WORKER'S ARM CAUGHT IN MUD BUCKET

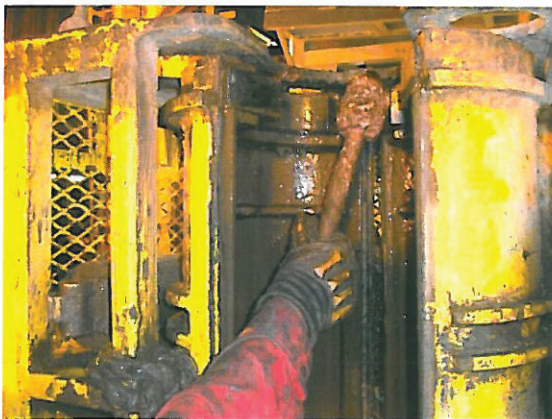
- The other crew members did not know that the IP was in the front of the mud bucket with his hand inside to dope the mud bucket seals.
- The mud bucket closing speed is approximately 3 seconds.
- The design of air hose arrangement was inadequate.
- There was poor communication between the IP and the man reintroducing air supply to the mud bucket.
- Inadequate instruction had been given to the crew personnel on how to isolate and de-isolate the mud bucket

Demonstration of IP Hand inside the Mud Bucket

- The company conducted retraining with all rig crews on the safe use of the mud bucket.
- Corrected the connection / disconnection of air supply to be highlighted with all crews.
- Warning chevrons were painted on the front of mud bucket at the opening
- Installed an independent air supply for the air winch.
- Modified the controls of the mud bucket so that two valves have to be operated simultaneously in order to close the mud bucket.
