Safety Alert

From the International Association of Drilling Contractors

ALERT 11 - 01

SAND LINE FLAGGING OPERATION RESULTS IN FATALITY

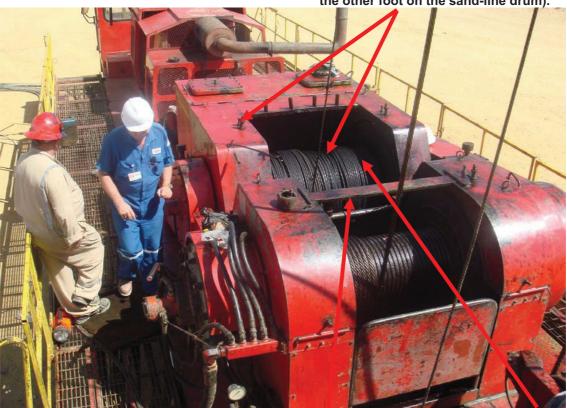
Location of the fatally injured person at the time of incident (one foot on top of drum housing and the other foot on the sand-line drum).

Location of the second individual (one foot on the sand-line drum and one foot on a lower bar of the draw works housing
