Safety Alert

ALERT 11 – 06

NEAR-HIT INCIDENT - DROPPED OBJECT PIPE HANDLING PUSH-ARM FELL TO THE RIG FLOOR

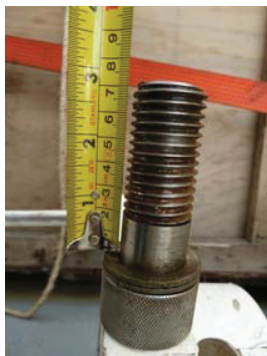
- An investigation revealed that the 882lb arm was held onto the davit by a 1 ½" long bolt. The short bolt did not allow a sufficient number of threads to screw into the support structure.

The amount of thread that held it in its place

- The failed equipment has been removed from service before any further operations were conducted.
- A notice has been sent to the manufacturer to alert them of this incident indicating the reason for failure.

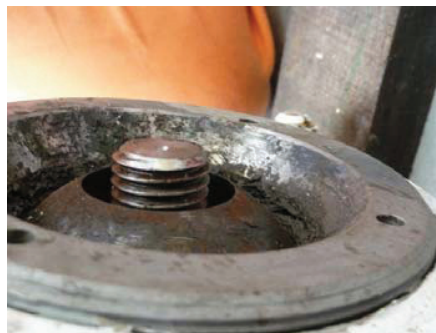
The amount of thread that held it in place

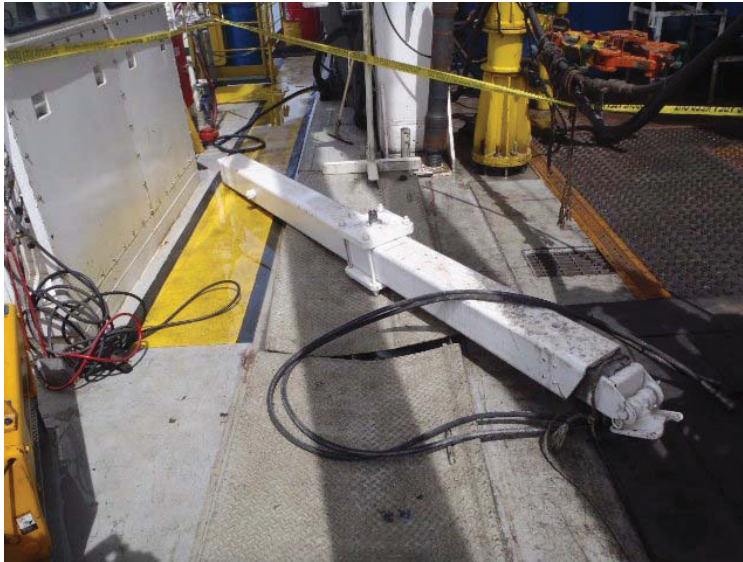
While drilling a 12 ¼" hole, the driller observed the unused Safety Push Arm fall 15 feet (4.5 meters) onto the rig floor just in front of the Driller's cabin. The arm caused dents to the rig floor cover plates. There were five (5) rig floor workers in the vicinity working near the V-Door, but luckily no one was injured and no other equipment was damaged. The piece of equipment that fell measured 12' 6" long and 8" X 8" wide, weighing 882lbs. It had the potential to cause fatalities.

The 882lb arm that fell from the derrick

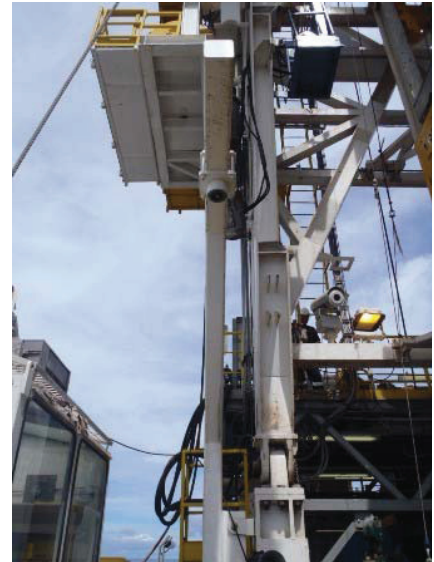
- There was no secondary retention (safety sling) installed on the arm to arrest a potential fall.
- Once it was decided to discontinue use of the equipment, there was no decision whether to remove or to re-use the equipment.
- Vibration of the rig may have contributed to the bolt unscrewing from the support structure.
- The failed equipment was installed the after initial rig-up and was not included in the derrick's inspection checklist, nor was it included in the Toolpusher's weekly checklist.
- The failed equipment was installed after the DROPS survey was conducted; therefore it was not included in the DROPS survey list.
- There was no record of the last inspection of the failed equipment including maintenance and greasing.
- There was no way to visibly inspect the bolt inside the slot to see if the thread was still in place and properly engaged.

The davit that held the arm
