## 1: Modified Ladder Beam

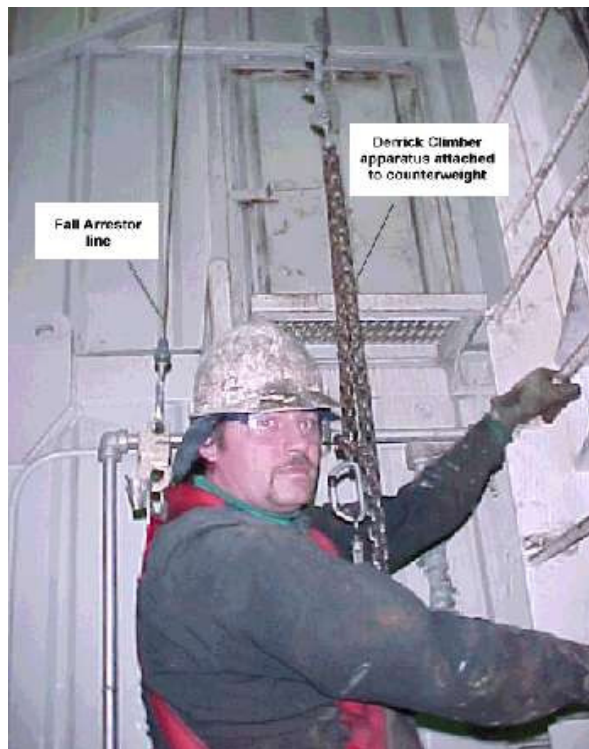
| Summary: | A 1/4 inch steel cable which connected the “derrick climber” counterweight to the harness failed causing the cable to spool through the sheave and fall out from the derrick. |

Fall Arrestor  
line

Derrick Climber  
apparatus attached  
to counterweight

Recommendations: 1. Assure yourself that your PM programme identifies, records and replaces items on both “derrick climber” and fall arrestor apparatus at suitable time intervals. 2. Ensure that the derrick climber and fall arrestor apparatus is of the correct design and type and is adequately inspected according to a set procedure and inspection details logged. , 3. Ensure that the counterweight cable has a “free run” and does not rub against the derrick structure., 4. Assure yourself that “management of change” is considered and a formal risk assessment process is used in your business unit for cases such as the fall arrestor being removed from service., 5. Assure yourself that both the process and accountabilities for reporting incidents are clearly understood within your business unit.

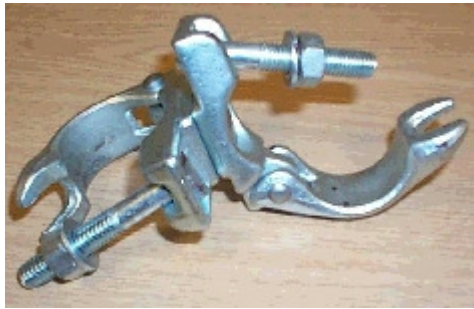
Summary: There is potential for the 'Mitie Generation' scaffold fittings to become loose.

Description: It has been brought to our attention from one of our offshore sites that there is a potential safety concern relating to recently distributed scaffold fittings. The new fittings are drop forged 'Mitie Generation' double fittings (as shown in the picture below). In some circumstances when the fitting is tightened, the T-bolts are twisting within the shoulder, giving the impression that the fitting is tight. However, if the fitting is again knocked, in some cases it will move within the gate, subsequently loosening the fitting.

Recommendations: If this issue becomes a frequent occurrence, it should be brought to the attention of your supervisor.

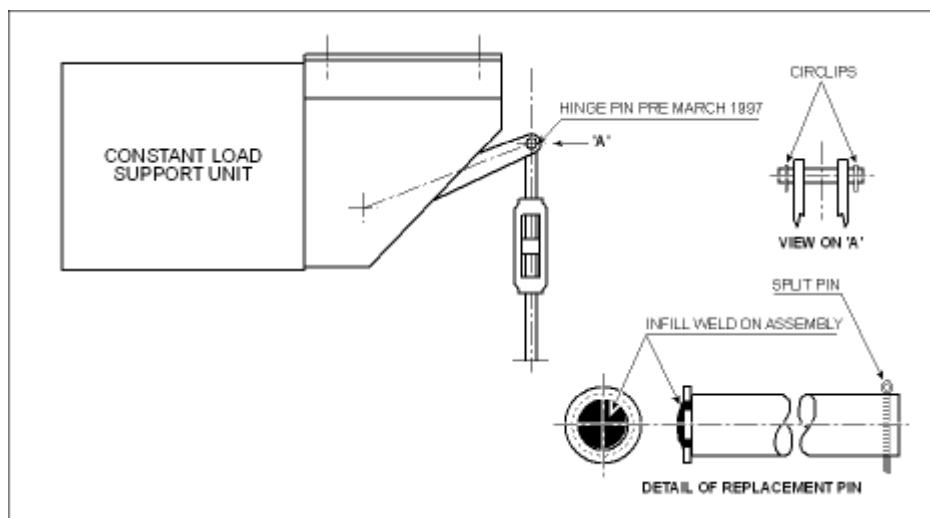
**Summary:** On a Type C50 Constant Load Support Unit (CLSU), circlip fixings holding support pins in place had corroded. Potentially, the support pins could have worked loose through flowline vibration.

Recommendations: Check all CLSUs and carry out on-site modification as necessary. The manufacturers can supply replacement pins direct.

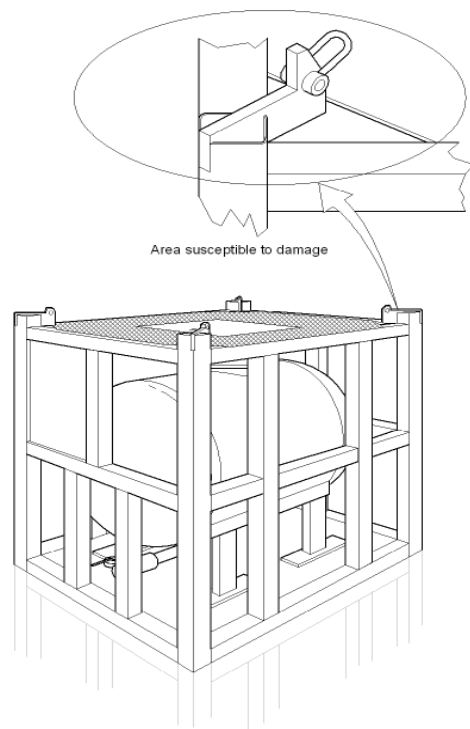
Summary: A chemical tank started to spin while being loaded from a supply vessel in marginal weather conditions. The crane operator bumped it into an adjacent chemical tank in order to counteract the spinning, resulting in one of the stacking guides becoming dislodged.

2. Weld on additional supports to improve the robustness of IBC stacking arrangements.

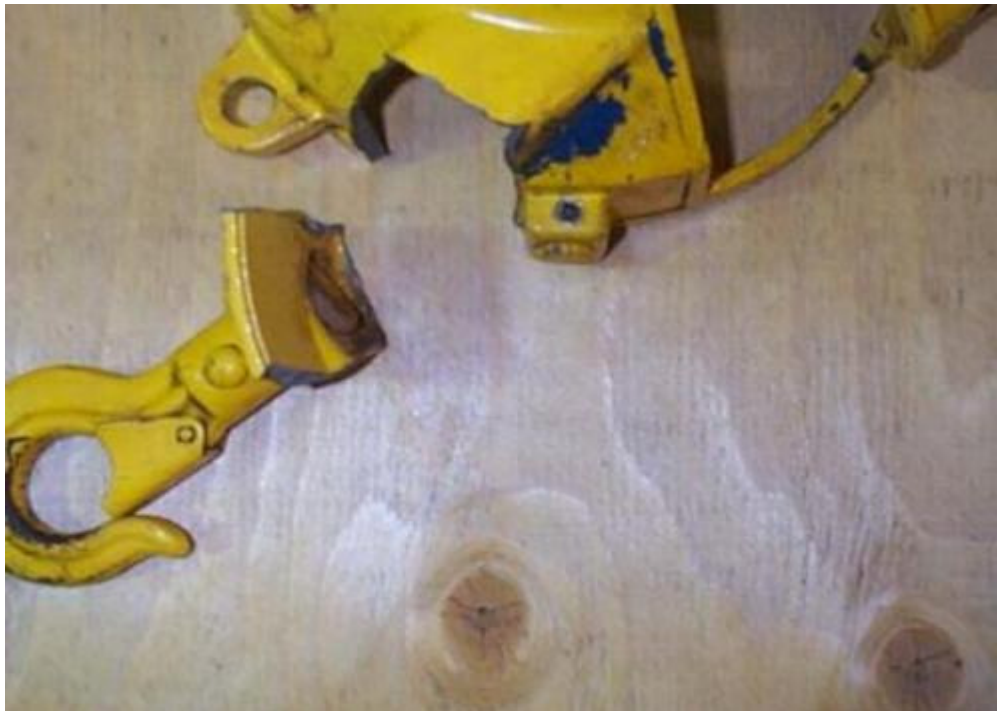
Summary: When a support wire on a balancer unit was released, the shock of recoil caused the reel casing to break apart and the main block fell to deck.

- Recommendations:
1. All Balancer Units should be externally inspected for proper functioning. Any unit found to be defective should be withdrawn from use and quarantined.
  2. Where practical to do so, return balance units to the rigging store when not in use.
  3. Introduce a regular inspection and operability routine to avoid the potential of this type of failure recurring.

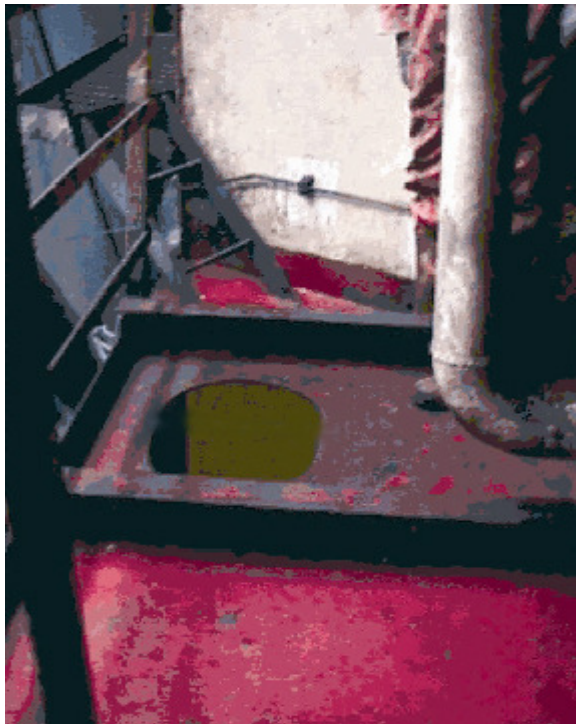
Summary: A painter stepped into an open access hole. Its small size had prevented him from falling through but his abdomen/chest had struck the flat edge of the plating.

1. Inspect infrequently visited areas to make sure there are no unprotected openings.
2. Ensure that infrequently visited areas are included in housekeeping audits.
3. Where appropriate, ensure pre-job discussions include a worksite safety inspection.
