## 171: Failure of Isolations

Summary: As residual fire water drained from joint, drop in pressure caused the fire pump to start

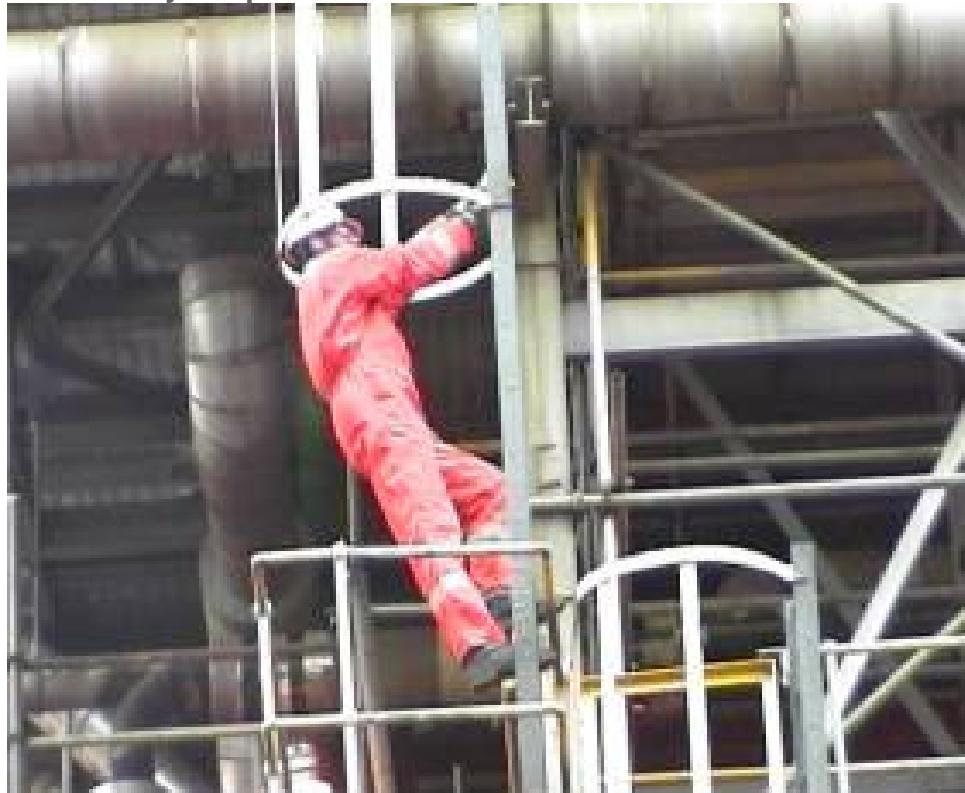
Summary:	A fatality occurred on an onshore site when an individual fell from a vertical ladder and fell through the gap between the bottom of the hooped guard and the handrail of the elevated platform at the foot of the ladder.
Incident consequences (potential or actual):	<i>No details available.</i>
Cause of accident or incident:	<i>No details available.</i>
Activity Location:	*Any Location Type
Activity Type:	*Any Activity Type
Description:	A welding supervisor fell over 9 metres to ground whilst descending from a fixed vertical hooped ladder. The ladder was located on a Heater Unit and had been in service since 1969. The welding supervisor had been carrying out routine weld inspections in preparation for a plant turnaround, prior to descending the ladder to return to ground. The supervisor lost 3 point contact with the ladder and fell backwards through an unprotected section of ladder, hitting the handrail, pivoting over it and falling to ground. This section of ladder between the top of the handrail and bottom of ladder guard hoops can be seen in the photograph below. The design and construction of the ladder and landing platform conformed with the appropriate British Standard. Site first aid and medical personnel attended the supervisor at the scene before he was taken to the local hospital where he later died.

**Photo of a reconstruction. It does NOT show the deceased, nor necessarily his position on the ladder.**

Recommendations: Messages:

1. Even the most routine of activities involve hazards
2. Basic occupational safety standards for older equipment should be equivalent to those expected on new plant

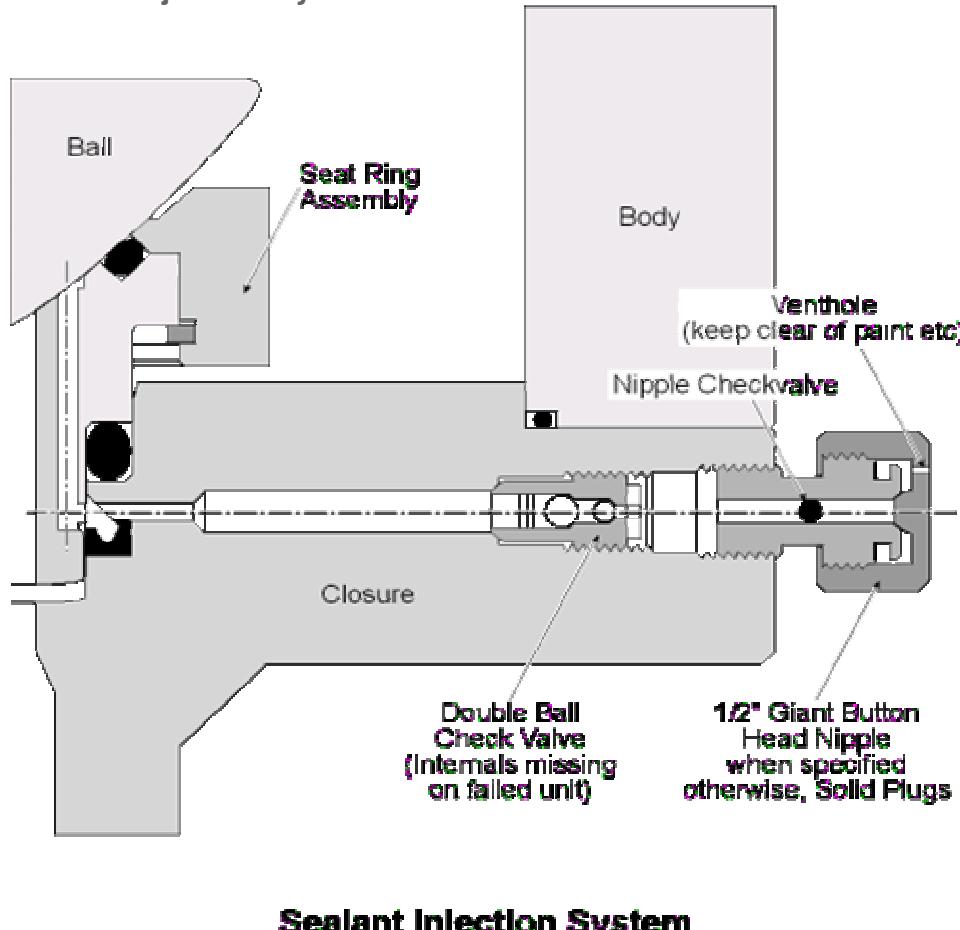
### Sealant Injection System

Summary:	Sealant was being injected into a depressurised 30" sphere launcher inboard valve by a competent technician when one of the four injector nipples was found to be blocked.
Incident consequences (potential or actual):	<i>No details available.</i>
Cause of accident or incident:	<i>No details available.</i>
Activity Location:	*Any Location Type
Activity Type:	*Any Activity Type
Description:	Sealant was being injected into a depressurised 30" sphere launcher inboard valve by a competent technician when one of the four injector nipples was found to be blocked. The nipple was removed along with the separate internal check valve and on closer inspection the internal spring and ball of the check valve were found to be missing. It was not evident when the failure of the check valve had occurred but it was suspected it was as a result of over-pressuring during previous injection activities. The consequence was that the remaining check valve in the nipple was the only barrier between the body cavity and atmosphere. Failure of the nipple to reseat correctly would have resulted in a hydrocarbon release when the line was re-pressurised.

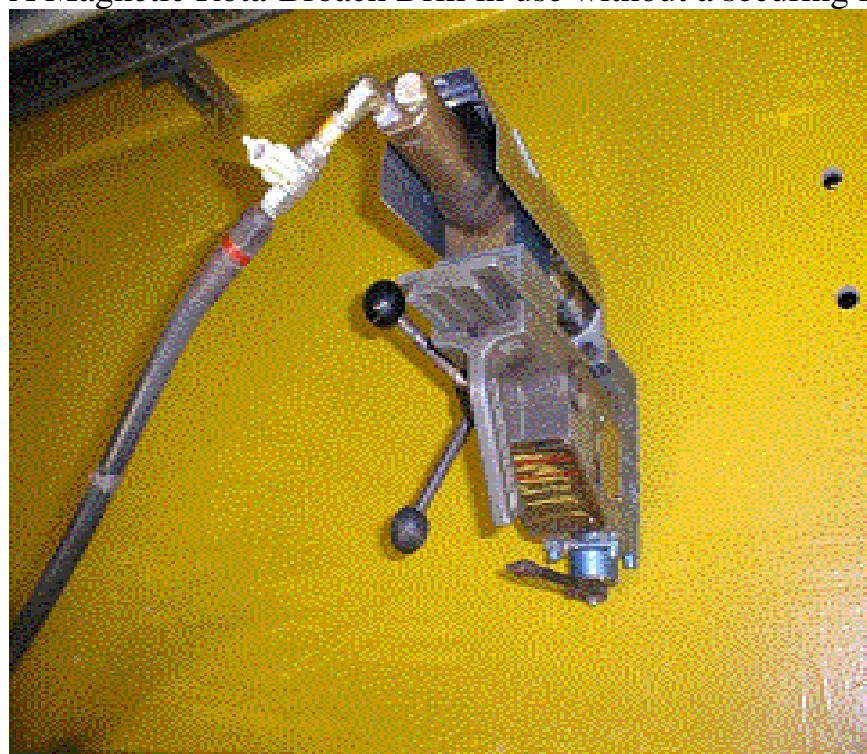
A Magnetic Rota-Broach Drill in use without a securing lanyard

- Recommendations:
- Personnel involved in using the Rota-Broach drill should be competent in the use of power tools and should have read the manufacturers instructions prior to using the drill.
  - A suitable method of preventing the drill from falling should be provided in the event that the magnetic attachment fails e.g. securing lanyard/strap/chain or an alternative engineered solution.

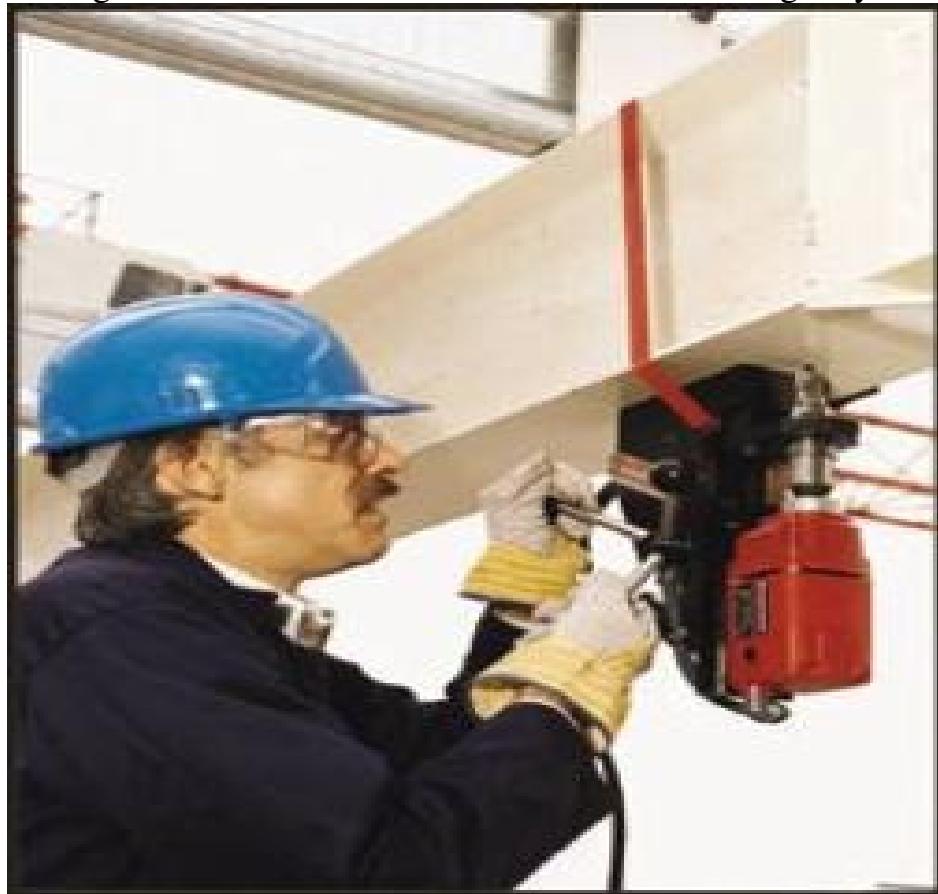
A Magnetic Rota-Broach Drill in use with a securing lanyard

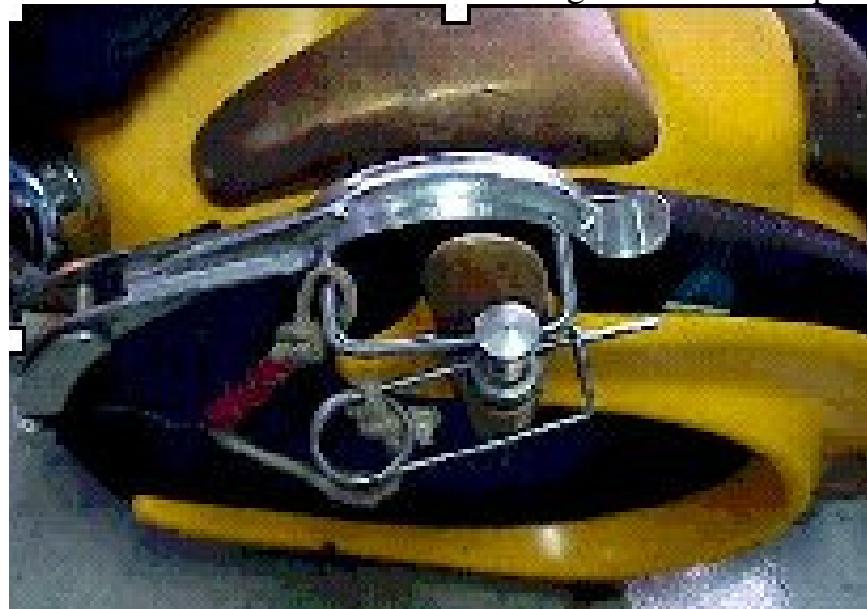
Locking pin arrangement on the Kirby Morgan 17 prior to modification. An overall view of the Kirby Morgan 17 Superlite hat. The hat and neck dam are attached with the new locking mechanism in place.

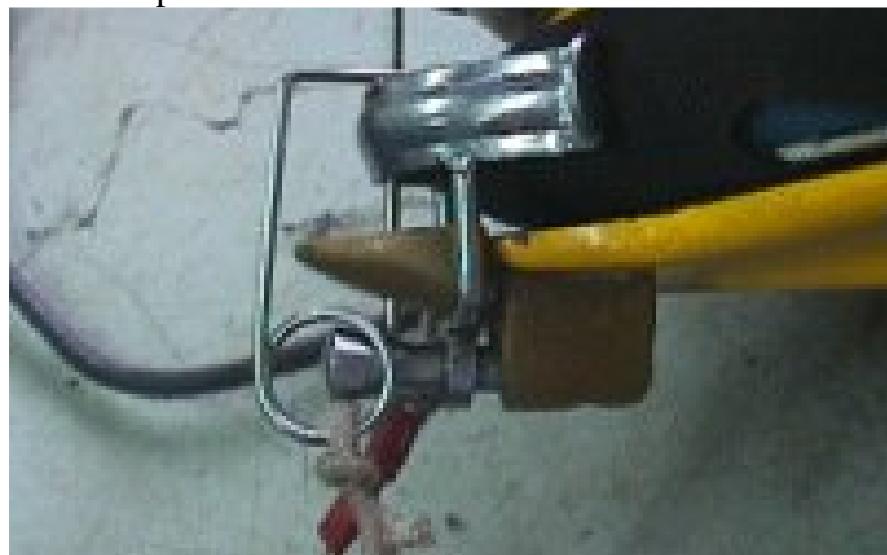
Locking pin arrangement on the Kirby Morgan 17 after modification. The plunger and the latch catch body have been drilled out, both directly in line. The neck clamp assembly is fitted as previous, however, it is now locked in position with the secur

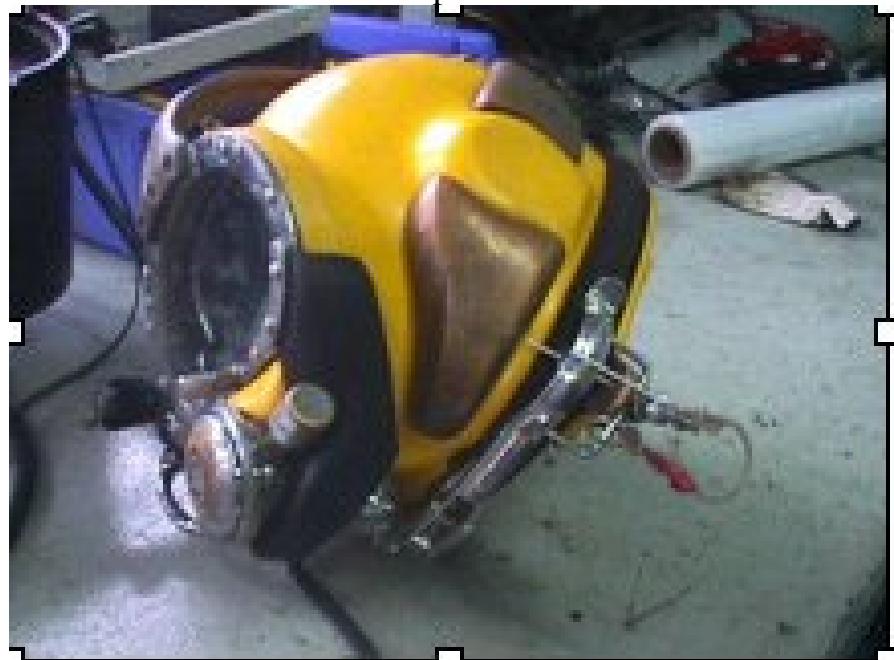
Locking pin arrangement on the Kirby Morgan 17 after modification. The neck clamp is locked in position by the latch catch assembly and a securing pin is inserted behind the plunger to avoid accidental pushing

and release of the neck clamp.

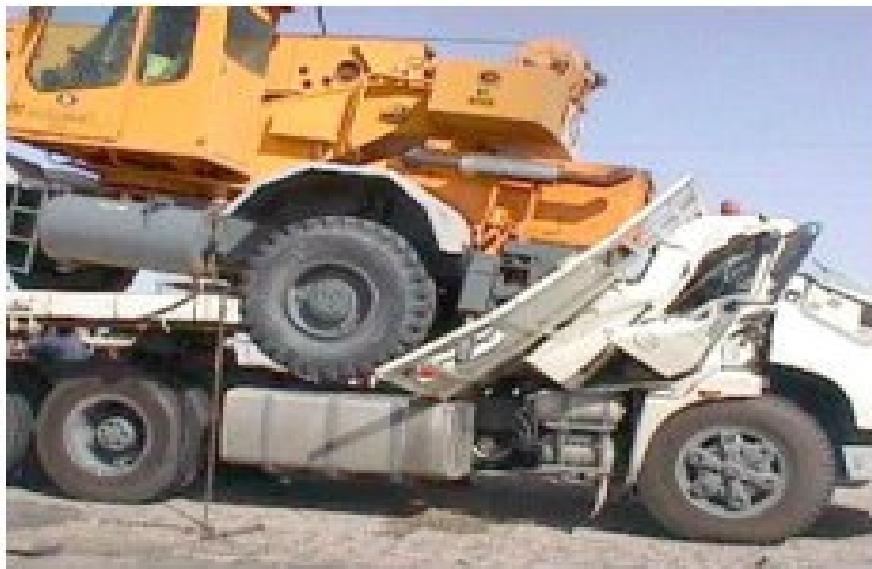
The crane crashed into the cabin.

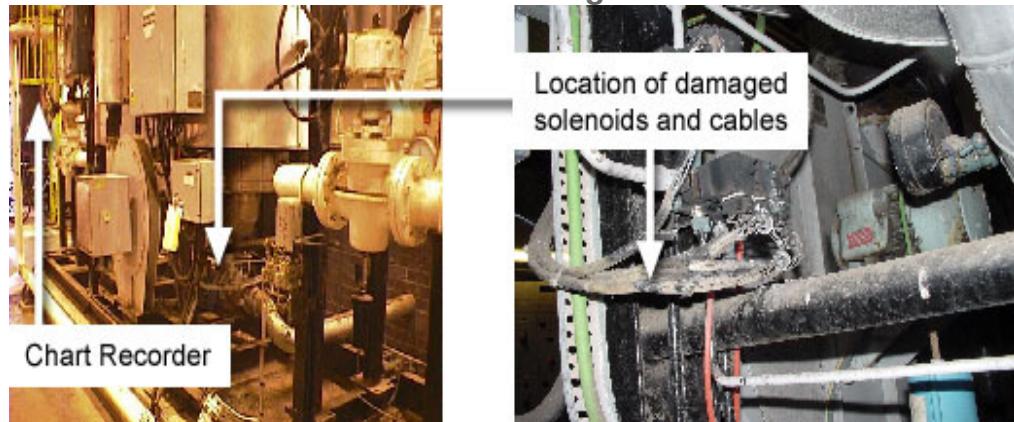
### **Location of Chart Recorder and Damaged Solenoids and Cables**

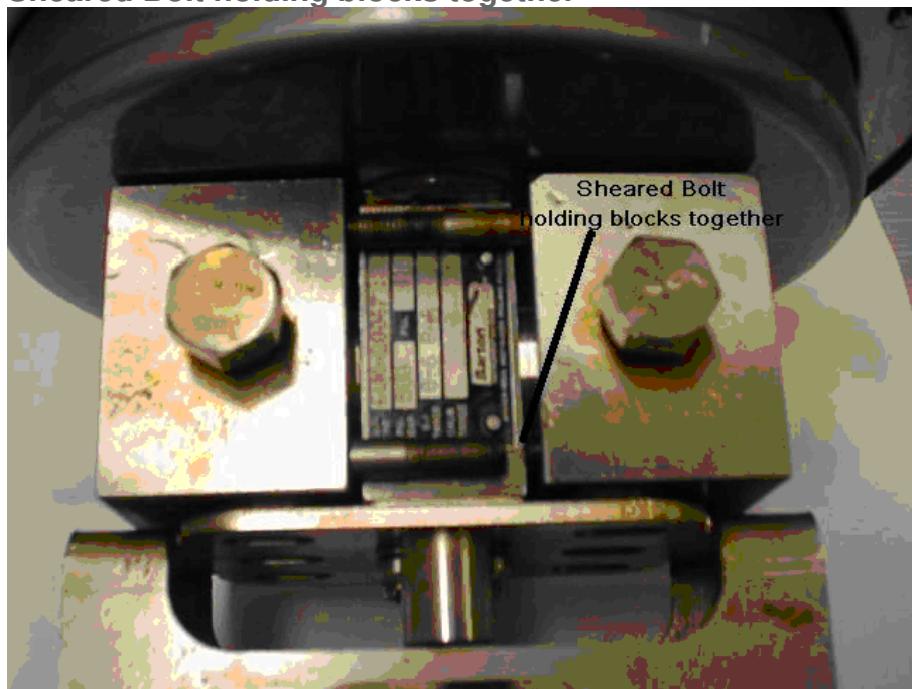
#### Sheared Bolt holding blocks together

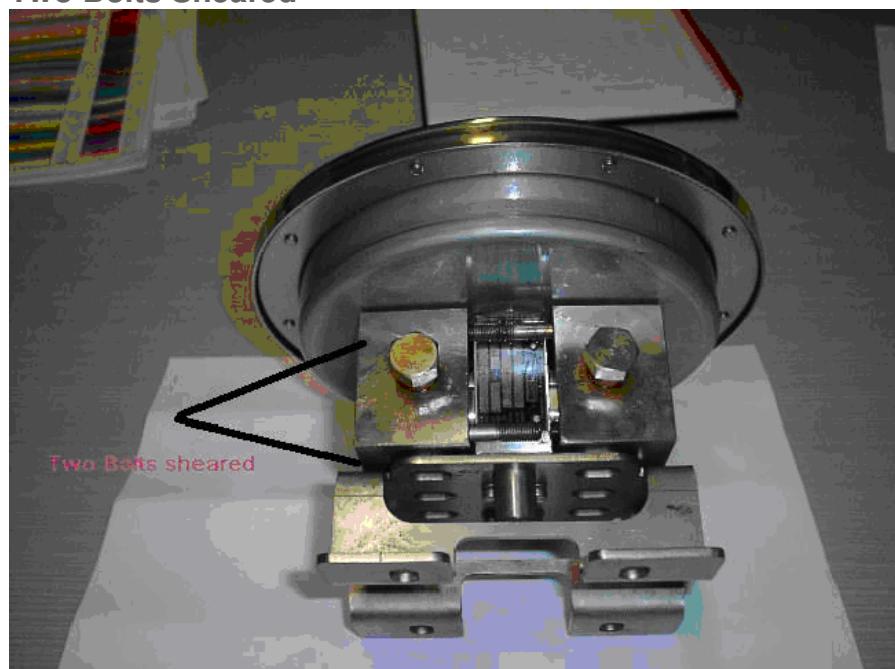
**Two Bolts Sheared**

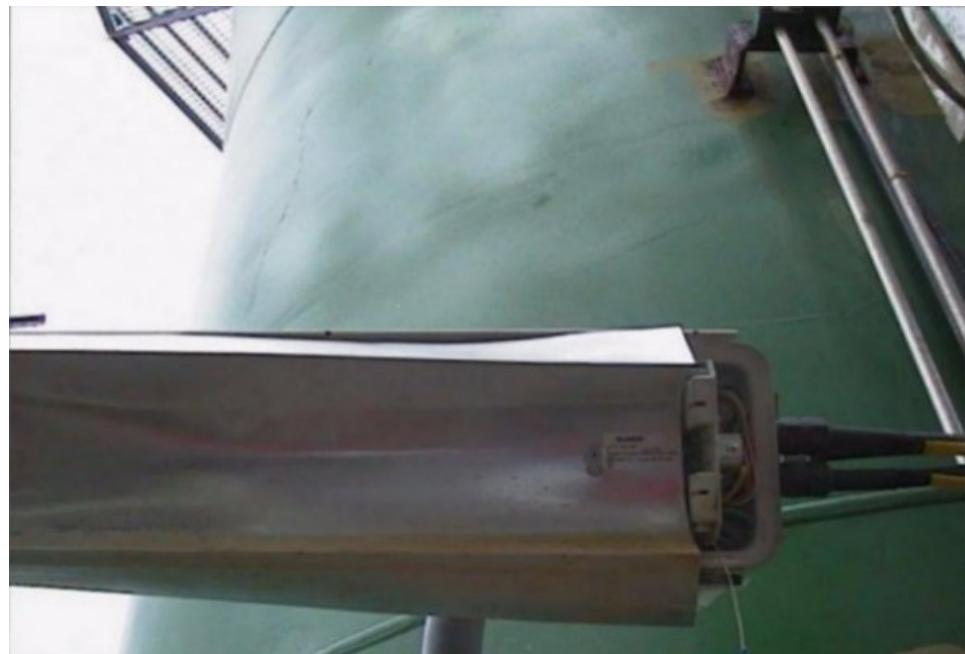
#### **Looking up at damaged light fitting**

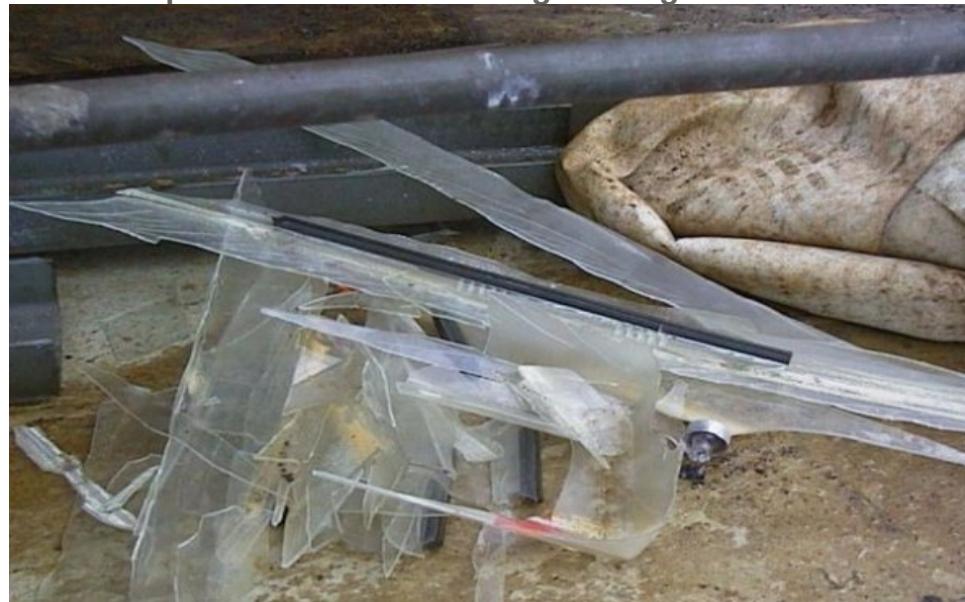
**Shards of plastic and metal from light fitting**

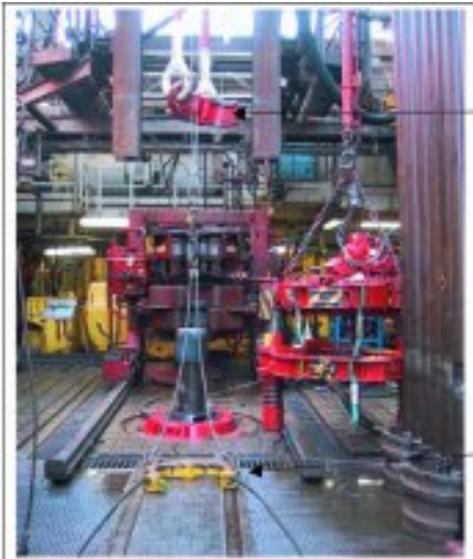
Pin end of casing struck  
upright stanchion

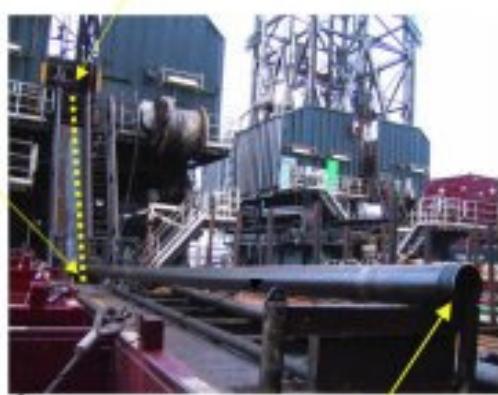
As casing moves away from crane boom the pin end rises and clears the end of the catwalk striking an upright stanchion 2.5m up.

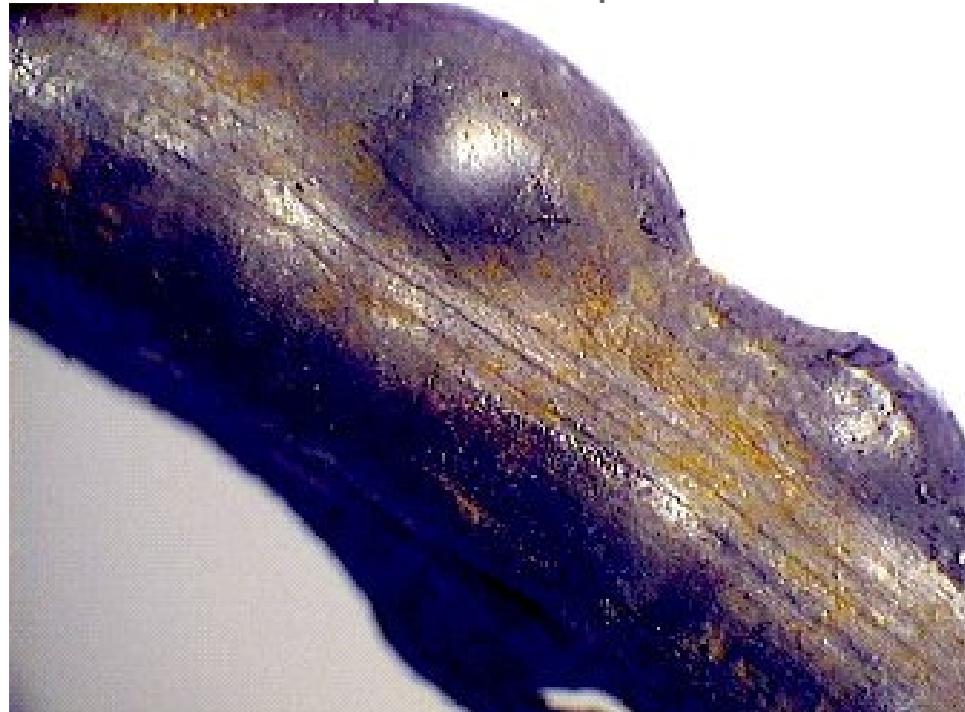
### Failure Mechanism – Explosive Decompression

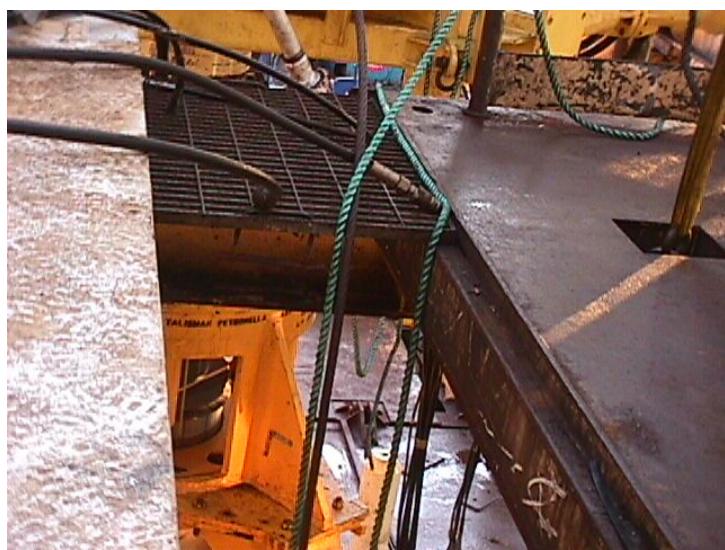
**Mezz deck showing gap**
