### 301: HP Grease Gun Cartridge Holder Failure

Summary: Correct procedure for changing the grease cartridge in the high pressure grease guns.

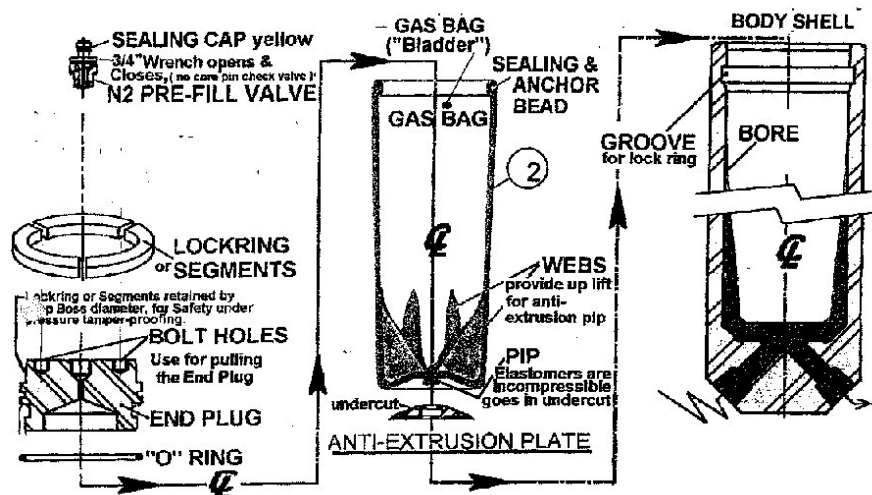
Summary:	During examination of a seal oil pump discharge damper on East Brae. A technician identified that one out of the three lid retaining collets, (attachment fig1) had dropped out of the retaining groove, on the internal bore of the pulsation damper.
Incident consequences (potential or actual):	<i>No details available.</i>
Cause of accident or incident:	<i>No details available.</i>
Activity Location:	Fixed Installation
Activity Type:	Inspection/testing
Description:	During examination of a seal oil pump discharge damper on East Brae. A technician identified that one out of the three lid retaining collets, (attachment fig1) had dropped out of the retaining groove, on the internal bore of the pulsation damper. The lid had also moved inward from its normal assembled position. This could have resulted in a seal oil system pressure boundary failure, upon next pressurisation. Other damper checks revealed dampers in a similar condition, one of the three lid retaining collets had dropped out of the retaining groove. Lessons learnt. Procedure to inspect integrity of dampers before seal oil system start up. Recommendations. Fit new retaining plates, fixed via bolt holes for pulling of end plug. (fig 1)

Recommendations: Fit new retaining plates, fixed via bolt holes for pulling of end plug. (fig 1)

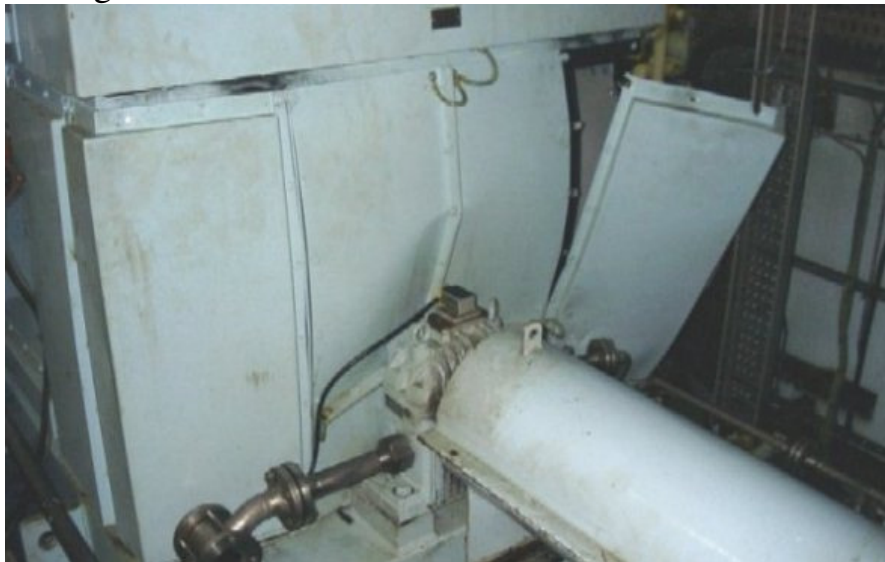
### **Damage to HV Motor Enclosure**

Summary:	An explosion occurred in an ExN motor enclosure during start-up of an HP compressor
Incident consequences (potential or actual):	<i>No details available.</i>
Cause of accident or incident:	<i>No details available.</i>
Activity Location:	Fixed Installation
Activity Type:	Production operations
Description:	During start-up of an HP compressor electric motor an explosive overpressure condition occurred in the motor enclosure. This resulted in deformation and displacement of enclosure panels. No injuries were sustained and the incident did not cause initiation of the platform detection or alarm system. Investigation is still ongoing but indications are that hydrocarbon gas had been introduced into the motor enclosure prior to an extended shutdown and had been ignited when the motor was energised. Gas appears to have been entrained in the Lube Oil system serving the compressor and motor as a result of compressor seal failure. The circumstances of this incident are similar to those addressed in HSE Safety Notice 17/90 (Revised 1995 but now withdrawn).

Recommendations: Operators should satisfy themselves that the risk potential and mitigation measures identified by Safety Notice 17/90 have been appropriately addressed on their installations. This may be particularly relevant where Operatorship has transferred since the Safety Notice was last issued

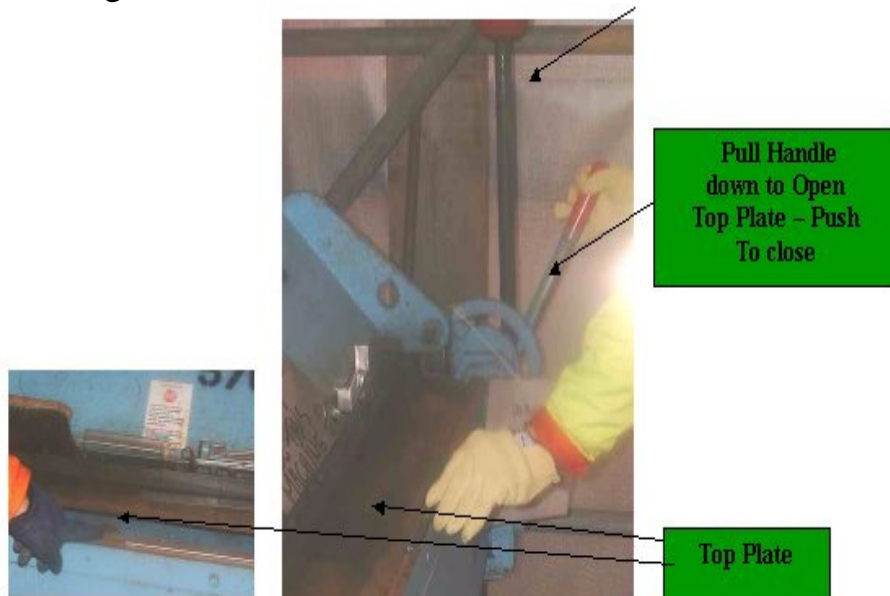
## Bending Machine

Summary:	Person operating a sheet metal folding machine crushed one finger, the tip of which was subsequently partly removed in hospital.
Incident consequences (potential or actual):	<i>No details available.</i>
Cause of accident or incident:	<i>No details available.</i>
Activity Location:	*Any Location Type
Activity Type:	Onshore fabrication, repair
Description:	<p>On the 12th February, at approximately 16:00, an employee from Salamis was working on a sheet metal bending machine. Whilst carrying out this operation it was necessary to hold the machine open by pulling the spider arm towards you with one hand and then adjust the metal with the other. When conducting this activity his hand came off the handle causing the top bed of the machine to come down in a controlled manner. He pulled his finger away, and due to the body's natural movement this caused his other hand to push the spider arm forwards, closing the top bed and catching the tip of his glove and index finger. He suffered a crush to his finger with the loss of pulp tissue. He returned to the beach the following day and attended Aberdeen Royal Infirmary. The tip of his finger was subsequently removed.</p>

Recommendations: 1. After an assessment of current gloves available, a more suitable glove was identified which allowed for improved dexterity and better grip. Other sites to review their gloves for adequacy. 2. The bending machine (Morgan Rushworth Type BP50/16) was brought onshore for inspection and confirmation of serviceability. Other sites to verify that equipment of similar type is operating correctly. 3. Contractor re-fresher training/awareness on safe working of equipment to be conducted. 4. Operator/maintenance checklists to be developed and made available at equipment site

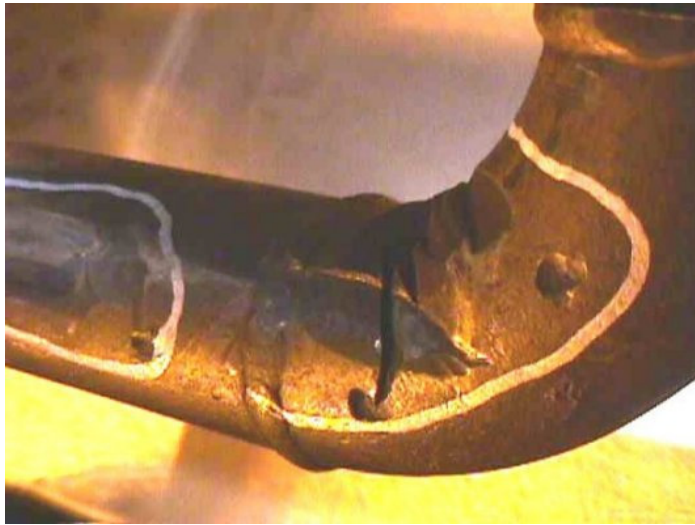
Area close to leak

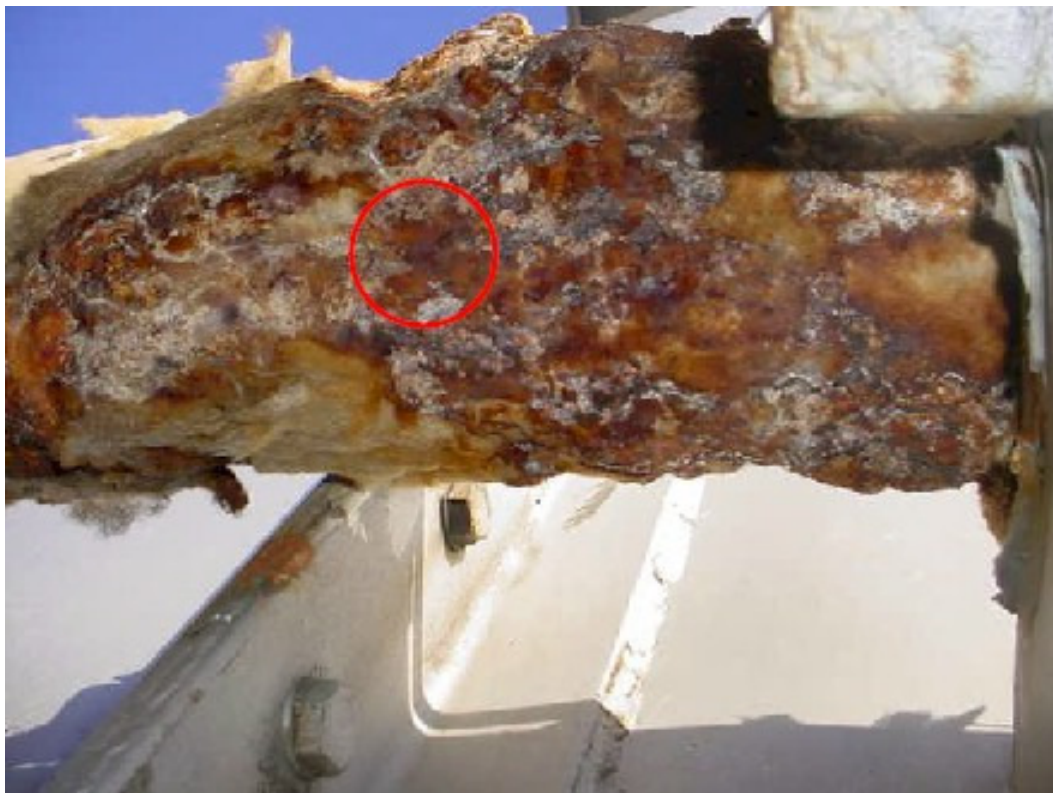
Summary: This alert highlights a potential design fault which can, if not detected, lead to corrosion under insulation (CUI).

**Pipework after lagging removal showing close proximity to vessel seam**

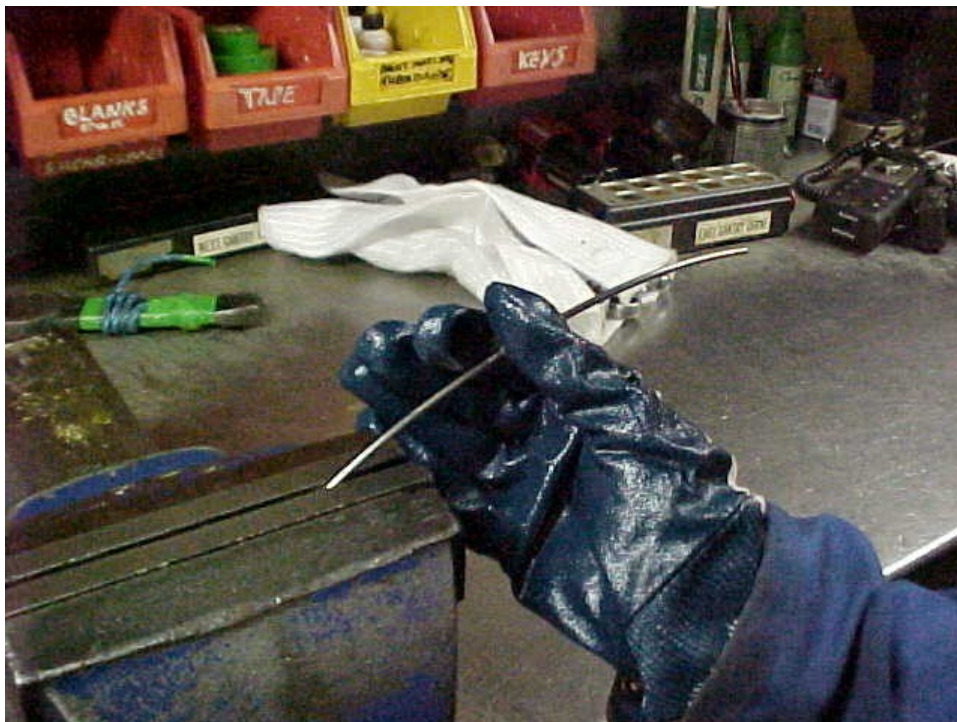
### Wire & Glove Pic 1

Summary: Wiring slipped and went through finger

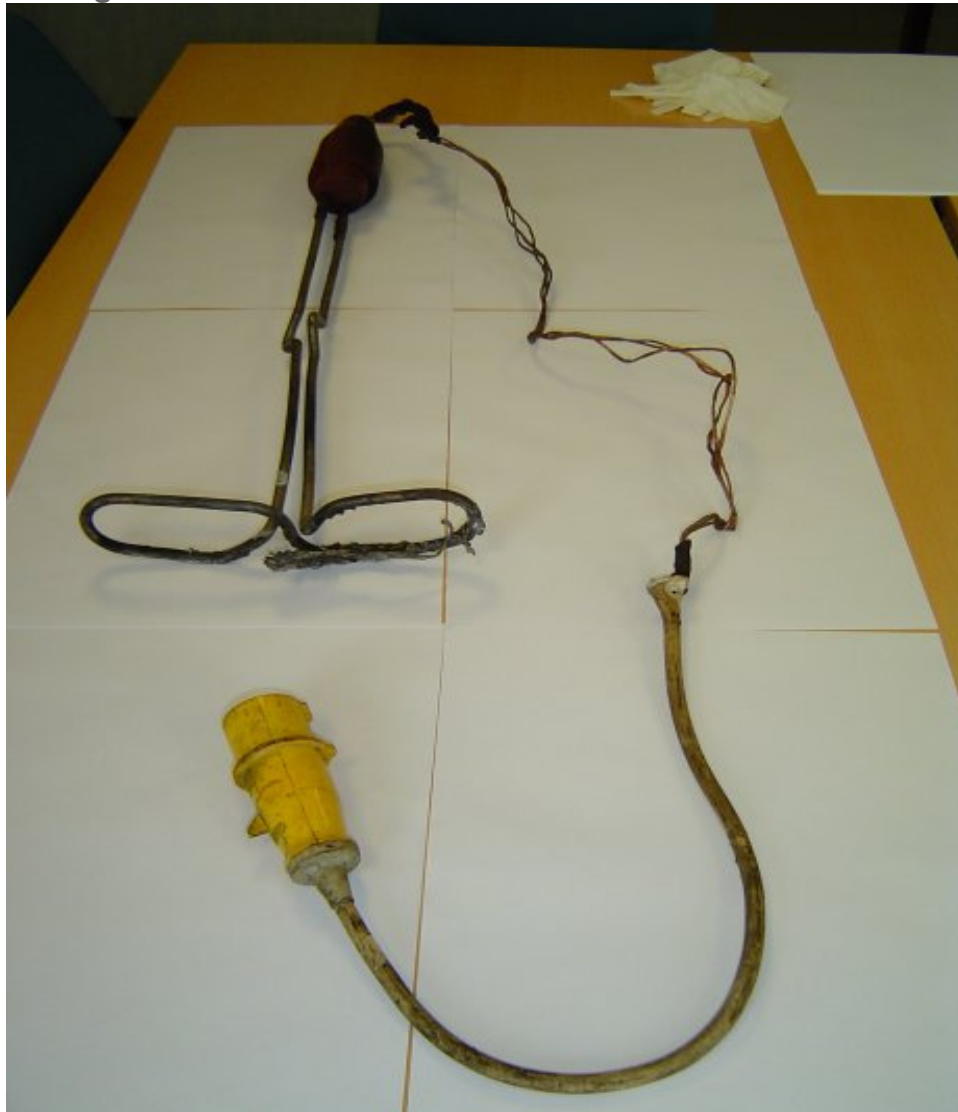
Summary:	A heater element used to heat processing chemicals for radiographic film development ignited a waste bin within the platform production lab
Incident consequences (potential or actual):	<i>No details available.</i>
Cause of accident or incident:	<i>No details available.</i>
Activity Location:	Fixed Installation
Activity Type:	Inspection/testing
Description:	A temporary darkroom for radiography had been set up in the platform production laboratory. Heating of the developer solution was achieved by immersion of a "figure of eight" heater element in the chemical bath. It appears that this element had been laid on the deck while still energised and the technician had been called away to another location. The element ignited an adjacent waste bin and spread to a localised area within the lab. Heat detection alerted platform staff to the fire which was extinguished by means of electrical power isolation and limited use of a portable extinguisher. Damage was relatively minor and localised and no injuries were sustained.

#### **Damaged Heater Element**

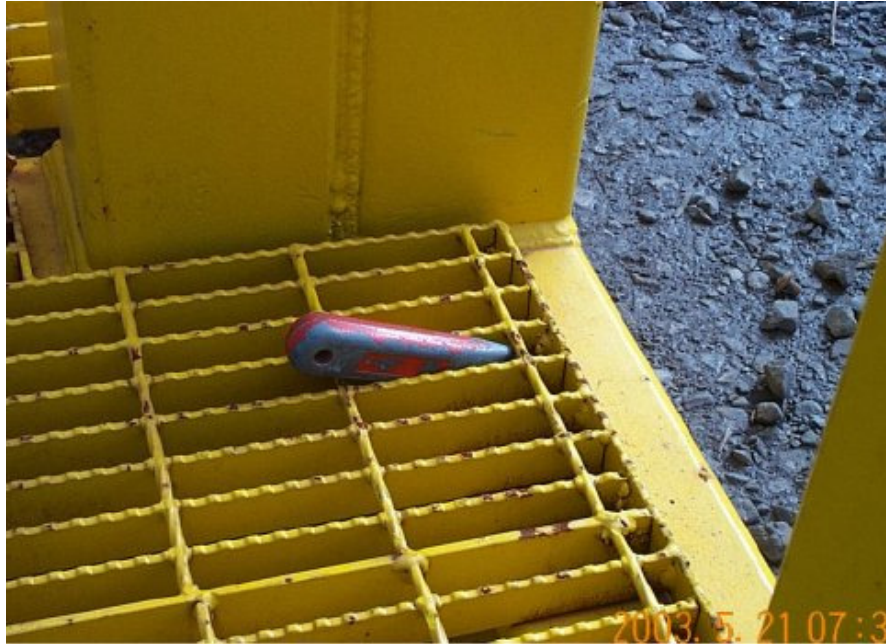
### **Knife lodged at grating edge**

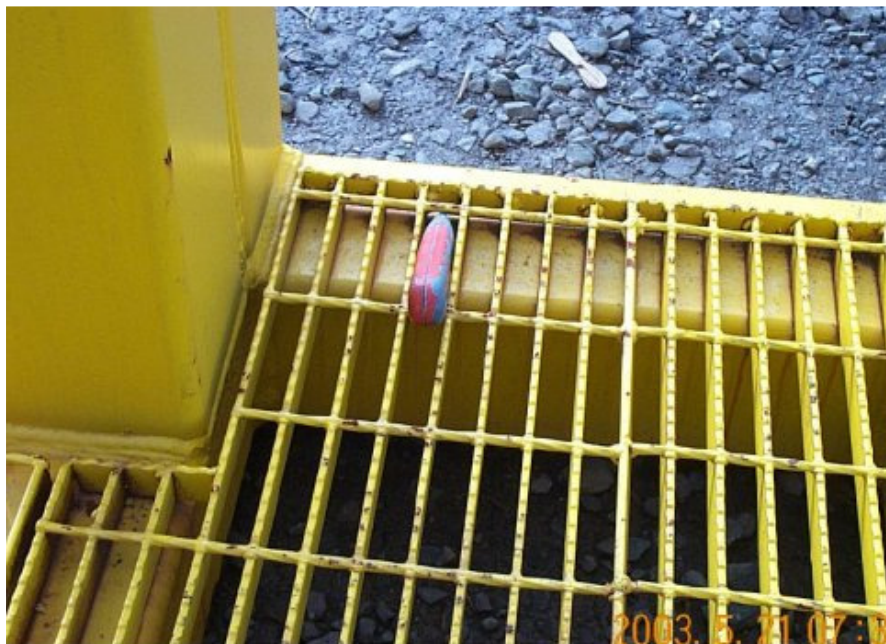
### **Location of knife and displacement potential**

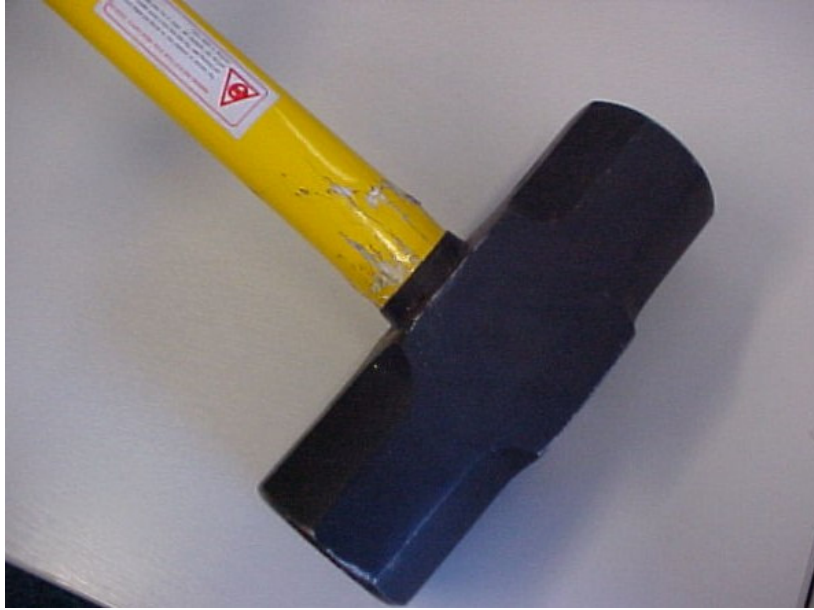
Summary:	A fibreglass sledge hammer shaft failed during first use
Incident consequences (potential or actual):	<i>No details available.</i>
Cause of accident or incident:	<i>No details available.</i>
Activity Location:	*Any Location Type
Activity Type:	*Any Activity Type
Description:	To support a new client policy, the company was changing over to use of fibreglass shafts for all hammers over 2lbs. One of the first to be sent offshore was a 14lb hammer. Within a short period of use, the shaft showed signs of cracking just behind the head of the hammer. Use was stopped and the defect reported. After discussion with the supplier and the client, we have now withdrawn all fibreglass handled hammers and will revert to wooden shafts
Specific Equipment:	<i>No details available.</i>
Lessons Learnt:	Latest technology is not necessarily better. Good pre-use inspection is still a critical requirement and cannot be ignored or bypassed by supposedly better technology in this case.

**Fibreglass shaft cracked near head of hammer**

Task Description:	<i>No details available.</i>
Recommendations:	Take care in the selection of tools. Ensure users are aware of pre-use inspection requirements.
Contact Details:	Howard Dunn, Sparrows Offshore Services Ltd. (44) 1224 704868

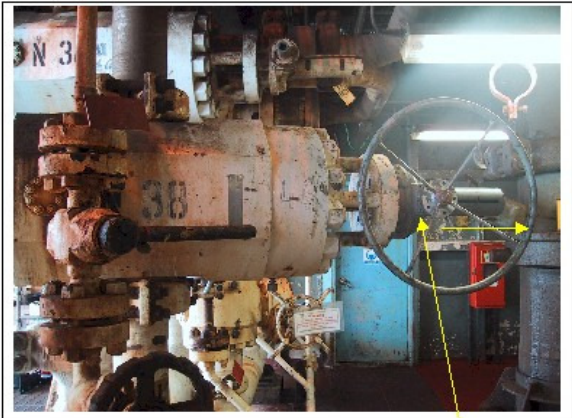
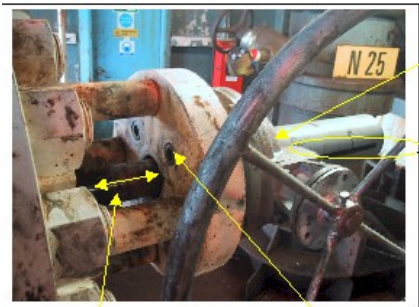
Gearbox casing came off valve stem when valve stroked unintentionally

Valve handle was removed at time.  
Casing weighs 60 lbs

Valve stroke length 12"

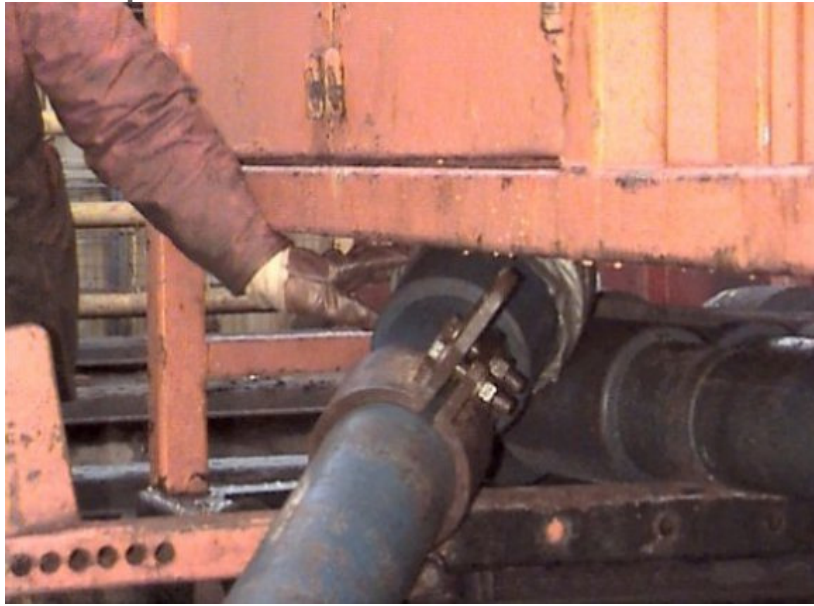
Handtrap2

Summary:	Whilst lifting a short section of lubricator from a Pressure Control skid, the Operator caught his hand between the thread protector of the lubricator and the frame of the skid (see picture below). The storage unit is designed for long joints which can be rolled out and lifted by overhead crane. The section was too short to fit across the sliding rail brackets in the skid, as such a decision was taken to lay one end on the deck then use slings to fully remove the section from the skid. Unfortunately as the end was being lowered to the deck, the operator saw that the other end was not free. On attempting to free the trapped end his hand became caught as the other end dropped to the deck.
Incident consequences (potential or actual):	<i>No details available.</i>
Cause of accident or incident:	<i>No details available.</i>
Activity Location:	Fixed Installation
Activity Type:	Lifting, crane, rigging, deck operations

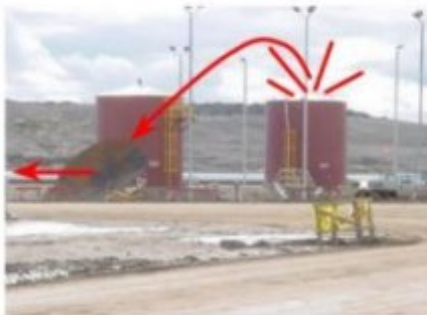
**2. Filling of a vertical tank**

Fortunately no injury happened, but an operator was on top of the tank a few seconds before.

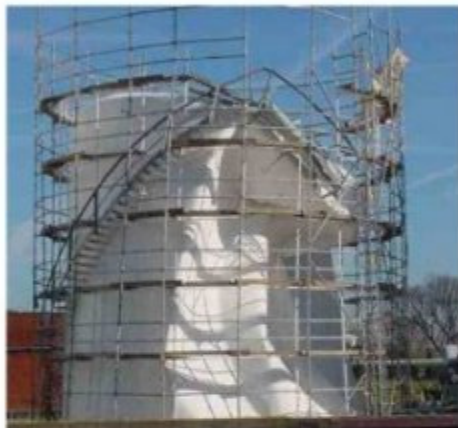
The collapse of this tank happened while it was being emptied. A plastic sheet protecting the roof was trapped in the vent; hence a vacuum was caused.

The plastic sheet  
on top of the tank

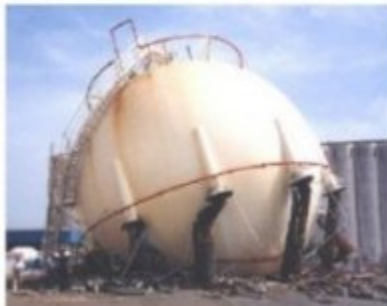
- Water caps over the fire-proofing concrete were of poor design thereby letting water penetrate between the steel beams and the concrete.

- ♦ Vertical cracks in the concrete let water in.
- ♦ Repairs had been done to the concrete, but with poor workmanship.
- ♦ The new concrete had not adhered to the old concrete, again letting water in.
- ♦ The deluge system had been tested with salt water, increasing the possibility of corrosion.

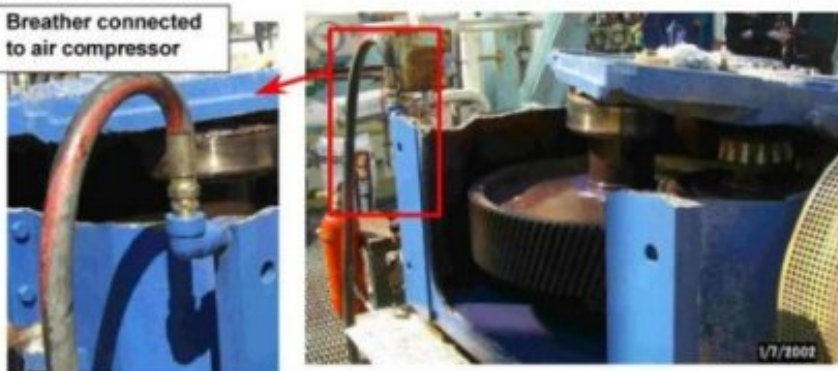
Breather connected  
to air compressor

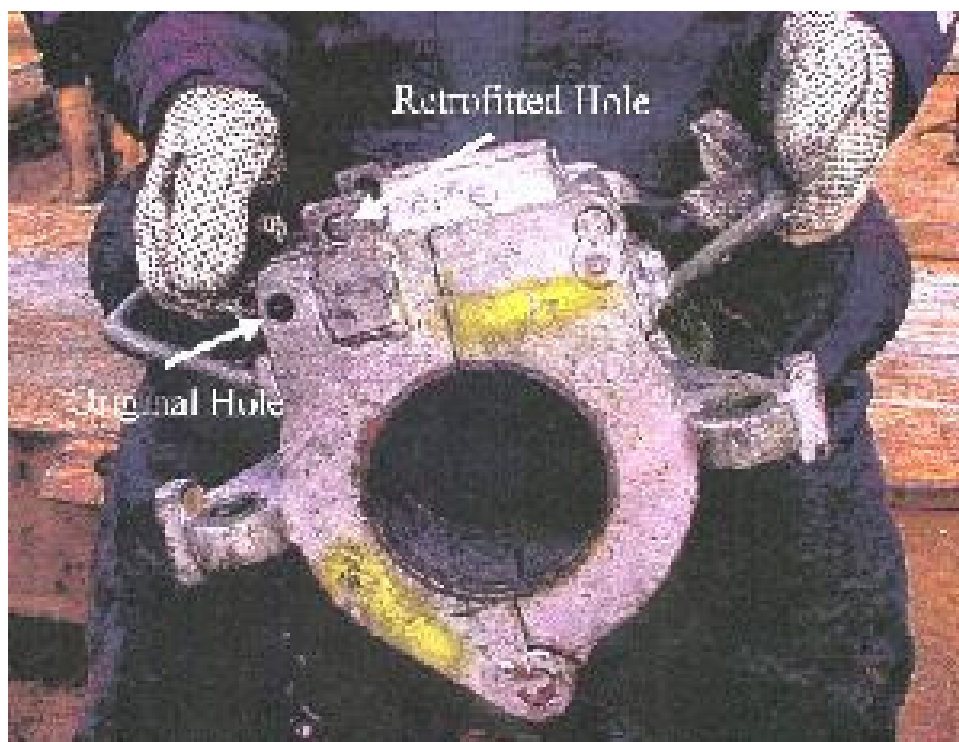
### **Defective elevator**
