MAERSK	SAFETY ALERT				
	FOCAL POINT	NEIL SMITH	APPROVED BY	GLENN CORR	ISSUE DATE
GRYPHON ALPHA LOSS OF HEADING, MOORING SYSTEM FAILURE AND SUBSEQUENT LOSS OF POSITION.

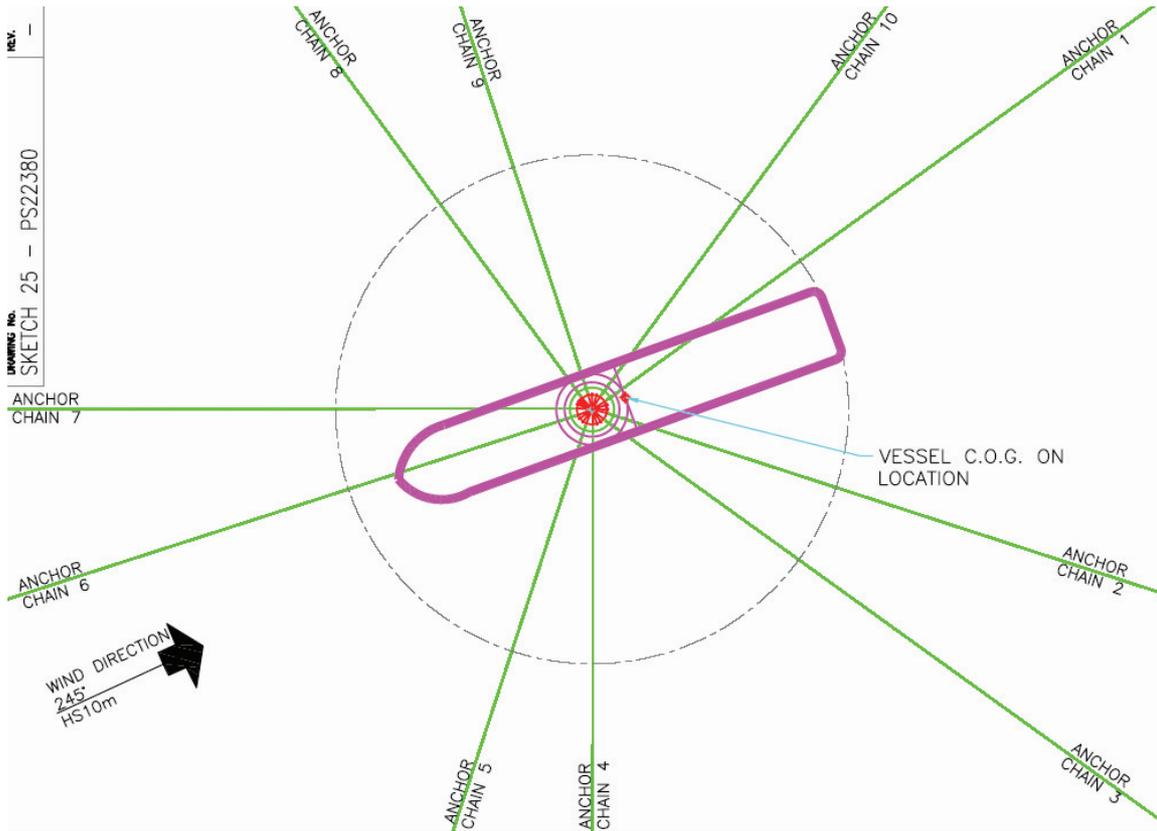
0704

Vessel just prior to incident at 07:04

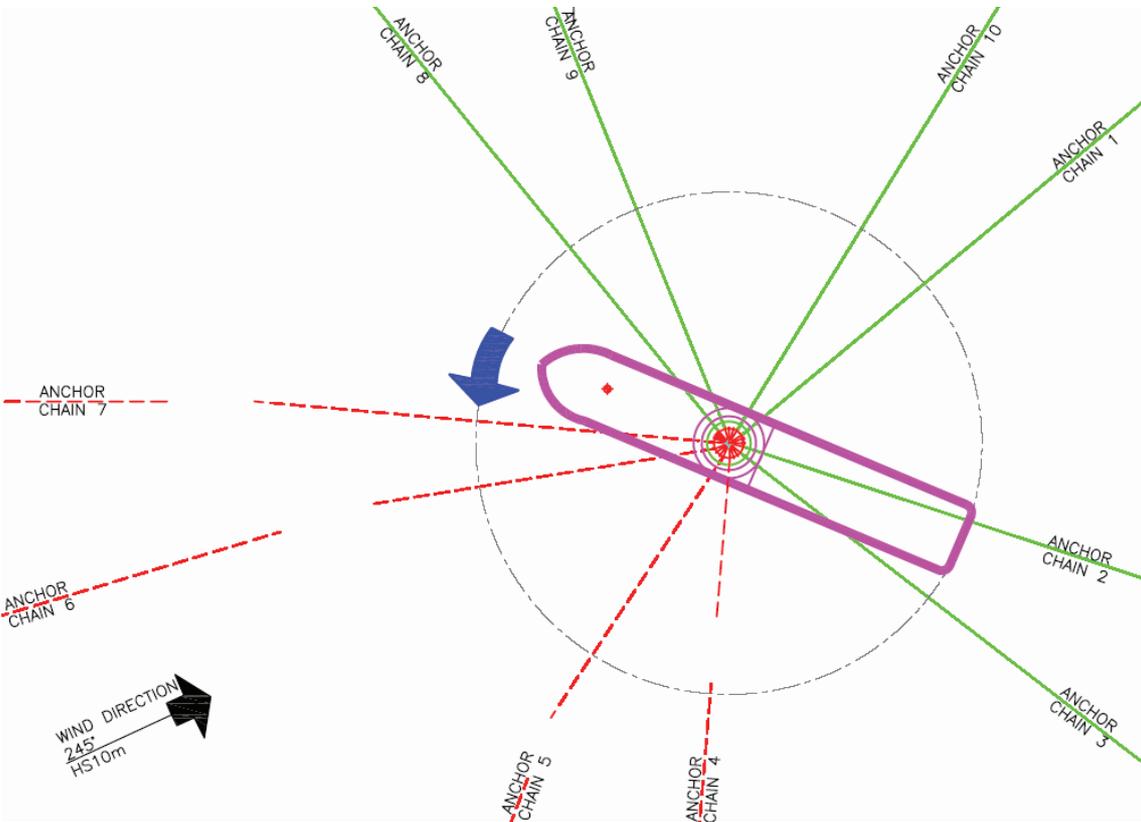
0719

The initiating event was the low tension failure of windward mooring line 7.

The PM system then drove the vessel beam on to the prevailing weather. This resulted in three further windward mooring lines (in order, 6, 5 and 4) failing progressively as the vessel heading turned beam on to the environment. The mooring lines failed due to the high environmental forces they were subjected to, which exceeded the design criteria.

Vessel with four failed mooring lines and approx 95m from field centre at 07:19
