Thermowell Safety Alert for Step Change

Janice A

Temperature measurements in compressor

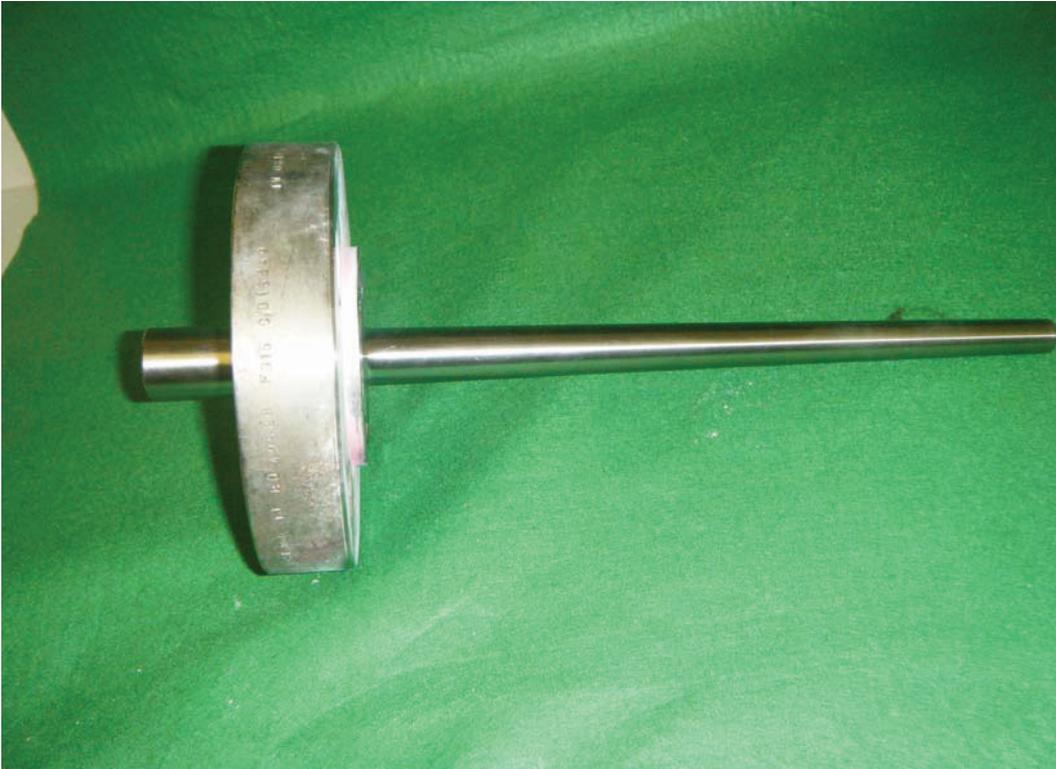
Picture 1

During a routine inspection of the online Janice gas compression packages hydrocarbons was found to be seeping from a thermowell (picture 1) on the 2nd stage discharge dampener on train B. The compressor was shut down and the thermowell removed for investigation.

On the 10th July 2011 during a routine inspection of the Janice gas plant, oil was seen to be seeping from the threaded area of a thermowell on the 2nd stage discharge dampener of gas compression train B. The compressor was shut down in a controlled manner and the thermowell removed for investigation and analysis.

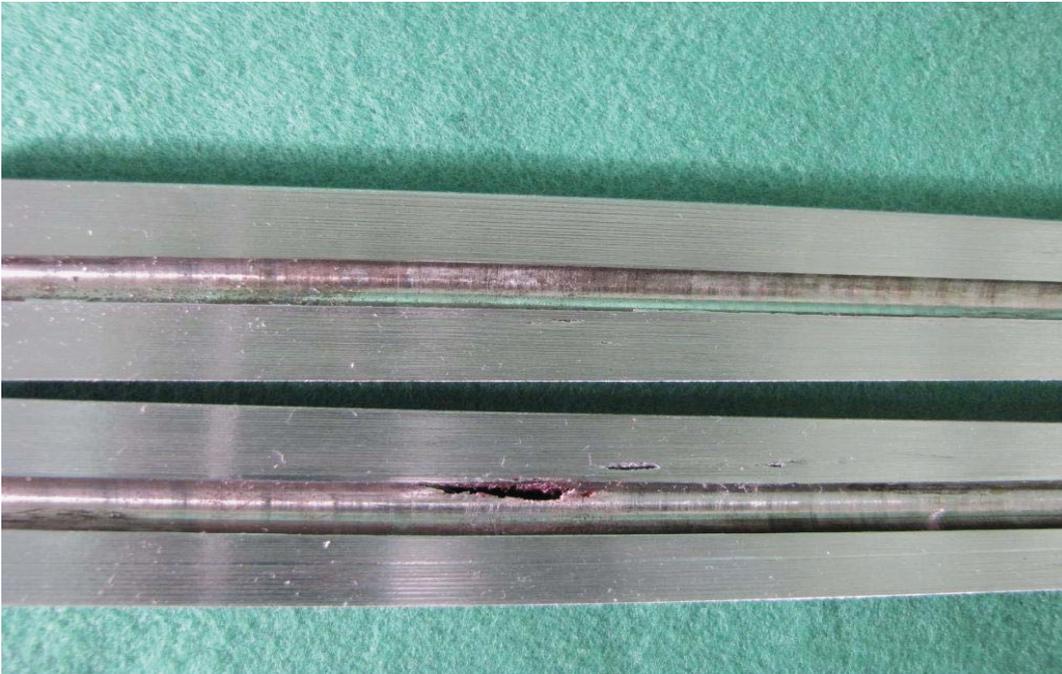
Picture 2

The thermowell was found to have small through-wall cracks through which the hydrocarbons leaked. Further and more detailed testing indicated the presence of relatively large shrinkage cavities in the body of the fitting, (pictures 2 and 3). The presence of these cavities, along with vibration in the plant from the gas compressors, caused the cracking. These cavities should not be present and were caused as a result of faulty manufacturing process.

Small cracks developed from the shrinkage cavities to the metal surface as a result of vibration.

1. Operators may wish to check the certification on thermowells they may have purchased to establish if any of them come from this same batch number. If any do, they may wish to plan to change them out.
2. The manufacturer did carry out all the tests identified on the order, but none of these would have found this defect type. Therefore, Operators may wish to consider specifying additional inspections at the supply stage for thermowells on high pressure hydrocarbon service to check for sub-surface defects.
