I Failure of Pressure Washer

2 Equipment Damage – Dropped ROV/Tether Management System (TMS)

3 Grinding Disc with Defects

8 Pilot Ladder Failure

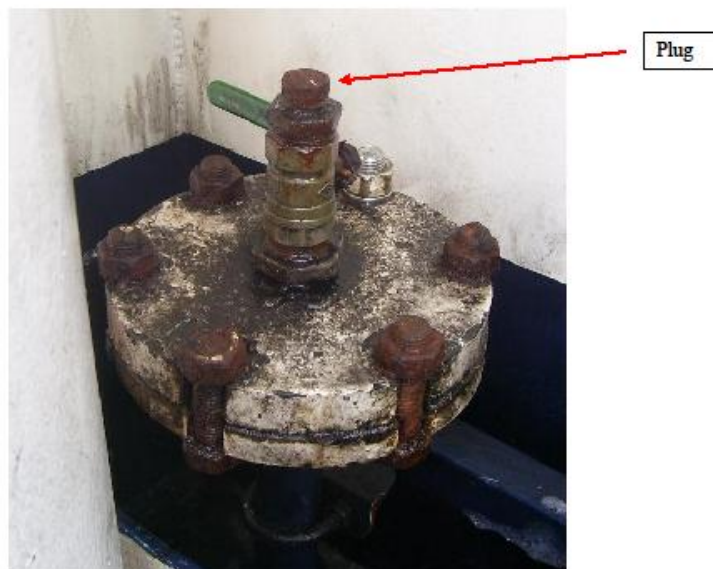
Starboard Waste Oil Connection

- At 0940 hrs the 2nd Engineer checked with the barge if it was ok to resume pumping and the pump was restarted.
- At 0955 hrs the Motor man heard a noise from the starboard side and noticed waste oil spraying out from the starboard connection. The motor man immediately stopped the pump using the Emergency Stop.
- Approximately 20 litres was spilt on the vessels deck with one litre going over the side into the water.

- No check list was in use prior to commencing discharge of waste oil
- During the handover all the relevant information was not passed on.
- The joining crew did not use a check list before resuming operations.
- The scupper plug under the waste oil saveall was not in place
- The unused (stbd.) connection was not properly capped with the valve closed.
- A secondary check of the lines after resuming discharge of waste oil would have indicated the starboard connection was leaking
- Company procedures were not adhered to.
- Poor Communication
- No evidence of a checklist being used for waste oil discharge since early 2010.

All personnel are reminded to ensure that Company Procedures are followed at all times. The use of a checklist would have prevented this incident from occurring. This incident also highlights the importance of a proper handover whether during crew change or change of watch.

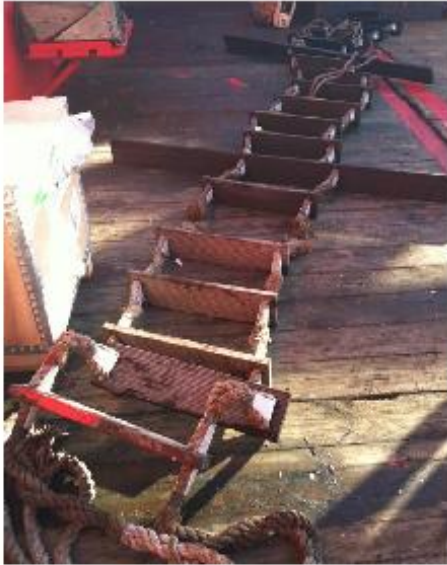
- The pilot ladder was in poor condition and the pilot ladder ropes were worn by contact with the sheerstrake.
- There were no measures in place to reduce the effect of the sharp edge of the vessel's sheerstrake on the pilot ladder ropes.
- The wear on the pilot ladder ropes from contact with the sheerstrake was not considered as the company risk assessment process was not effectively implemented on board.
- Experience Transfer highlighting the potential hazard from the deployment of a pilot ladder over the sheerstrake was not yet issued to the fleet.
- The pilot ladder was stowed on the open deck by the pilot boarding station and was not covered and suffered deterioration from the weather.

Damaged Pilot Ladder

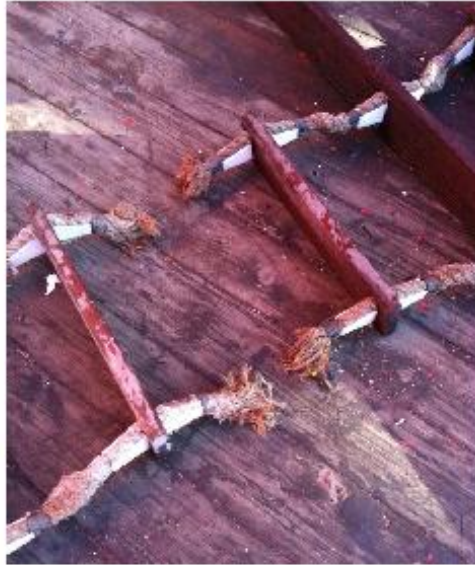
Pilot Ladder Where Parting Occurred

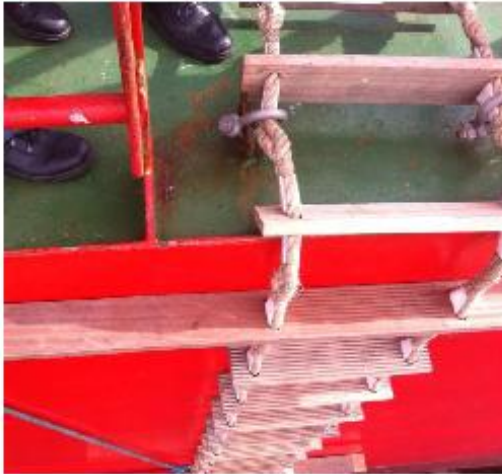
Pilot Ladder Deployed Over Sheerstrake

1. Any sharp edges with the potential to affect pilot ladders to be removed
2. A new and unused spare pilot ladder to be provided
3. Gratings to be installed to raise pilot ladders from deck (if not stored in a dry and clean environment)

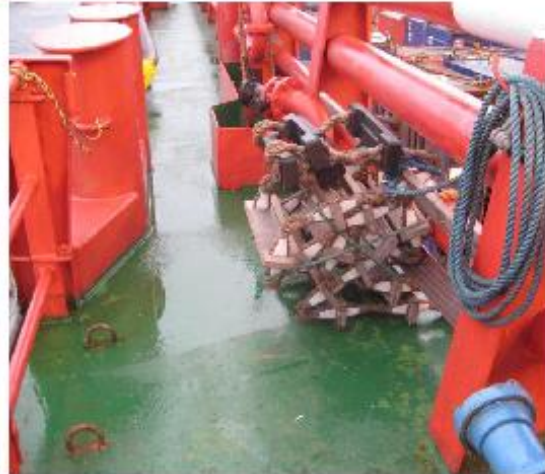
Pilot Ladder In Stowed Position

4. Weather proof covers to be provided for pilot ladders (if not stored in a dry and clean environment)
5. Regular inspections of pilot ladders to be carried out by a competent person on board
