MARS 201165 Lifeboat damaged by ruptured air cylinders

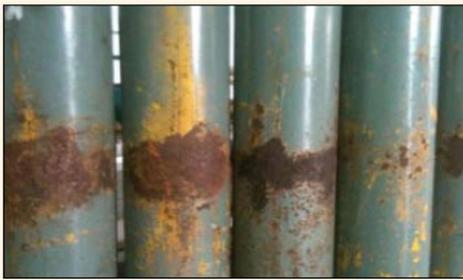
An oil tanker's totally enclosed fibreglass lifeboats were equipped with high-pressure air cylinders stowed beside the keel. One day at sea – shortly after the lifeboats had undergone a 5-yearly inspection by an accredited contractor – one of the compressed air cylinders suddenly and spontaneously burst, resulting in extensive damage to the lifeboat's keel and hull. Fortunately, no-one was injured. Once the vessel arrived in port, a local lifeboat service company was contracted to investigate the incident and assess the damage with a view to carrying out repairs. In the absence of supporting documents (certificates/ work reports etc.) and from the dates punched on the cylinders, it appeared that it was more than six years since the last hydraulic test of the air cylinders. (IACS Recommendation No.88: Air bottles for air supply in totally enclosed lifeboats should be hydraulic pressure tested by a competent service station recognised by a Recognised Organisation at intervals not exceeding 5 years and the hydrostatic test date must be permanently marked on the bottles.) The substantial corrosion of the cylinders' exteriors suggested that routine inspections and maintenance had also been seriously neglected. After the air cylinders were removed and closely examined, it was ascertained that the cylinder shells had suffered a 50% diminution in thickness in the corroded patches. After assessing the damage, the lifeboat was deemed to be beyond economical repair. It had to be scrapped and a replacement lifeboat obtained. The investigation report was forwarded to the fleet Head Office in order to instigate legal action against the original equipment manufacturer (OEM) for potential breach of code(s) in the material, design and construction of the cylinders, and against the authorised contractor who last serviced the lifeboats and equipment for negligence.

▲ View of localised corrosion on the exterior of air cylinders

Editor's note: As a consequence of this incident, it is presumed that all air cylinders in the other lifeboat were also renewed. This incident highlights the need for compressed air or gas cylinders, fire extinguishers and hydraulic systems to be regularly inspected, maintained and hydraulically tested at recommended intervals. They must be renewed if there are any signs of wastage or corrosion, which may be particularly serious in locations that are exposed or enclosed.

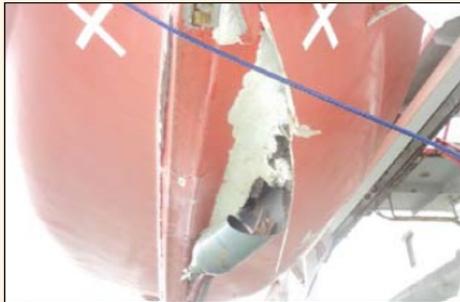
▲ View of damaged hull and ruptured air cylinder

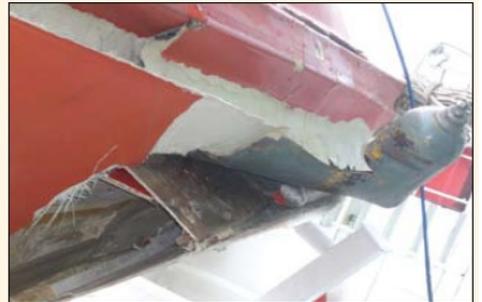
▲ Close-up view of damaged hull and ruptured air cylinder
