## Overfill of Helifuel Tank and Subsequent Ignition

# SAFETY ALERT

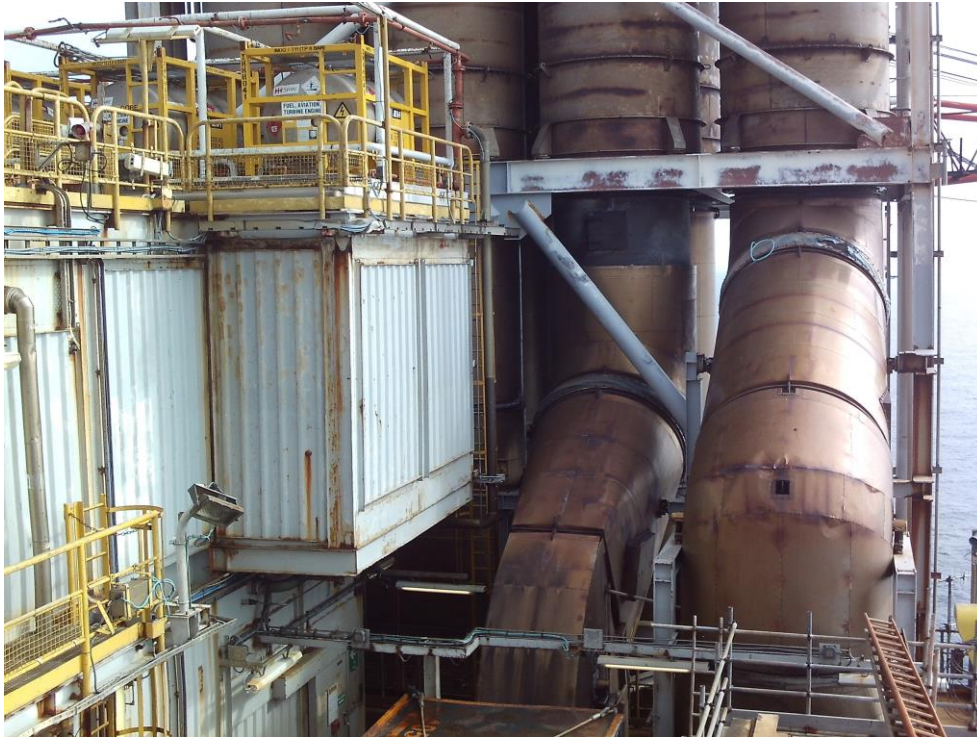
During the non-routine transfer of aviation fuel from one tank to another, an overfill of the tank occurred resulting in the release of approximately 0.57kg of aviation fuel through an open vent line on the recipient fuel tank. The released aviation fluid was projected onto nearby turbine exhaust pipework and subsequently ignited for a short period of time before self-extinguishing. Transfer operations were immediately suspended and the power turbine was shutdown.

The direct cause of the incident was determined to be an inaccurate level gauge which lead to the tank being filled beyond capacity.

Position of helifuel tanks and exhaust ducting

- Ensure the level indication is functional and subject to routine maintenance.
- Ensure non-routine transfer operations are subjected to sufficient risk assessment and develop a detailed temporary transfer procedure.
- When transferring between tanks, do not use two tanks of the same volumetric capacity, use a smaller supply tank.
