Potential dropped object during lifting operation

SAFETY ALERT

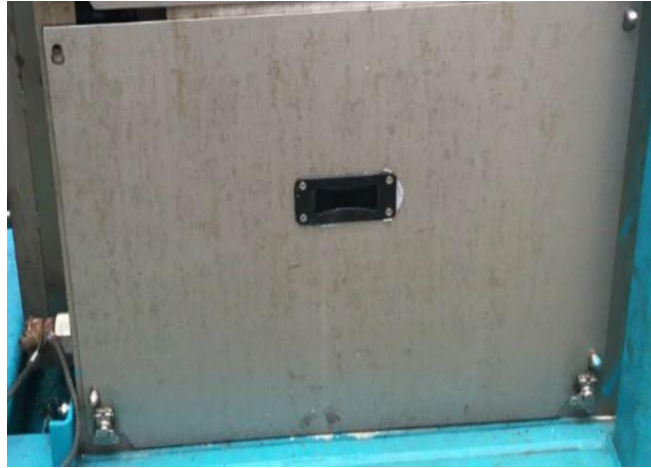
When the load was approximately 15m above the deck the load turned and the crane operator noticed one of the stainless steel panels for the unit was loose. The crane operator immediately lowered and landed the HPU on the starboard pipe deck. Once on the deck it was noted this panel (panel 1) was hanging only by the upper left locating pin. Alongside this another panel on the same unit was noted to have lost the upper left locating pin, the decision was then taken to remove all of the panels prior to the unit being lifted again. All the panels were loaded separately into the container and the unit was lifted again without incident.

Panel 1: The lift was inspected by all personnel prior to the lift by the crane operator. All removable panels locking clasps and locating pins were deemed to be secure. The current removable panel securing clasps are of inadequate design and are unable to withstand a moderate impact.

Panel 2: Removable panel locating pin was noted to be missing when the control unit was lowered back to the deck to inspect panel 1.

Design – inadequate design of removable panels securing mechanism

- Modify all existing units with this type of retaining clasps within the region.
- Formulate modification plan of all control units globally with these types of clasp.
- Safety alert issued internally and discussed with client. Share lessons learned with industry bodies.
- Update design specification of HPU.
