Three Way Valve Incident – ejected stem during changeout of Duplex Filter

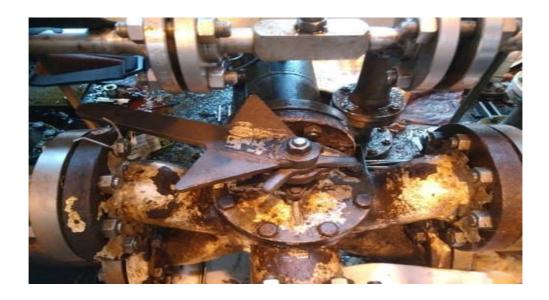
Operation technicians were attempting to change filter banks by operating a three way valve. In act of trying to "loosen" the valve, the pin through the shaft had sheared and the lifting jack nut backed out to the point where the threads were no longer sufficiently engaged. Pressure within overcame any remaining hold on the stem from the packing, and the stem and oil was ejected.

Immediate controls implemented to isolate equivalent valves.

Valve operating instructions shared among operations and maintenance teams to ensure valve is set up, operated and maintained in the correct manner.
