## Cargo snagging reduction measures

# SAFETY ALERT

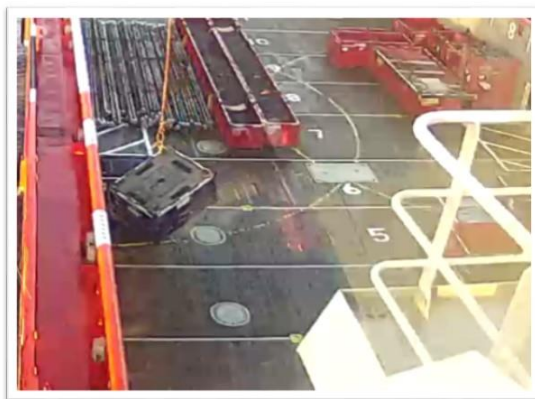
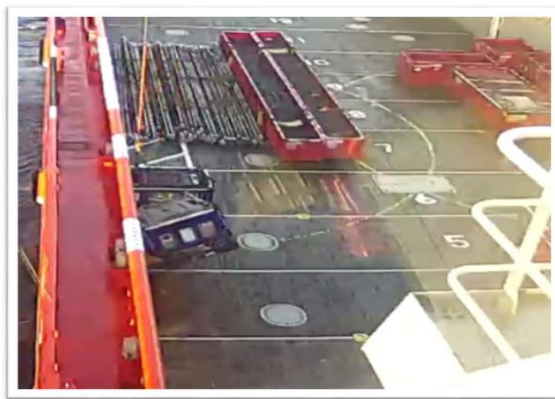
### Incident 1:

A CCU being back loaded from an installation impacted on a container already backloaded, the impact on the CCU caused it to then swing into a safe haven where it caught on the anti-snag bar and damaged the bar.

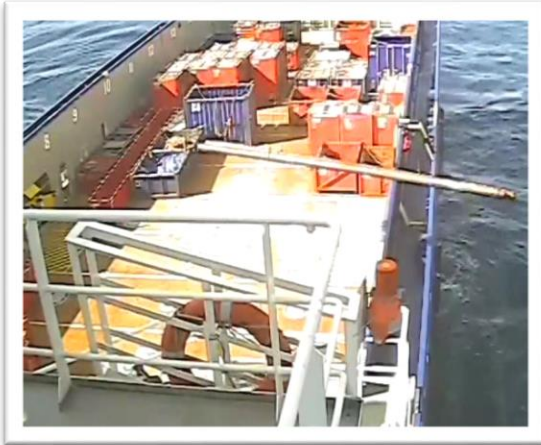
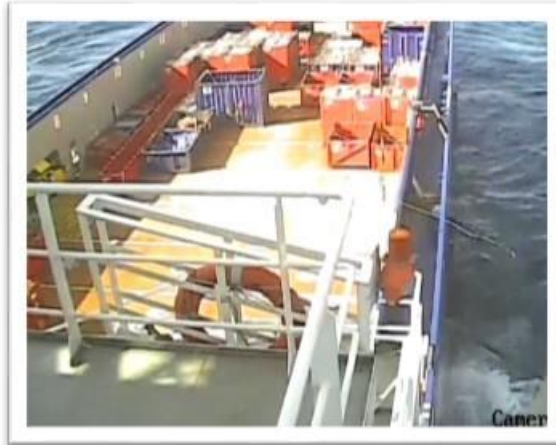
## Incident 2:

A drill pipe backloaded from an installation swung inside a safe haven doorway, the lifting slings broke and the pipe fell overboard.

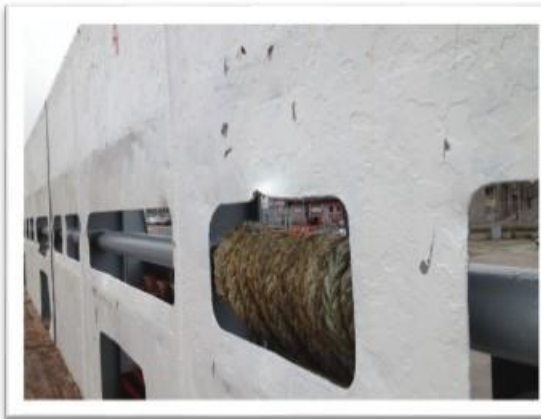
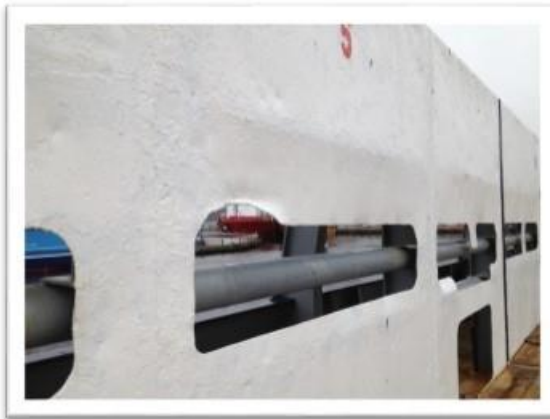
## Incident 3:

A PSV without anti snag bars and no 'tiger stripe' highlighting the cargo rail tops, suffered several snagging incidents causing damage to the vessel, cargo and offshore crane.

As a result, anti snag bars were fitted to all safe havens and the vessels top rails were highlighted.

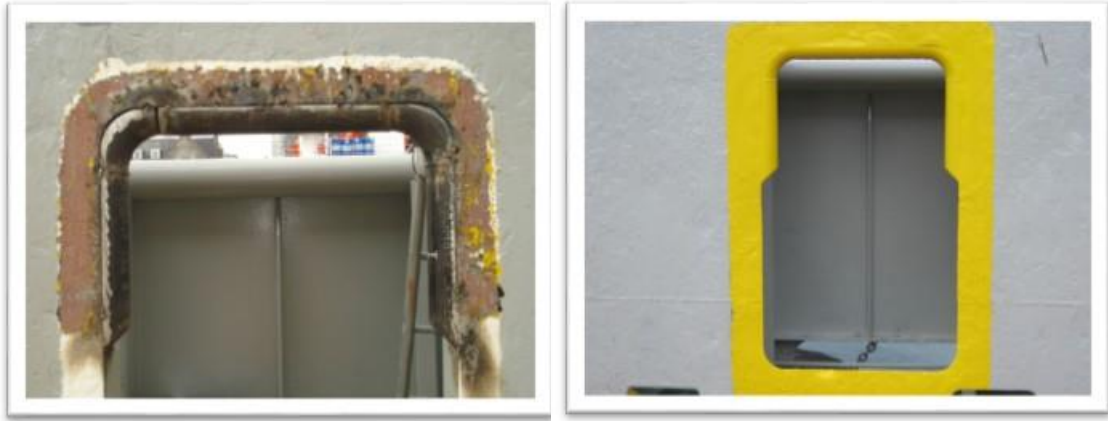
There was then a significant reduction in snagging incidents involving the vessel.

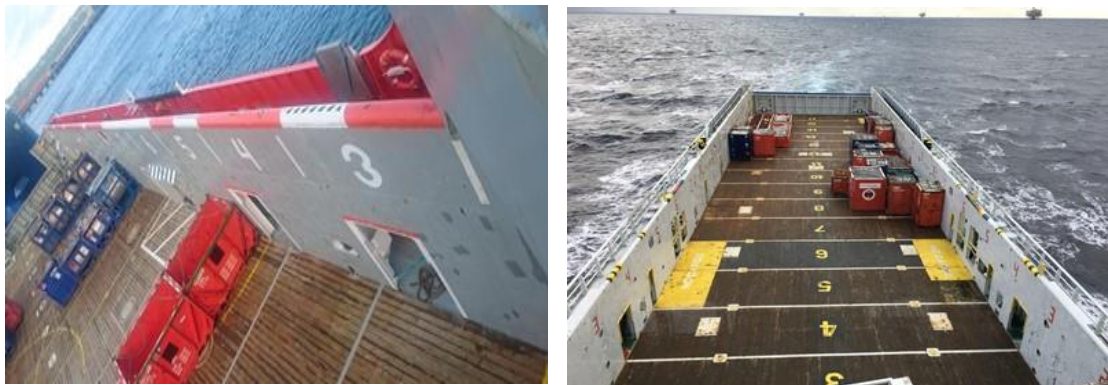
All term contracted PSVs are required to have their cargo top rails marked to highlight potential cargo snagging areas which may be hidden from the crane operator's view.

1	Vessel Masters should satisfy themselves that all potential cargo snagging areas on the cargo deck have cargo snag bars fitted. The anti snag bars should be regularly inspected to ensure they remain 'fit for purpose'.
2	Vessel Masters should satisfy themselves that the cargo top rails are sufficiently highlighted to ensure crane operators looking down from height can easily identify potential snagging areas.
3	Offshore crane operators should be made fully aware of the significance of the highlighted areas on the vessels' top cargo rails and when/where possible avoid loading small CCUs against these areas.
