Dropped Angle Iron from Drill Floor Ducting Support

SAFETY ALERT

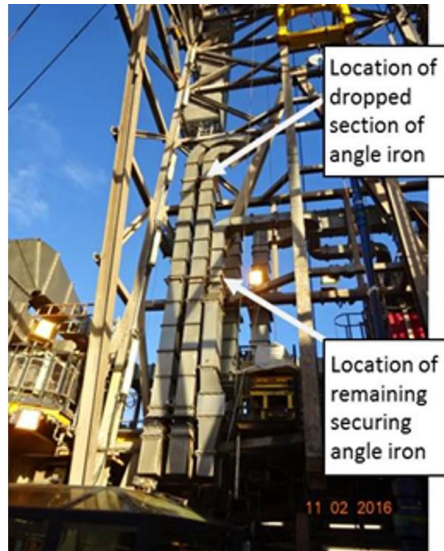
A piece of angle iron weighing 7.75 kg, used to secure the draw-works exhaust ducting dropped from approximately 12m. The angle iron hit and smashed the re-enforced glass roof of the dog house, bounced 2m laterally (contacting one of the wireline team on their hard hat) and eventually landed a further 2m away on the drill floor.

- the angle iron fell from the draw-works motor discharge duct after primary fixing bolts had either failed or worked loose.

- Potential bi-metallic corrosion. Carbon steel bolts were used to secure the stainless steel angle iron section.
- The failed / loose bolts were not identified during inspection. The ducting inspection work order only called for a general visual inspection from drill floor level.
- The draw-works exhaust duct is not captured in the weekly derrick inspection as it is owned by the platform maintenance & operations team.

- Reliable securing practices were not utilised as evidenced by double nuts used on other parts of the structure.

- Carbon steel bolts must be adequately isolated from any stainless steel material to avoid the potential for bi-metallic corrosion.
- To identify failed / loose bolts; incorporate inspection of bolts in the derrick inspection.
- Clearly define responsibilities for maintaining / checking equipment.
- Level of inspection detail for support structures must be adequate and clearly defined in the work orders.
- Reliable securing practices should always be used.

- Review the top side inspection scope for HVAC and exhaust ducting to ascertain whether support structures are included and that the level of inspection is a close visual inspection. If not, amend accordingly.
- Inspect HVAC & exhaust support structures at height. Identify any deficiencies in the securing mechanism and rectify.
- Identify high risk areas on all platforms with regards to dropped objects and develop a scheme to mitigate the risk.
- Review dropped object picture books for all operating rigs. Ensure all items with a DROPS potential within the drilling package are included, regardless of maintenance responsibility. Rectify any omissions.
