Fire in laundry tumble drier

SAFETY ALERT

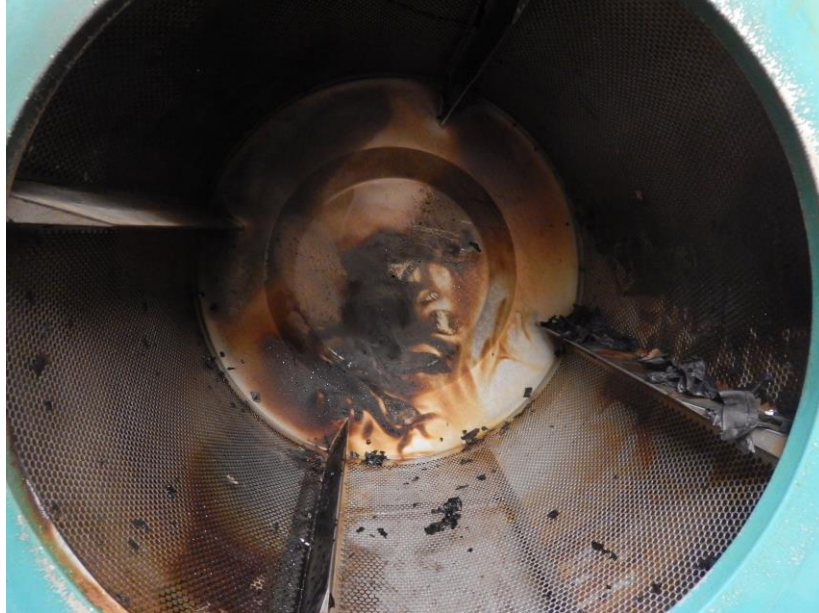
A fire in #1 tumble dryer in the platform laundry was caused by the contents of the dryer drum (coveralls) igniting. The fire was identified by fixed platform detection systems and extinguished by the Emergency Response Team. All platform personnel went to muster stations and production was shut down.

The tumble dryer heating element contactor had stuck in the closed position, meaning that at the end of the drying cycle, heating continued instead of the machine switching into a short cooling cycle.

The safety cut-out design relied on the stuck contactor being able to open, and so failed to operate. Heating of the drum contents therefore continued until the coveralls ignited.

There was no one present in the laundry room at the end of the drying cycle so the coveralls were not immediately removed from the dryer at end of cycle.

- Establish clear maintenance guidance for tumble dryers including inspection and replacement of heating element contactors.
- Review tumble dryer safety cut-out design and consider replacing if design relies on single contactor which has potential to stick in closed position.
- Facilities contractor procedures should require that a steward is always present in the laundry at the end of each tumble dryer drying cycle.
- Fit smoke detector in laundry.
- For more information see: HSE Offshore Information Sheet 3/2009 Tumble dryer fires in laundry rooms - <http://www.hse.gov.uk/offshore/infosheets/is3-2009.htm>
