High Value Learning

Failure of a fire pump clutch, as a result of a gear box anti-rotation pin failure

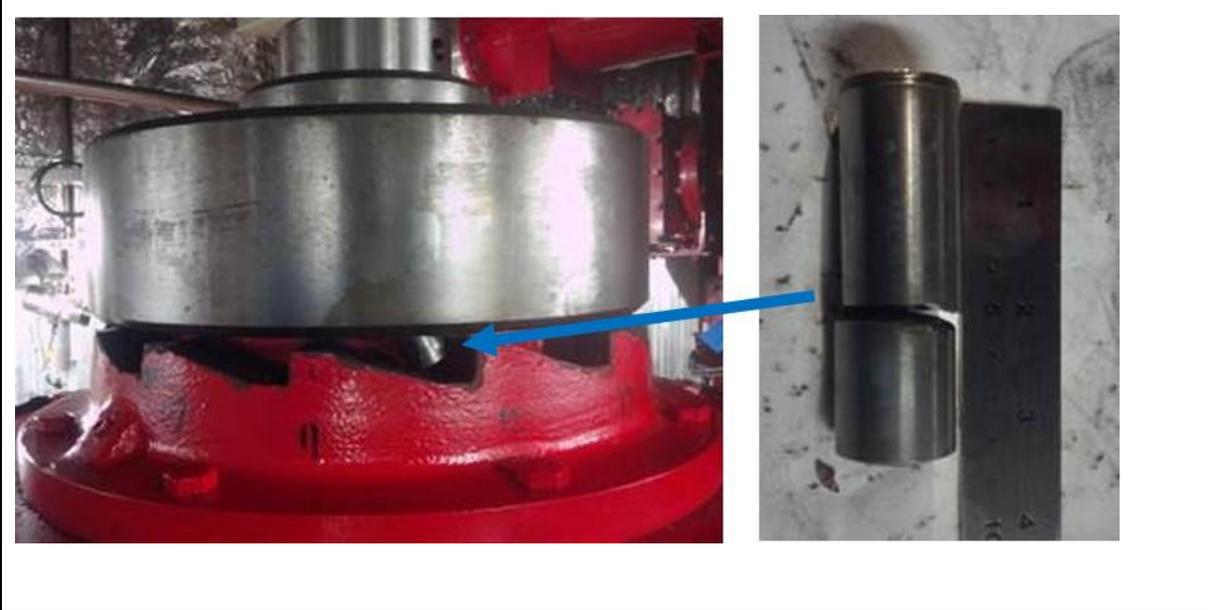
A failure of a diesel engine driven fire pump clutch occurred during routine pump start up. Clutch components were released at high speed into the fire pump room. This resulted in damage to the fire pump room and to the engine and its ancillary systems. Lubricating oil pipework was damaged, resulting in the release of approximately 100 litres of lubricating oil within the room. There was no further consequence of this release (i.e. fire or explosion). No personnel were present, so there was no harm to people. The fire pump assembly was unavailable for several months whilst an investigation and corrective repair was carried out.

The event was investigated with support from the package OEM and supplier. Investigation of the event revealed that the clutch failure was the result of damage which had occurred within the right-angle gear box (connecting the line shaft fire pump to the clutch / diesel engine). A failure of the gear box "anti-rotation" pins had occurred, which caused the gear box to seize and ultimately led to failure of the clutch in operation.

- All fire pump anti rotation pins inspected in field for circumferential cracks (all installations).
- Revision to company maintenance strategy for gear box anti-rotation pins. Periodic inspection and replacement maintenance routines scheduled going forward.
