Electrician suffered flash burn to hand

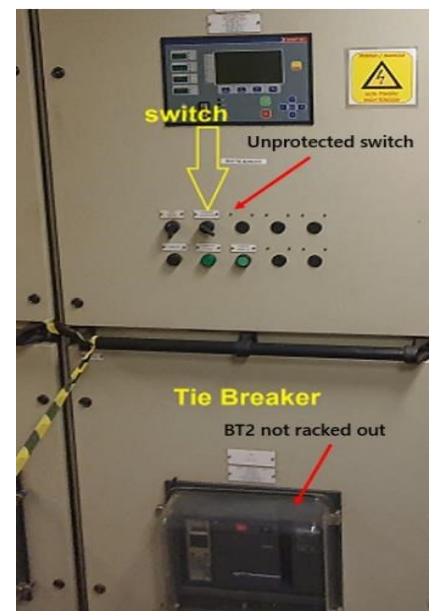
A third-party electrician on a vessel in dry dock got burnt whilst verifying the integrity of insulation on a 690 Volt bus bar. A voltaic arc was created resulting in a flash burn to his hand. Following medical treatment and a period of restricted duties, he returned to work.

- The switchboard was energized / live.
The bus-tie status switch had been moved to “auto” from “off” and an [as yet] unidentified function of the Power Management System commanded bus-tie breaker 2 (BT2) to close;
- The crew ‘racked out’ most of the circuit breakers, therefore physically isolating them. BT2 was not physically ‘racked out’ because the crew mistakenly believed that this would cause the vessel to blackout. ‘Isolation’ was made using the status switch which may have been considered sufficient had the switch been effectively guarded (locked and tagged), but it wasn’t, and no further action was taken to prevent access.

- The existing shipyard Permit To Work system was augmented with task risk assessments, lock-out tag-out control processes and emergency response instructions and toolbox talks;
- The circuit breaker switches were modified to facilitate effective lock-out tag-out;
- A functionality test of the vessel main power management system was conducted, and documentation / manuals and training updated.
