# SAFETY ALERT

## Crewman caught in the line of fire while using Riser Torque Wrench

ALERT 6-20

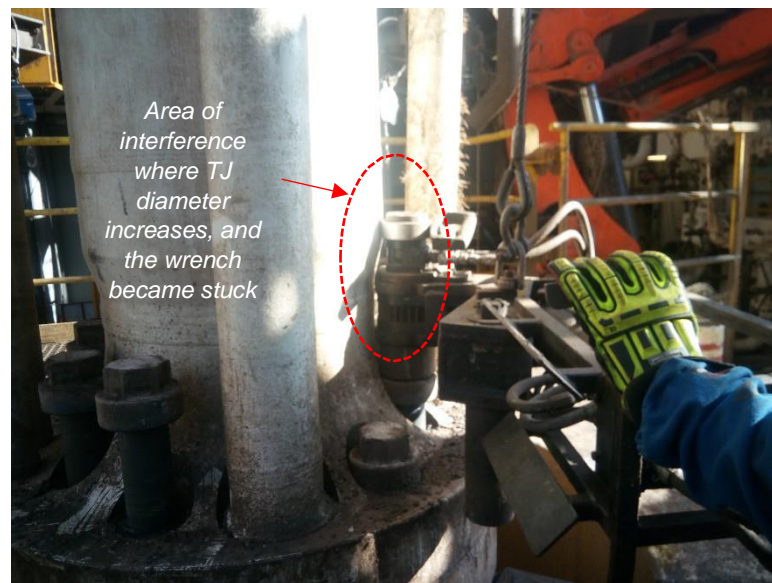
While raising the sixth bolt, one of four on an inner bolt circle, the bolt was unscrewed until the upper section of the wrench motor contacted the larger diameter portion of the TJ. This caused the wrench to become stuck against the body of the TJ, where its diameter increases to accommodate the inner barrel. When the wrench operator and assistant were unable to manually remove the wrench, they gave signals to the nearby winch operator to raise up on the winch, in an attempt to free the wrench from its stuck position. As the wrench operator continued manual attempts to release the stuck wrench and while leaning over it, the wrench suddenly became free, elevating the wrench and the operator rapidly as stored tension in the winch rig-up was released.

***Reenactment of the position of the Riser Torque Wrench on the Telescopic Joint (TJ)***

- Interference between the TJ and wrench which occurred where the outer barrel of the TJ reduces above the flange. Once the interference was encountered, the wrench could not be easily reversed to lower the bolt back down.
- Once the spring compensator was fully extended by paying in the winch, there was no visual or audible indicator to gauge the amount of tension and stored energy introduced to the entire winch rig-up.

- A winch should never be used to free a stuck torque wrench or similar tool or in any other situation where an unknown amount of stored energy may be introduced.

- When a potential interference issue is identified that cannot be eliminated by engineering controls, work procedures and risk assessments should highlight potential for interference, methods to avoid interference, and steps to follow if interference occurs.
