Grinder Disc Fatal Injury

SAFETY ALERT

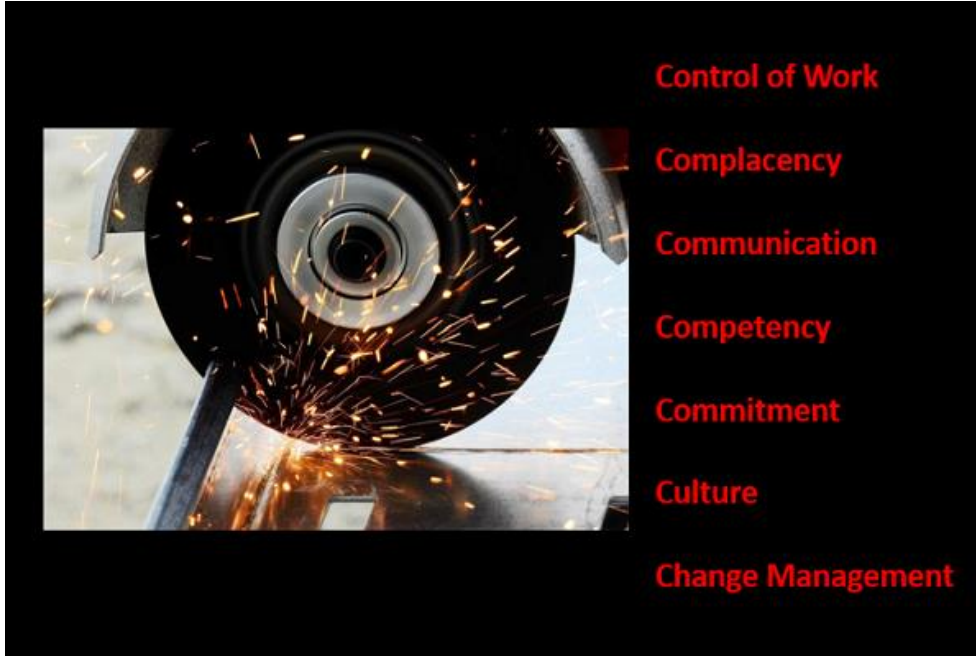
A contractor employee was modifying a road guardrail post using an angle grinder. While testing the grinder, a disc shattered and ejected fragments into his neck, resulting in a fatality.

- Contractor fabricated the guardrail after adopting an incorrect installation method.
- Contractor employee was not trained in the proper use of the angle grinder.
- 9" angle grinder protection guard was removed in order to fit a 14" cutting wheel.
- Angle grinder was rated for a higher speed which exceeded the specification limits of the disc used.
- Personal Protective Equipment (PPE) was not available on site.

- Do not modify working tools - this includes the removal of provided guards.
- Ensure the correct tool for the job is selected and operated in accordance with the manufacturer instructions.
- Ensure personnel are qualified to perform tasks and maintain proper communication amongst crews.
- Ensure the correct PPE for the job is identified and provided at site.
- Exercise your authority to stop the job.
