## Helideck events – foreign object debris awareness

## **SAFETY ALERT**

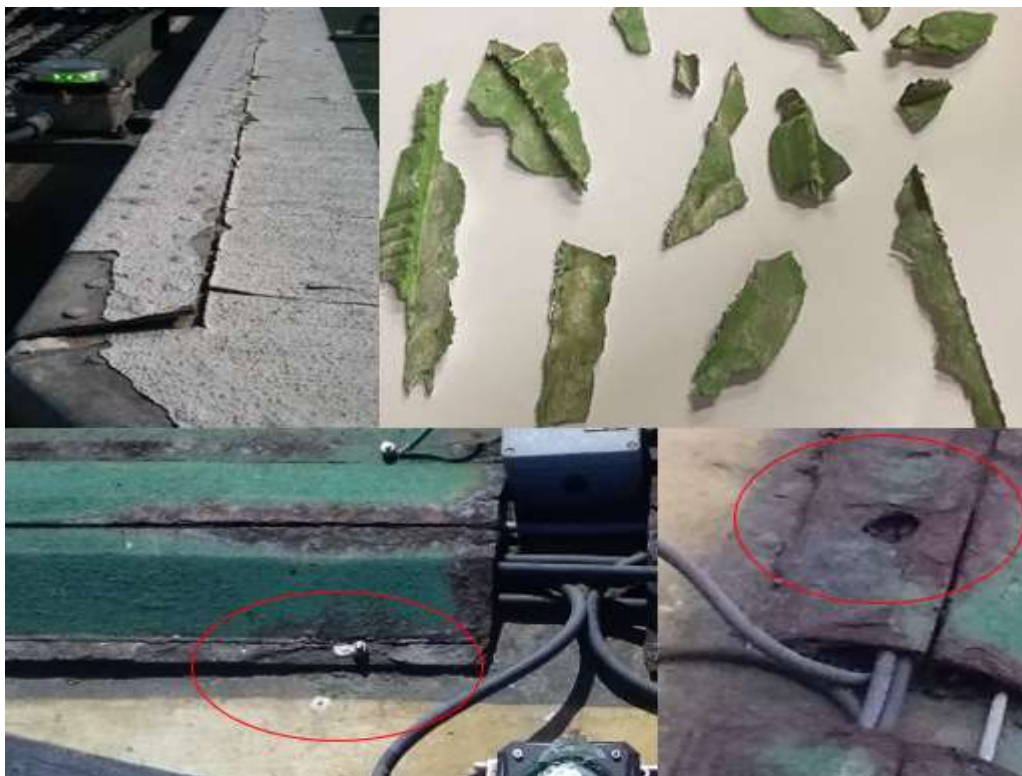
- 1) Helideck gutter railing detached from edge of helideck creating significant helideck coating debris and degradation of helideck surface
- 2) Unserviceable perimeter light highlighted extensively corroded lighting cable covers creating potential FOD hazard

- Ensure appropriate preventative maintenance tasks are in place to maintain CAP 437 compliance and minimise degradation of helideck surface and associated areas; do the checks require to be increased to achieve this outcome?

- Always engage with aviation team to ensure all stakeholders are advised and no precautionary limitations are required on helicopter operations in accordance with the asset performance standard and CAP 437
- Discuss events with asset team members to raise awareness of potential foreign object debris hazards
- Reiterate the importance of continued vigilance required whilst carrying out pre and post flight checks, reporting any issues ASAP
