IP struck by water from fire monitor

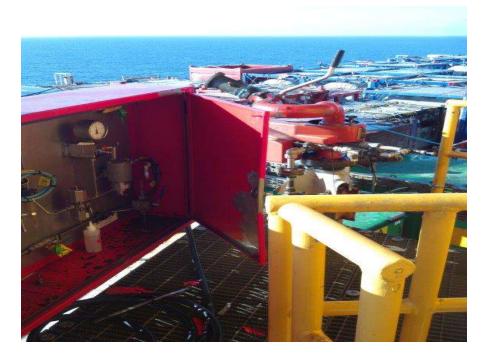
A power outage and low instrument air pressure set off an oscillating fire monitor, filling the deck drains. Technicians attempted to redirect the monitor – successful for a period of time. The monitor started oscillating in a non-standard arc, resulting in water impinging on a control cabinet. The IP attempted to shut-down the monitor and was struck by water rebounding off the cabinet. IP was sent onshore for assessment, returning to work 5 days later.

Carry out a suitable and sufficient Dynamic Risk Assessment
