Near Miss – Casing stud failure on water injection pump

SAFETY ALERT

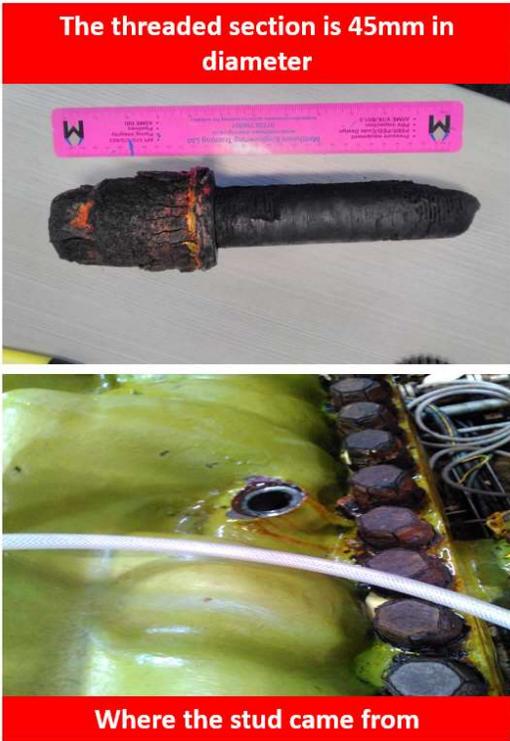
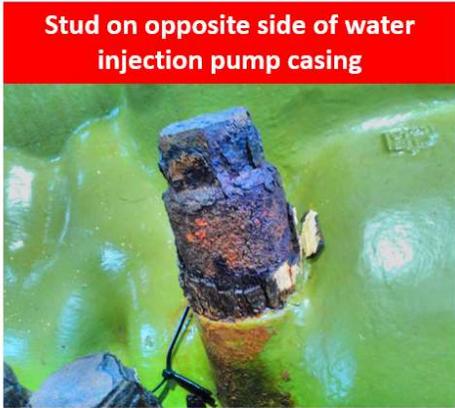
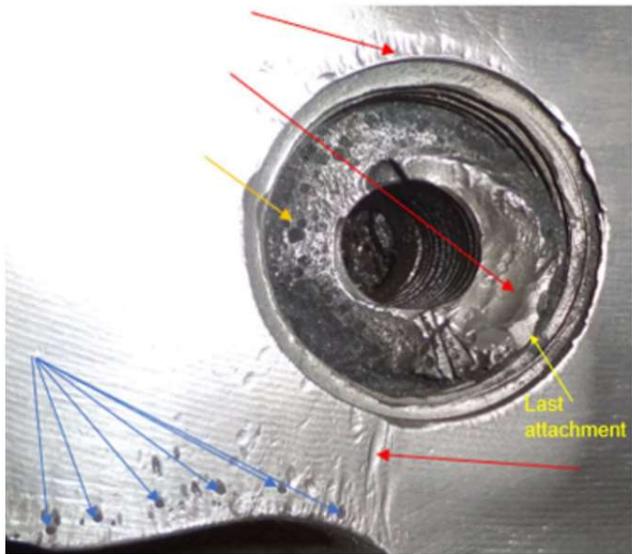
The bottom of the failed fastener is cleaned however still in the casing hole. (Note hole in centre is due to attempts to remove the rest of the remaining stud)

Blue arrows show pump OEM original design hydraulic profiling holes

Red arrows indicate erosion, smooth surfaces, even extending out the other side of the fastener hole

Orange arrow indicates corrosion

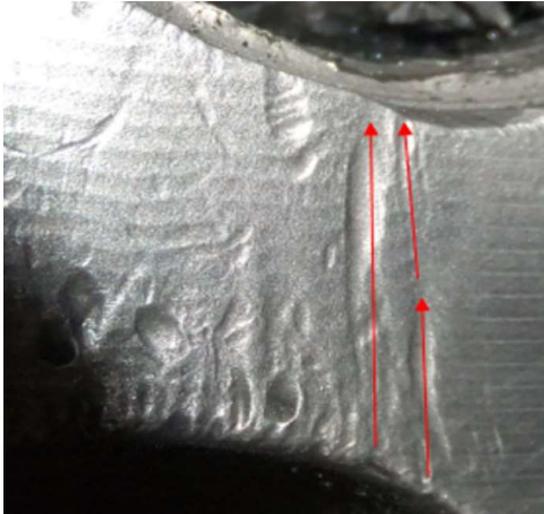
Cleaned area of erosion leak path to the fastener from last stage impeller (approx. 120barg), these channels are small approx. 0.75mm wide by 0.25mm deep, however this is enough to allow the sea water to get to the fastener. Hydraulic vortex erosion under this 120 barg is the estimated failure mode, this has also damaged/destroyed the gasket at this point

5. Are there any planned maintenance routines in place to inspect or schedule pump overhaul?
6. As part of pump overhaul, consider coating the two long casing fasteners to minimise corrosion/erosion effects if the pumped fluid does get to them, HVOF tungsten carbide suggested. This relates to fasteners 14 and 34 in this alert, the ones closest to the shaft and the last stage impeller. Only the area of the stud closest to the casing join requires additional protection.

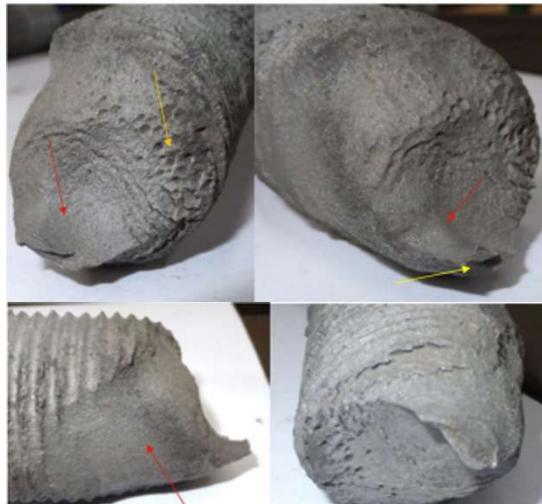
was. The pumpset was reliable and was being operated within all recommended operating parameters. It was pumping de-aerated sea water. The pump materials were standard for a sea water injection pumpset. There was no condition monitoring data in alarm. The pump had been in service for an excessive period with only minor routine maintenance having been conducted. The fastener failed due to erosion and corrosion.

This is the failed fastener, cleaned, showing evidence of corrosion and erosion damage.

Red arrows show erosion

Yellow arrow shows the final attachment point

Orange arrow shows corrosion
