SAFETY ALERT

Safety Alert No. 400
October 9, 2020

Trapped Pressure Ejects Rod From Chamber and Strikes Subsea Technician in the Face

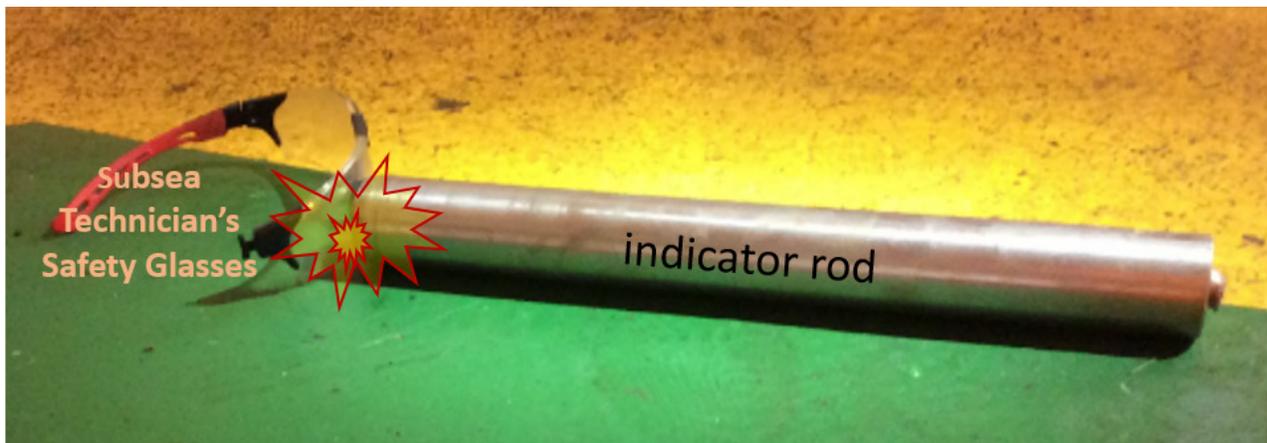
Sheared Indicator rod ejected from Hands-Free Goose Neck (HFGN) cartridge operator striking a subsea technician's safety glasses.

During blow-out preventer equipment pressure testing operations, a subsea technician sustained an injury while removing the Hands-Free Goose Neck (HFGN) locking cylinder assembly bolts. The technician was performing a work-around procedure when a sheared indicator rod ejected from the back side of the HFGN cartridge operator, striking the technician's safety glasses and face. The rod then continued to travel past two supervisors and landed on the upper moon pool platform.

An [investigation](#) indicated that the choke and kill stab locks would not retract because both the indicator rods sheared. The contractor's maintenance records showed the indicator rods sheared several months earlier but were not repaired or replaced. Instead of fixing the sheared indicator rods, the subsea team performed a work-around procedure to retract the choke and kill stab locks. This work-around did not note the hazard of indicator rods loose inside the cartridge operator flange after both sheared from the de-coupling segments.

BSEE recommends that operators and contractors consider the following:

- Maintain equipment in accordance with OEM specifications;
- Follow proper procedures when performing work orders;
- Do not use "Out of Service" equipment;
- Do not create work-around procedures for "Out of Service" equipment; and,

- Always be cognizant of potential trapped pressure and note this as a hazard on procedures and Job Safety Analysis.
