CONNECTING DATA TO DECISIONS

Linking Total Transformer Monitoring & Actionable Information
to Drive Business Value for Utilities

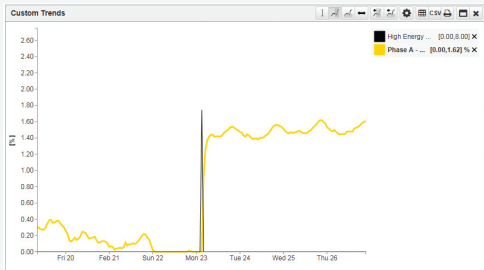
Figure 1. Capacitance increase in bushing A1 and high energy event recorded at the same time.

It was then found that at the precise moment of the bushing capacitance increase, a high energy event (partial discharge activity with significantly high magnitude, generally equal or higher than 20 V peak-peak [6]) was recorded in the same phase (from same sensor) by the online monitoring system. In this case, the recorded event had just 8 pulses per second and it happened just once. The fact that this event was recorded in conjunction with the capacitance increase was an important detail that prompted an additional offline test: oil sampling from the bushing and Dissolved Gas Analysis (DGA). Table 2 reports the results of the DGA analysis for bushings A and C. It can be clearly seen that the amount of acetylene in bushing A is well above the tolerance values, being 76 ppm; while level of acetylene in bushing C was zero, as expected.

Following the results shown in Table 2, South Korean Transmission Company promptly planned and executed the bushing replacement within a few months, thus saving the bushing from a potentially catastrophic incident. It must be noted that both the capacitance change and the repetition rate of the high energy event were quite small in terms of absolute magnitude. But being able to detect both these phenomena online and see that they occurred in the same moment provided crucial information enabling South Korean Transmission Company to take a very successful action.

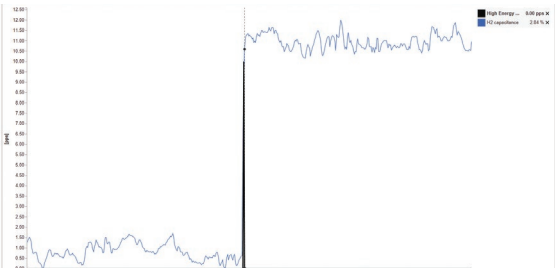
By looking at the data it was observed, once again, that a high energy event was recorded in conjunction with the capacitance increase in the same phase. Figure 1 shows the recorded data (not averaged, published every hour) and the partial discharge pattern. The event was characterized by impulses with significant magnitude (60 V peak-peak) and very small repetition rate (just 6 pulses per second), almost describing a sudden arcing activity. Recognizing the same correlation pattern (capacitance change + high energy event) seen in the KEPCO case, it was then suggested to the utility to take an oil sample of the bushings.

Figure 1. Capacitance increase in bushing H2 and high energy event recorded at the same time

Table 1 reports the comparison between the DGA from bushing H2 and H1, showing the acetylene concentration exceeding 20 ppm in the bushing where the capacitance change and high energy events have been detected, confirming the online analysis and enabling the utility to immediately plan the bushing replacement. The correlation of partial discharges and bushing monitoring data, along with proper offline tests, was successful in identifying the problem at a very early stage, optimizing the maintenance (in this case truly condition-based) and ultimately saving the transformer.

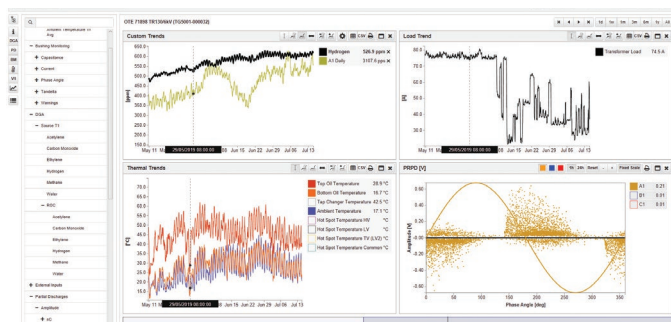
- Looking at all the data collected by the holistic monitoring system, it is possible to see that there is almost no correlation to load temperature or humidity. The gas generation and partial discharge activity are not influenced by the load, nor by temperatures and humidity.

Figure 2. Online results synchronized and visualized in a way to enable further investigation on the possible correlation

Due to an absence of hot and arcing gases, the perfect condition of the bushings (in terms of capacitance and TanDelta) as well as the absence of a clear correlation with load or temperature, the utility decided to:

- Keep the transformer monitored and under control in order to analyse the gas and partial discharge development during the next few months.
- Plan the gasket replacements in order to perform a proper oil treatment and refilling under vacuum to remove any possible trapped bubble.
- Agree that maintenance was to be planned. However, this could be deferred to the next stop of the generator considering that:
 - the overall picture provided by the online monitor indicated that the transformer was not in a critical condition, and
 - the transformer was continuously monitored so any unexpected change in the condition would promptly notify the Subject Matter Expert.

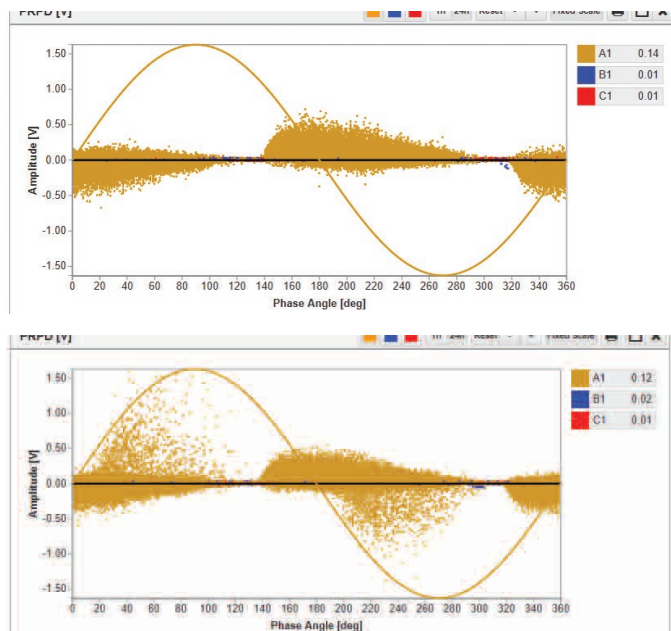
- The partial discharge module immediately detected a persistent active partial discharge source in phase A. This activity had two components, likely indicating two different defects:

- The first is always present and constant in amplitude and repetition rate (5000 pps) with indirect polarity and typical for defects inside the main tank (including the bushing turrets, i.e. whatever is outside the bushing core). This activity has no cross coupling with the other phases which means that the source is far from the other two phases or very close to the partial discharge sensor.

- The second is sporadic, with smaller repetition rate (in the range of 1000-2000 pps) and with direct polarity indicating that it could be inside or very close to bushing A. The overall partial discharge activity was increasing over time in terms of repetition rate, indicating that the active defect was in phase A.

- From the phase-resolved partial discharge (PRPD) pattern it was difficult to identify the partial discharge source, however similar shapes of the pattern had been recorded when the oil treatment was not conducted properly leaving small air bubbles trapped, or when small puncturing activities were present in the paper insulation on the top of the winding column (e.g. in the stress ring).

Figure 3. PRPD pattern of the stable partial discharge activity in Phase A1 (left) and the sporadic activity overlap (right)
